# Fire Risk Assessment

## Mountford House

**1-66, Glover Street,  
West Bromwich, B70 6DS**

**Date Completed: 04/12/2024**

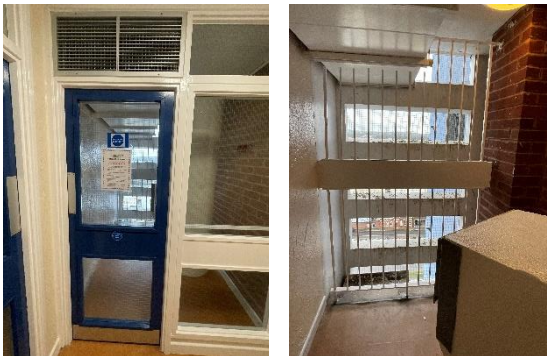
17) A high-level metal duct provides ventilation to stairwell lobbies on each floor. The duct has been installed with a grill with built in fire damper and has been coated with a 60-minute fire protective coating.

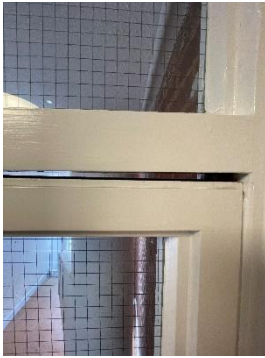
- 19) 15<sup>th</sup> floor chute room combination frame. Gap between frames require fire stopping.
-

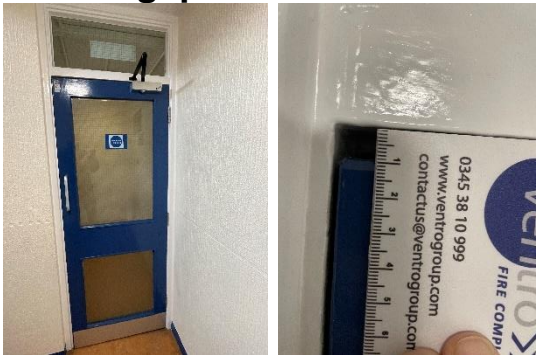
**20) 13<sup>th</sup> floor landing door to stairs has a gap from the handle side down that extends to 10mm. Door requires rehangng to reduce gap.**

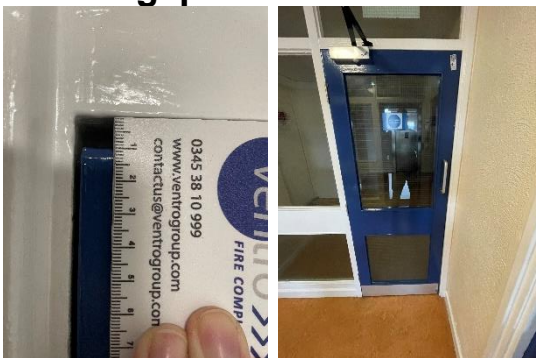
**21) 13<sup>th</sup> floor lobby door has an excessive gap from the handle side down that extends to 10mm. Door requires rehangng to reduce gap.**

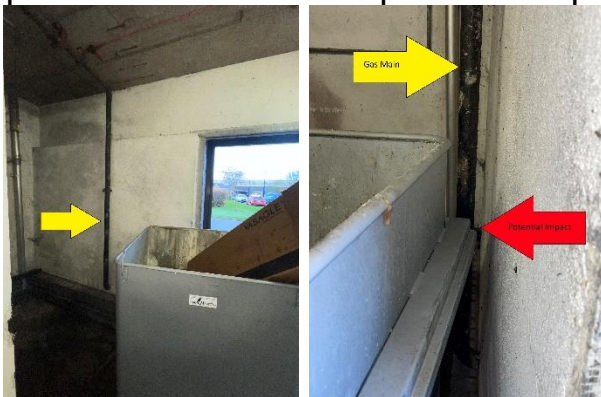
**23) Bin storage room – The fibre cement boards enclosing a shaft containing soil stack and gas main have been damaged by the movement of bins. The fire resistant boards should be replaced with a product of equal or better fire resistance to enable 60 minutes protection. Because the shaft contains a gas main an intumescent vent should be installed to the finished surface.**

Email sent to SG at Cadent to inspect the gas riser in bin store which potentially requires the installation of a barrier. This would protect the main from potential impact from the movement of bins.

10/23	Bin Storage room – Remove / replace damaged fibre cement boards to shaft to provide 60 minutes fire resistance & install intumescent ventilation grill to surface. (barrier to erected / contact CH)	 	P2	Within 1-3 months. Fire Safety Rapid Team	
-------	--	--	----	--	--

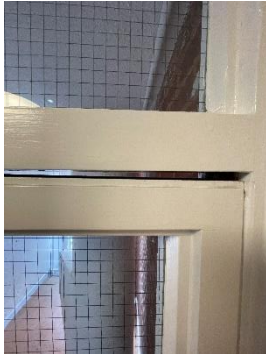
Question/ Ref No	Required Action	Supporting photograph	Priority	Timescale and Person Responsible	Date Completed
10/19	15 <sup>th</sup> floor chute room – Fire stop gap between frames

P2	Within 1-3 months. Fire Safety Rapid Team

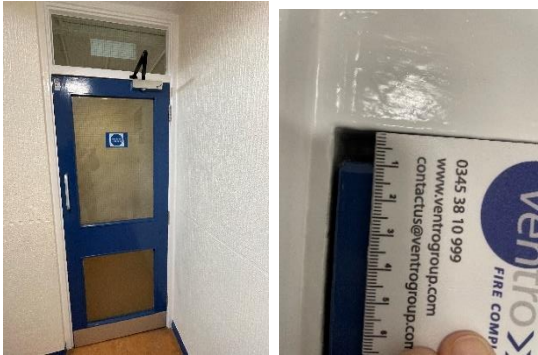
<p>10/20</p>	<p>13<sup>th</sup> floor - Rehang landing door to stairs to reduce excessive gap on handle side down (10mm)</p>

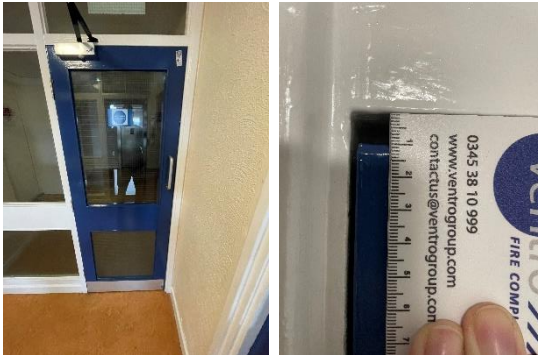
<p>P2</p>	<p>Within 1-3 months. Fire Safety Rapid Team</p>	
<p>10/21</p>	<p>13<sup>th</sup> floor – Rehang lobby door to reduce excessive gap on handle side down (10mm)</p>

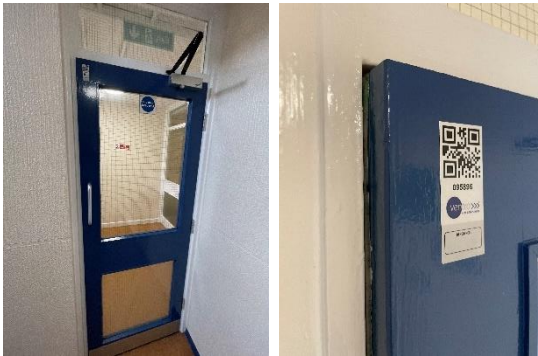
<p>P2</p>	<p>Within 1-3 months. Fire Safety Rapid Team</p>	
<p>10/22</p>	<p>6<sup>th</sup> floor – Landing door to stairs not reliably self-closing requires adjustment</p>

<p>P2</p>	<p>Within 1-3 months. Fire Safety Rapid Team</p>

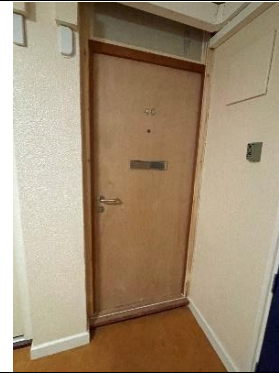
Flat 40 – replacement timber nominal fd30s door installed. Consider certified FD30s door set.
