Fire Risk Assessment

Mountford House

**1-66, Glover Street,
West Bromwich, B70 6DS**

Date Completed: 14/12/2023

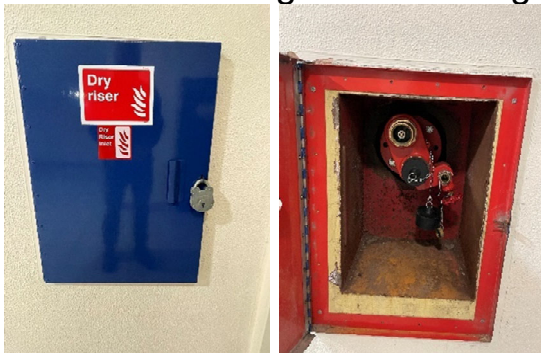
The dry riser inlet is internal and adjacent the ground floor lift cars. It is accessed utilising a suited bridge door padlock.

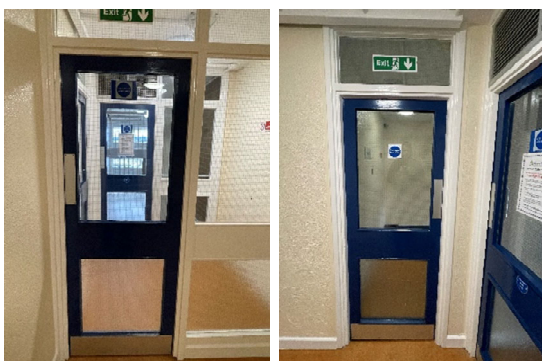
- 3) None of the corridors that form part of the means of escape are dead ends.
 - 4) The means of escape are protected to prevent the spread of fire and smoke.
 - 5) The communal landing / staircases are protected by use of self-closing 44mm notional 30-minute timber fire doors with vision panels. All doors have been upgraded with combined intumescent strips / cold smoke seals. [Refer to section 10/12.](#)
-

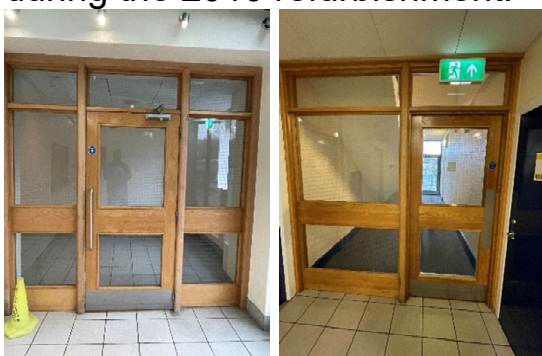
- 6) The ground floor lobby is protected by use of nominal 54mm FD60s doors and combination frames. These doors were installed during the 2010 refurbishment.

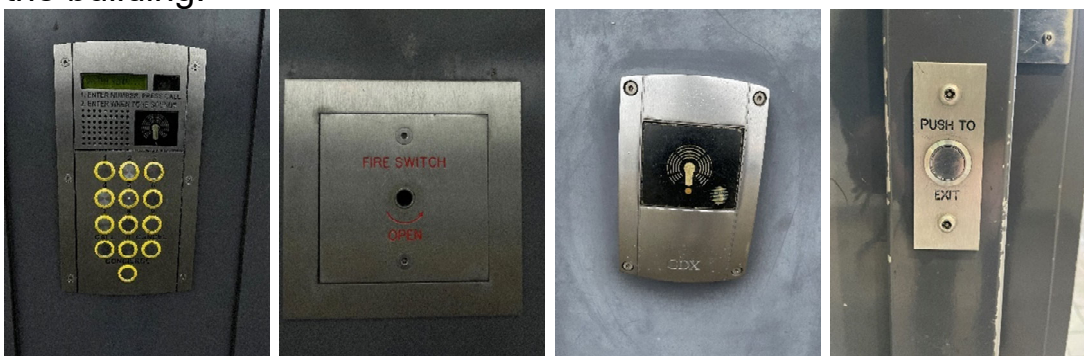
- 7) All communal doors are fitted with automatic closing devices that are checked on a regular basis by Caretaking Teams as part of their checks. Defective closing devices are replaced either by the Caretaking Team(s) or the in-house repairs team(s).
- 8) All communal fire doors are subject to a 12-week check by the Fire Safety Rapid Response Team.
- 9) The final exit doors have door entry systems installed. These systems are designed to fail safe i.e. door unlocked in the event of a power failure. This prevents residents being locked in or out of the building.

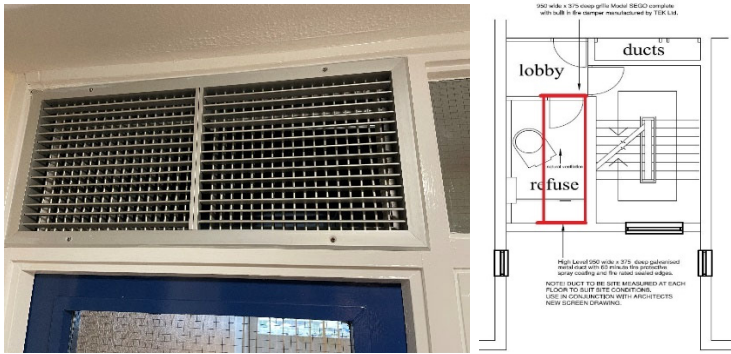
17) A high-level metal duct provides ventilation to stairwell lobbies on each floor. The duct has been installed with a grill with built in fire damper and has been coated with a 60-minute fire protective coating.

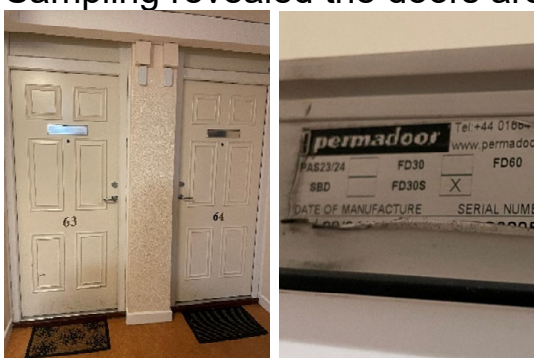
27) Individual flat doors are FD30s composite fire door sets with intumescent strips, cold smoke seals and self-closing devices. Sampling revealed the doors are manufactured by Permadoor.

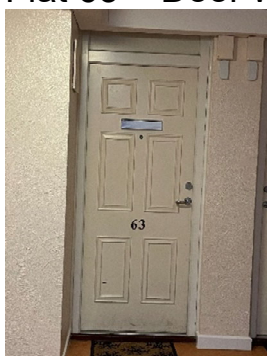
a) Flat 63 – Door was correct.

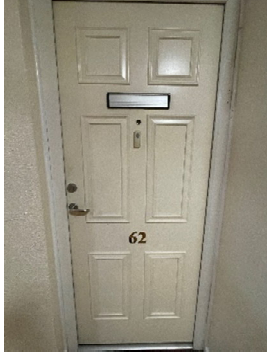
b) Flat 62 – Door was correct.

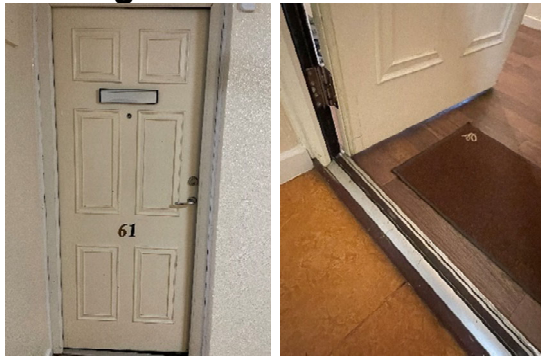
c) Flat 61 – Door binds on threshold and not reliably self-closing.

In conclusion, the likelihood of a fire is at a medium level of risk prior to the implementation of the action plan because of the potential fire hazards that have been highlighted within the risk assessment, including the requirement of firestopping to the rear of the dry riser inlet cabinet and the corrective works to ensure flats 35 & 61 entrance doors can reliably self-close.

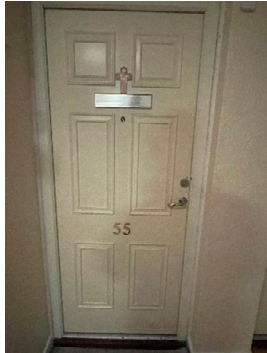
d) Flat 55 – Door was correct.

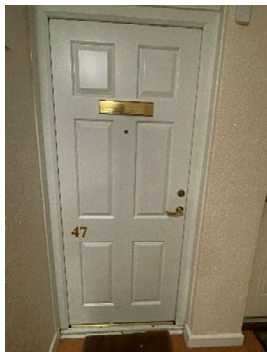
e) Flat 47 - Door was correct.

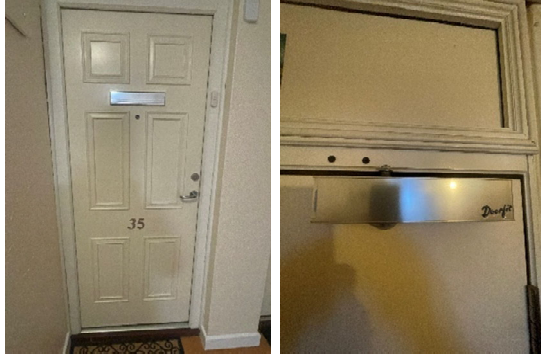
f) Flat 35 – Connecting arm removed from self-closer.

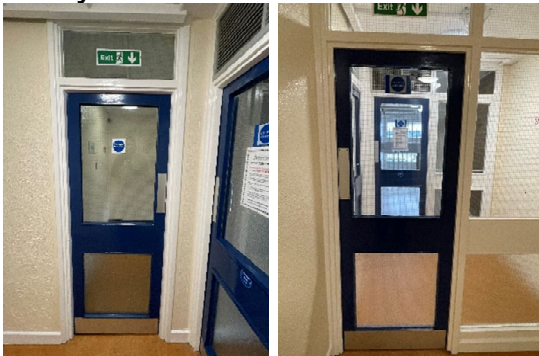
- 12) The communal landings & staircases are protected by use of notional self-closing 44mm 30-minute timber fire doors with vision panels and 25mm rebates. It is recognised that these doors do not meet today's benchmark of a certified FD30s fire door install however, because they were installed at the time of the buildings construction and to the standard of that time they are deemed as acceptable so long as the doors are free of damage and function as they were intended to do so. It has been recognised that all of the landing / staircase notional doors in this block have been upgraded with combined intumescent strips & cold smoke seals to enhance their original design and minimise departures from today's standards.

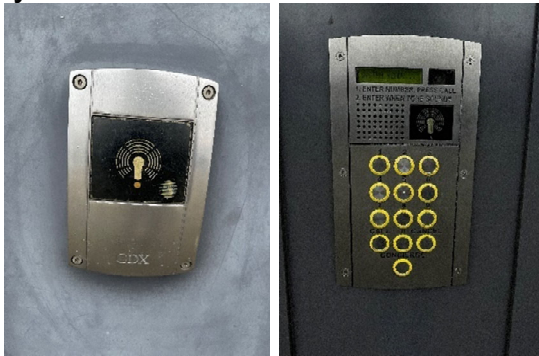
- 1) Regular checks are undertaken by Caretakers / Cleaning Team(s) 365 days per year which helps reduce the risk of arson.
- 2) Restricted access to the premises by means of a door entry system.

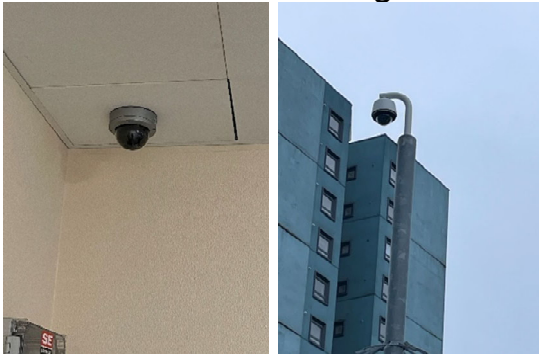
- 3) CCTV has been installed to the ground floor lobby, each entrance and around the building.

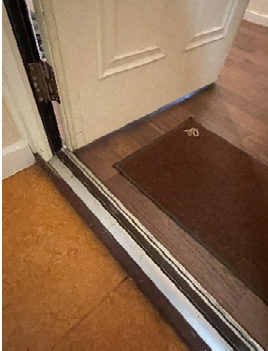
Question/ Ref No	Required Action	Supporting photograph	Priority	Timescale and Person Responsible	Date Completed
7/28c	Flat 61 – adjust entrance door to prevent binding on threshold. (Not self-closing).

P2	Within 1- 3 months Fire Rapid Response

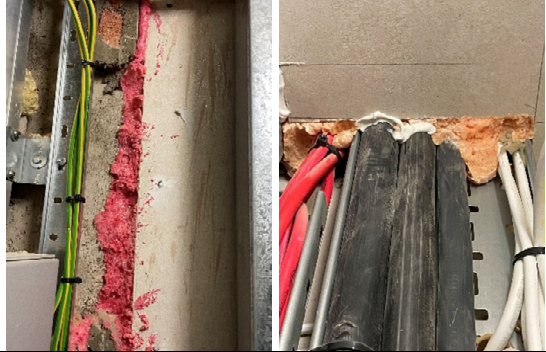
Observations	
Consideration should be given to enhance fire stopping where fire stopping foam has been utilised in some service & riser cupboards.
