Fire Risk Assessment

Ashcroft

**Windmill Lane,
Smethwick, B66 3JR**

Date Completed: 06/10/2023

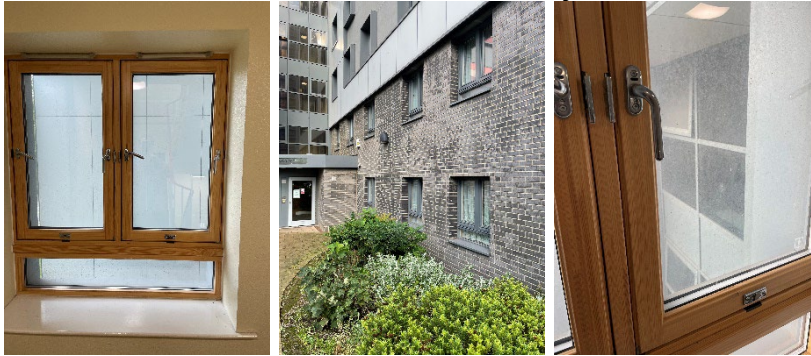
- 3) All windows are double glazed units housed in aluminium frames. Timber frames were noted internally within the staircase.

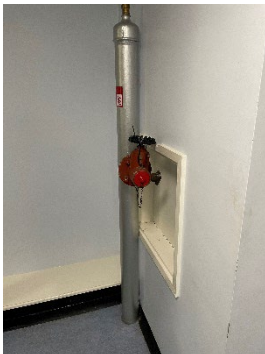
- 16) Dry riser outlets on lobbies are not housed in service cupboards but deliveries are secured by cable tie.

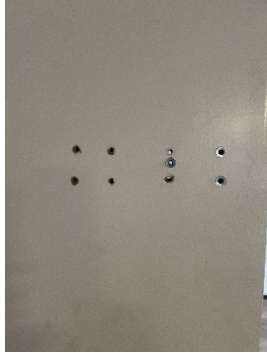
f) Fire door to roof (directly behind steel door) Open at time of inspection and several holes evident the full width of the door.

P2	Repairs. 1-3 months	
07/21-F	Fire door to roof void. Fill door with intumescent filler.

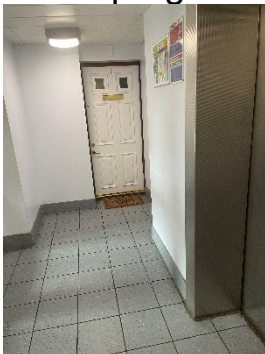
23) The lift doors at ground floor have no fire separation from the flats on the left-hand side of the building. The installation of a fire resisting door and partition should be considered as part of future works programme.

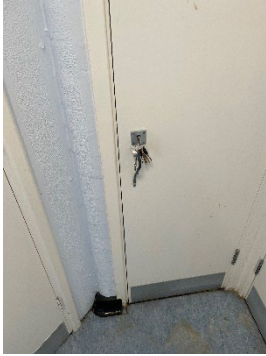
- 14) **Floor 6. Chute room small door. Lock cannot turn to engage.**
-

P2	Fire Rapid Response Team 1-3 Months JM:12067912	16/10/2023
10/14	Floor 6. Chute room. Small door. Repair required to lock to ensure it can be turned to engage.

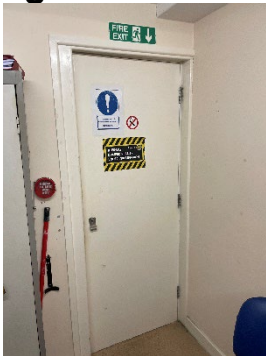
23) Ground Floor Welfare room door not positively closing against latch.

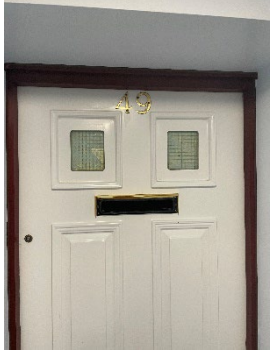
- a) Flat 63 - Door not positively shutting against latch.
- b) Flat 38 - Door not positively shutting against latch.
- c) External inspection. Flat 49 has a missing letter plate.

JM:12067606	
07/21-C	Flat 49. Renew intumescent letter plate.

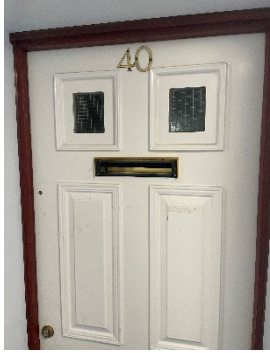
- d) External inspection. Flat 40 has a missing letter plate.

P2	Fire Rapid Response Team 1-3 months JM:12067640	16/10/2023
07/21-D	Flat 40. Renew intumescent letter plate.

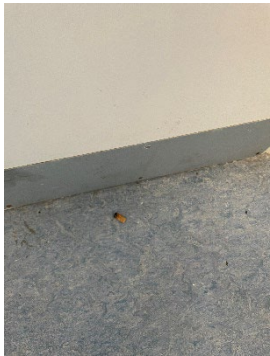
In conclusion, the likelihood of a fire is at a medium level of risk prior to the implementation of the action plan because of the potential fire hazards that have been highlighted within the risk assessment, including evidence of smoking within the staircase.

P2	Fire Rapid Response Team 1-3 Months JM:12068188	16/10/2023
14/01	Tenants to be reminded that no smoking is allowed within communal areas.
