# Fire Risk Assessment Beaconview House

**Beaconview Road, West Bromwich ,  
B71 3PL**

**Date Completed: 02/02/2024**

**Current Risk Rating = Tolerable**

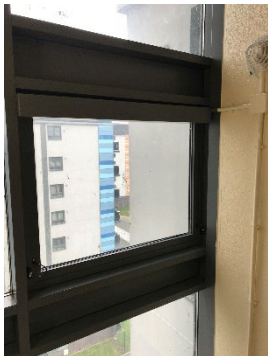
- 11) Communal windows can only be opened by operating the automatic smoke vents.

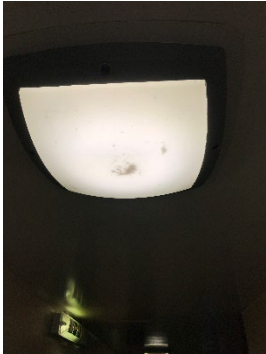
- 13) Emergency lighting is provided to communal landings and stairs. Checks are done on a monthly basis by Sandwell MBC in house electrical team or approved contractor.

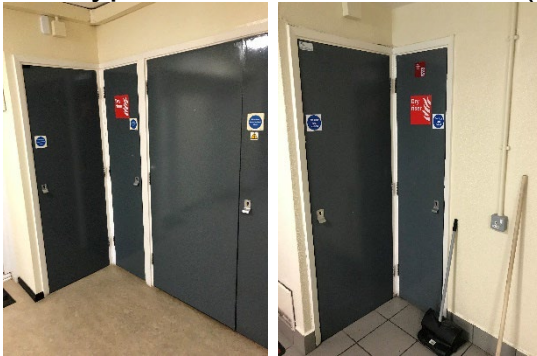
- 14) Dry riser cupboard doors are timber 44mm nominal FD30s with intumescent strips and cold smoke seals, kept locked / secured with type 54 suited mortice lock(s).

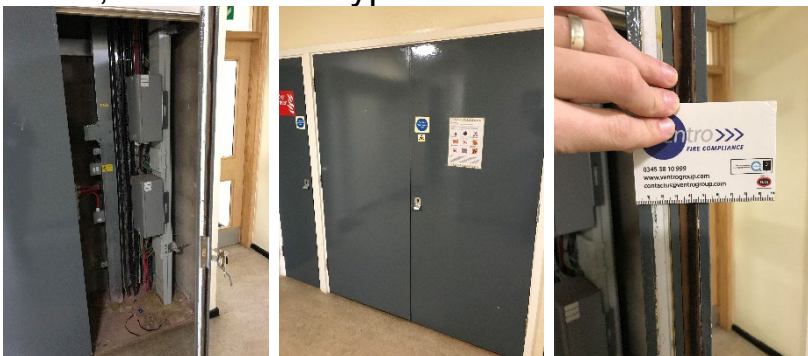
- 15) Service cupboards are nominal timber 54mm double FD60s doors, secured with type 54 suited mortice locks.

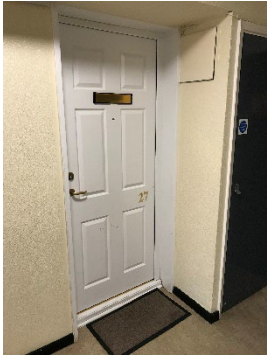
- 18) Individual flat doors are predominantly nominal 44mm FD30s composite doors sets with intumescent strips and cold smoke seals.

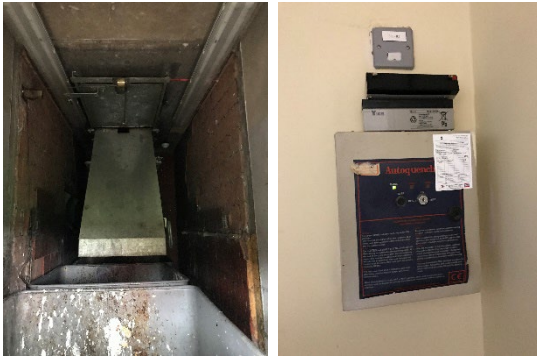
- 4) A sprinkler or deluge system is provided to the refuse chute bin store. An approved contractor maintains the system. The frequency for the maintenance checks are twice per year (April and October) of each calendar year. The control panel can be found in the main office area

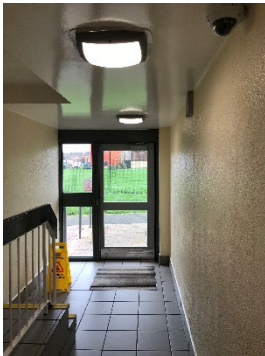
- 1) The premises have a sufficient emergency lighting in accordance with BS 5266 and has test points strategically located.
- 2) The units are provided to the communal landings, stairs and lift motor room.

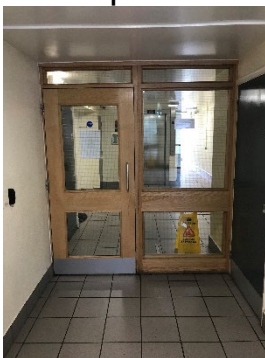
- 10) corridors / staircases are protected by use of FD30s fire doors with vision panels.

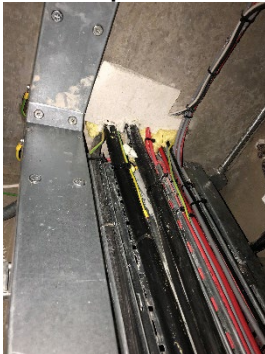
- 12) Noted the use of expanding foam was present within the communal cupboards around cabling as part of the fire stopping knowing that intumescent pads and a concrete slab is present and this foam is only used as an enhancement it is deemed tolerable. This should be enhanced as part of future works to the building and replaced with intumescent mastic to improve fire stopping

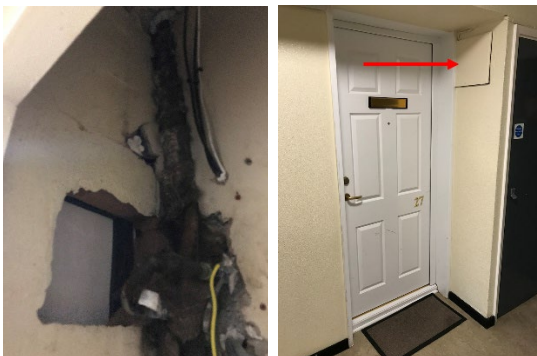
- 13) Access panels to stop taps are fixed to masonry and bedded on Intumescent material.

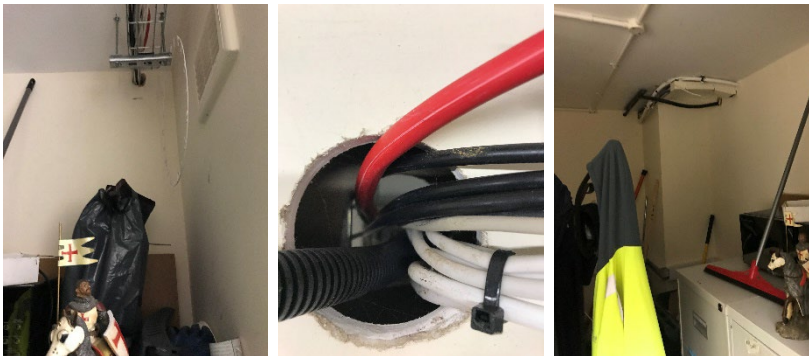
- 16) Fire stopping required to holes in walls in small office/ storeroom in areas such as where the cable tray breaches walls into server room and opposite side of smaller office area/ storeroom

10/15	3 <sup>rd</sup> floor replace missing combined intumescent cold smoke seal from bottom hinge side of electrical service cupboard door	N/A	P2	Fire Rapid Response 1-3 months	
10/16	Fire stopping required to holes in walls in small office/ storeroom in areas where the cable tray breaches walls into server room and opposite side of the wall

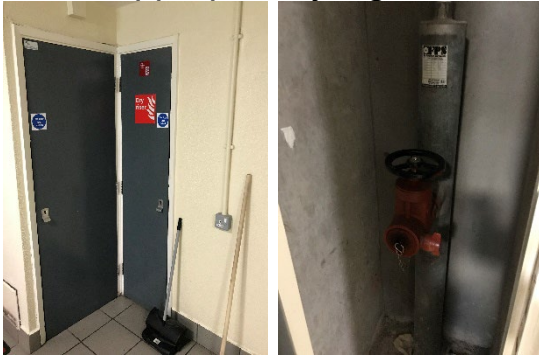
- 1) The dry riser inlet cupboard is located in the ground floor lift lobby and is appropriately signed

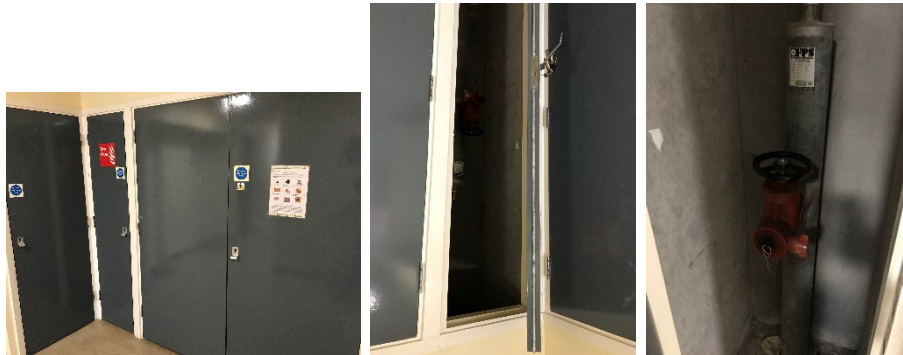
- 2) The riser outlets are available on each floor lobby (ground – 8<sup>th</sup>) these are protected via nominal 44mm 30-minute fire doors secured by suited 54 key & mortice locks.

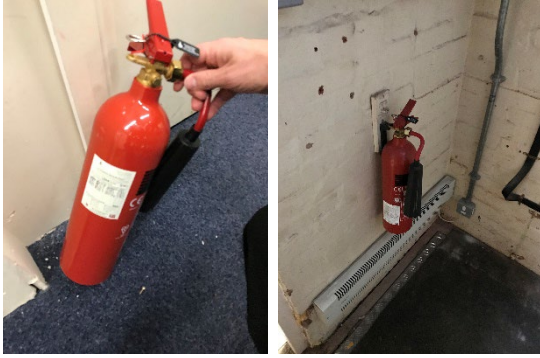
- 3) The dry riser is checked regularly as part of the Caretakers duties.
  - 4) Maintenance contracts in place to service the valves twice per year (April and October) with a hydraulic test undertaken annually (October) to comply with the requirements of BS9990.
  - 5) Portable fire extinguisher (CO<sub>2</sub>) is provided to the lift motor room and office area within server room. Maintenance contracts in place for maintenance of the extinguisher. The frequency for the maintenance checks are once of each calendar year last check was conducted October 2023
-

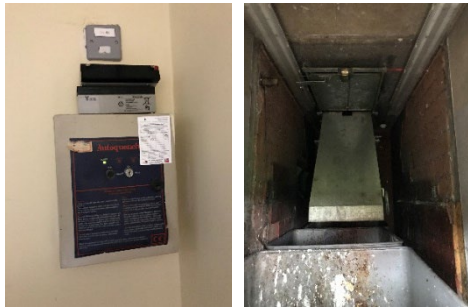
- 6) Bin room is protected by Deluge/sprinkler system and serviced 6-monthly, the control panel is stored within the ground floor office area.

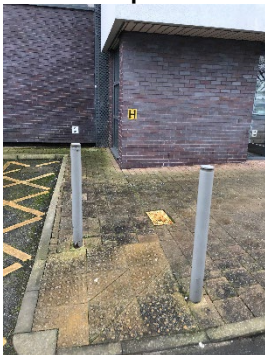
- 7) Fire hydrant can be located at the side elevation nearest the main access point to the building
