Fire Risk Assessment

Broome House

**Beaconview Road, West Bromwich ,
B71 3PN**

Date Completed: 26/01/2024

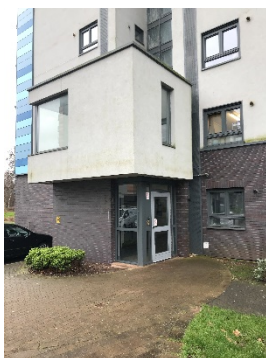
(Left side MAP)

There is an entrance/ exit to the left side elevation to the block with an additional entrance/exit to the right side elevation (from the main road). The left side elevations entrance acts as the main access point to the block.

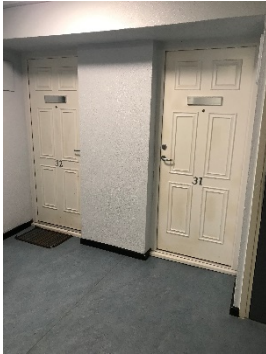
- 18) Individual flat doors are predominantly nominal 44mm FD30s composite doors sets with intumescent strips and cold smoke seals.

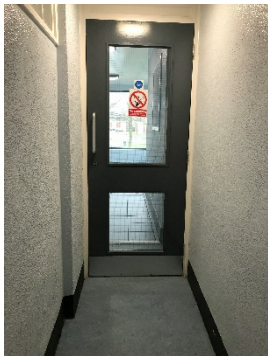
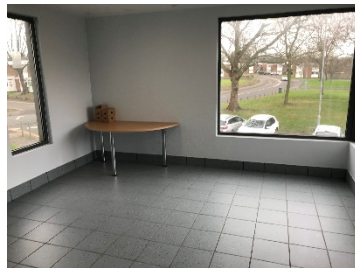
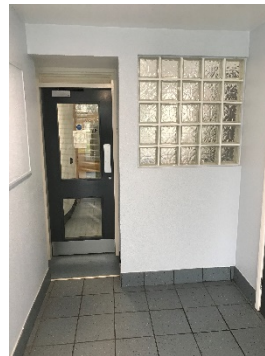
- 20) Communal viewing pod located on the first floor secured with a 44mm timber nominal door with intumescent strips, cold smoke seals and vision panels is secured with a type 34 mortice lock that residents have access this room remains relatively sterile with the cleaners cupboard also being within this area.

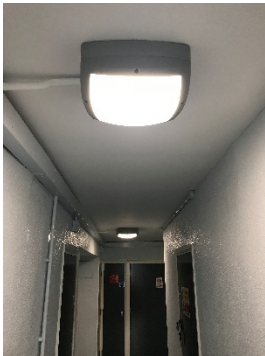
- 1) The premises has a sufficient emergency lighting in accordance with BS 5266 and has test points strategically located.
- 2) The units are provided to the communal landings, stairs and lift motor room.

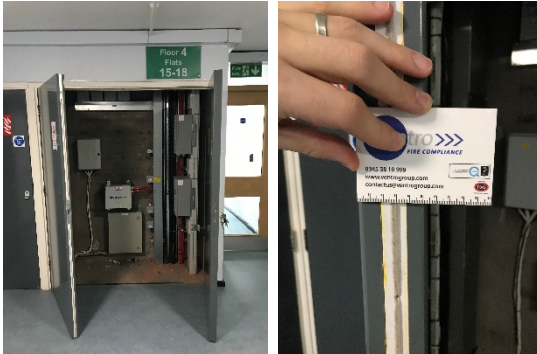
- 11) Cupboard doors within the communal areas such as residents meter cupboards/ electrical risers cupboards are notional 54mm FD60 timber fire door sets with intumescent strips, cold smoke seals.

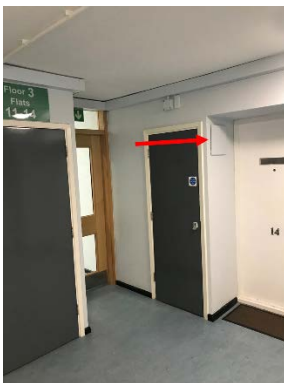
- 13) Access panels to stop taps are fixed to masonry and bedded on Intumescent material.

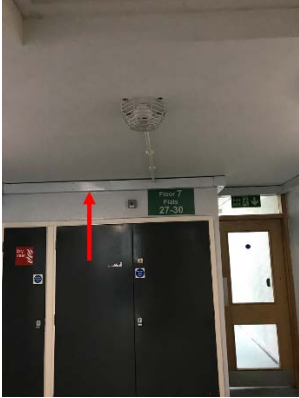
- 14) It was noted that metal trunking had been utilised to house cabling in communal areas

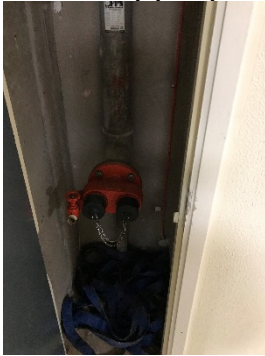
- 1) The dry riser inlet cupboard is located in the ground floor lift lobby and is appropriately signed

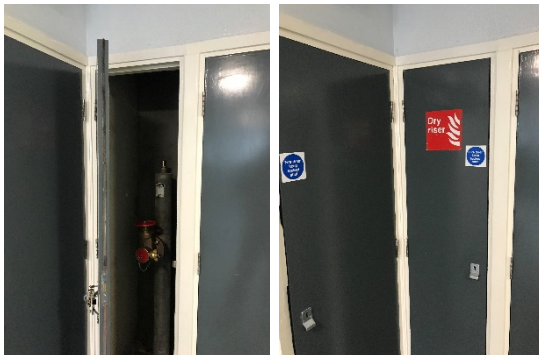
- 2) The riser outlets are available on each floor lobby (ground – 8th) these are protected via nominal 44mm 30-minute fire doors secured by suited 54 key & mortice locks.

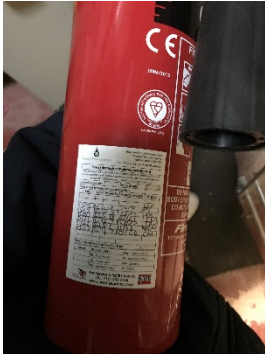
- 5) Portable fire extinguisher (CO2) is provided to the lift motor room. Maintenance contracts in place for maintenance of the extinguisher. The frequency for the maintenance checks are once of each calendar year last check was conducted October 2023

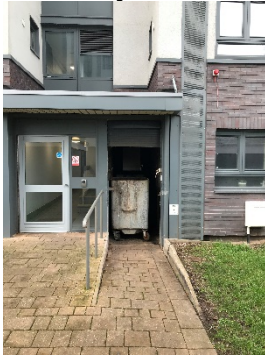
- 6) Bin room is protected by Deluge/sprinkler system and serviced 6-monthly, the control panel is stored under the stairs

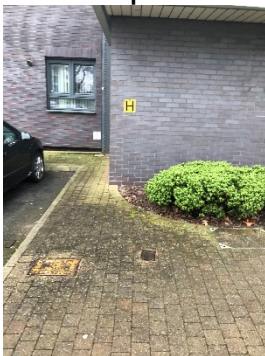
- 7) Fire hydrant can be located at the side elevation nearest the main access point to the building

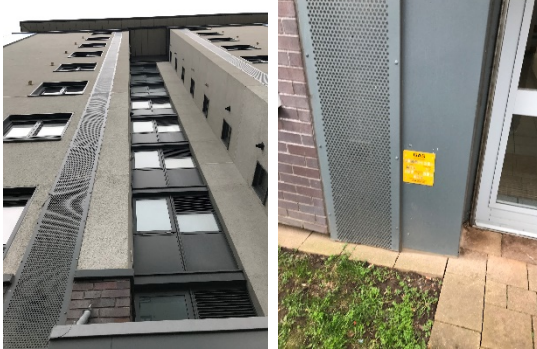
- 8) Gas appliances and pipework (where installed) are subject to annual testing and certification. This cyclical contract is managed by the in-house Gas Team. **Gas supplies are external secured behind corrugated panels.**

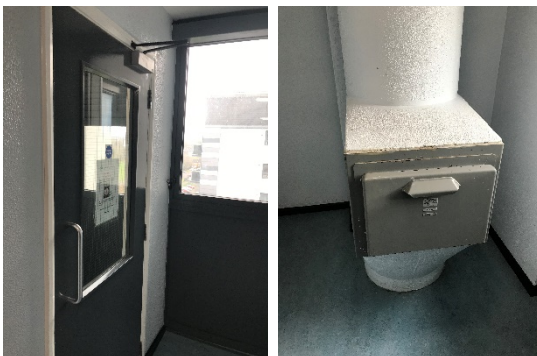
- 1) There is a regular Cleaning Service to the premises.
- 2) Refuse hoppers are accessed on each floor secured behind its own dedicated nominal 44mm 30-minute door with combined intumescent and cold smoke seals.
