# Fire Risk Assessment

## Bowater House

Moor Street, West Bromwich,  
B70 7AZ

**Date Completed:** 20<sup>th</sup> December 2024

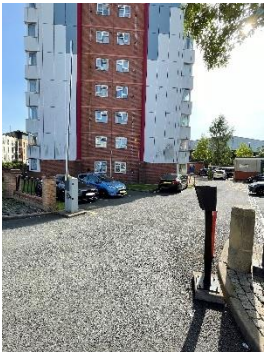
Access to the rear carpark is restricted by an automated barrier. The code to access through the barrier is 7495A. It was noted that during the assessment the barrier was continually in the raised position.

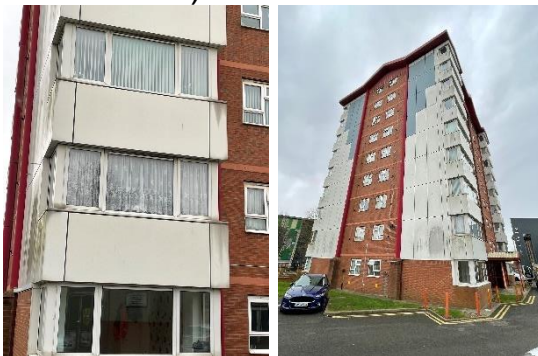
- 3) 3mm solid aluminium panels clad approximately 32% of the external walls to include the enclosure of the former balconies. Information available at the time of the risk assessment (delta submission) records fire classification as A1.

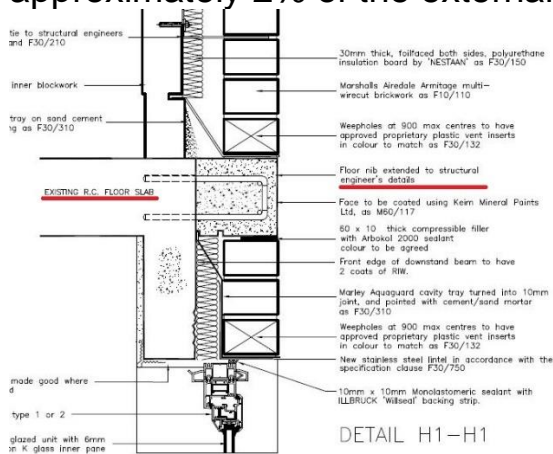
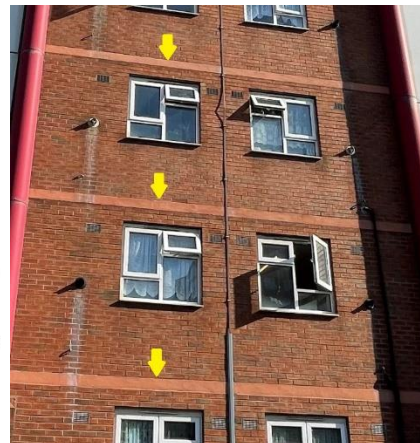
- 5) Insulation to the masonry cavity has been identified as 30mm foil faced PUR tongue & groove boards manufactured by Nestaan. This detail is recorded on an architect drawing.
- 6) The original concrete floor slab was extended and now forms approximately 2% of the external wall surface area.

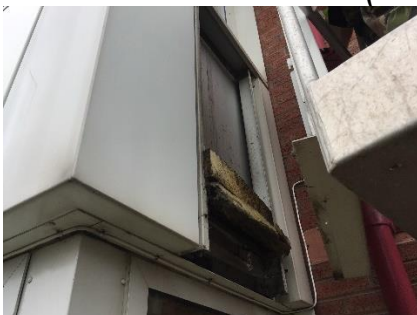
*Historic images were provided inhouse which appear to show a horizontal layer of mineral wool between the cantilevered concrete base and PUR board (enclosed balconies).*

*It appears that the extended concrete floor slabs could provide horizontal fire stopping between floors.*

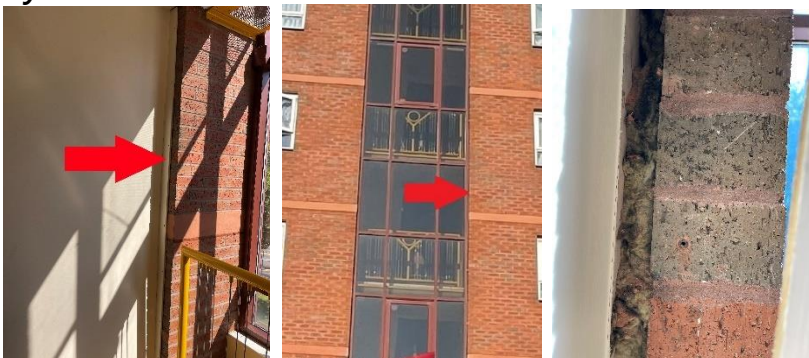
*An MDF strip with unknown fire rating was removed to inspect the cavity between the 1-hour party wall between a flat and the stairwell. This is where external masonry returns into the protected front stairwell. The cavity between the two surfaces was insulated with mineral wool. At the time of the inspection, it could not be determined if this cavity extended into the cavity of the external wall system.*

*Additional information was received after the inspection confirming that these cavities are in fact closed off by the return of the blockwork at the window positions. The MDF trim is in place for decorative purposes.*

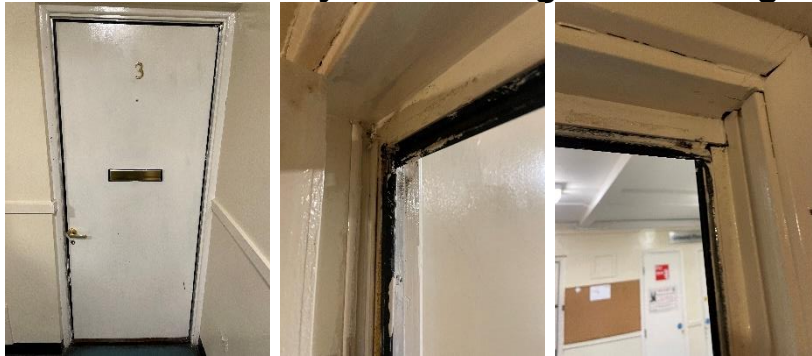
- b) Flat 3 – Cold smoke seal is partially missing, and the door is not reliably self-closing from all angles.**

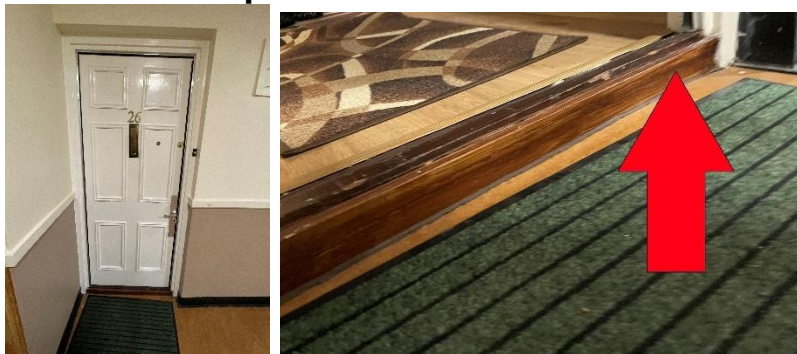
- d) Flat 26 – Door is not reliably self-closing, and the timber threshold strip is loose and should be re-fixed.**

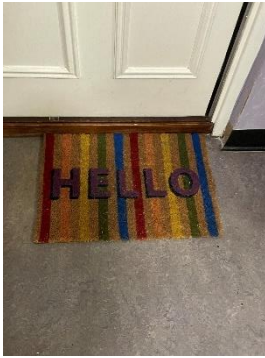
- 21) Individual floor mats were noted outside some flat entrance doors. The fire rating of the individual mats is unknown however, they are deemed to be of low risk.

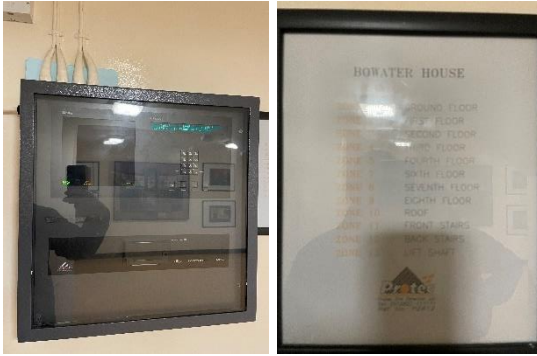
- 3) There's a communal fire alarm system installed at Bowater House. The panel and zone plan can be found within the ground floor entrance lobby. The system is checked and tested weekly and bi-annually by the in house electrical team or procured contractor. **The date of the last weekly test (recorded on site) was noted as 15/10/24 which suggests there may not have been any testing between this date and the time of this survey. Therefore, an email has been sent to the inhouse electrical team requesting further information. Confirmation was received from them confirming that routine testing of the fire alarm system has been delayed due to contractual changes with the approved contractor, and that routine servicing is close to being resumed.**

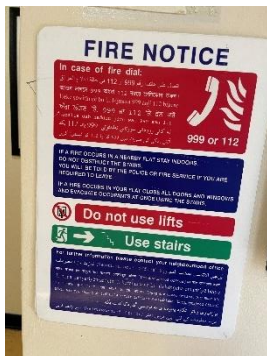
- 2) Fire Action Notices are displayed throughout the building. However, there is no instruction or reference to “on hearing the fire alarm”. A discussion with the (now former) Head of Building Safety and Compliance, RH has concluded that the Stay Put - Unless evacuation strategy shall remain in place. The communal fire alarm system shall also remain and continue to be maintained as a temporary measure until the results of the FRAEW from the specialist contractor have been received, and any identified remedials have been satisfactorily completed to lower any identified risks. The communal fire alarm will then be decommissioned.

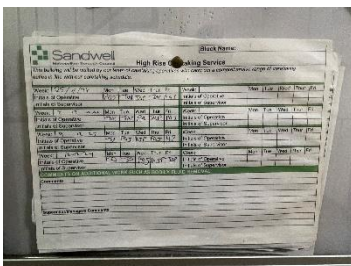
- 3) Regular checks by Caretakers minimise risk of waste accumulation.

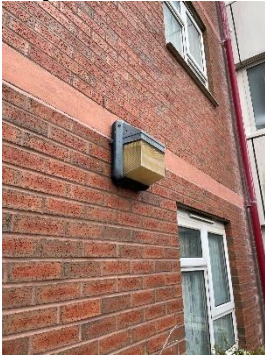
- 1) Regular checks are undertaken by Caretakers / Cleaning Team(s) 365 days per year which helps reduce the risk of arson.
- 2) Restricted access to the premises by means of a door entry system.
- 3) CCTV is not present.
- 4) There is no current evidence of arson.
- 5) The perimeter of the premises is well illuminated. The electrical compliance manager has confirmed that a job has been raised adjust the timer to the external lights.

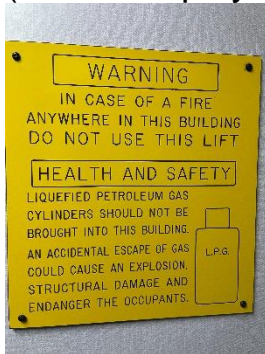
- 1) Residents instructed not to bring L.P.G cylinders into block.  
(Notice displayed in lifts see point 9-3)
