# Fire Risk Assessment

## Bowater House

Moor Street, West Bromwich,  
B70 7AZ

**Date Completed:** 5<sup>th</sup> September 2023

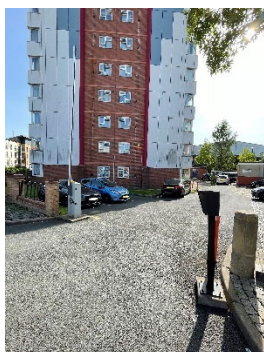
Access to the rear carpark is restricted by an automated barrier. The code to access through the barrier is 7495A. It was noted that during the assessment the barrier was continually in the raised position.

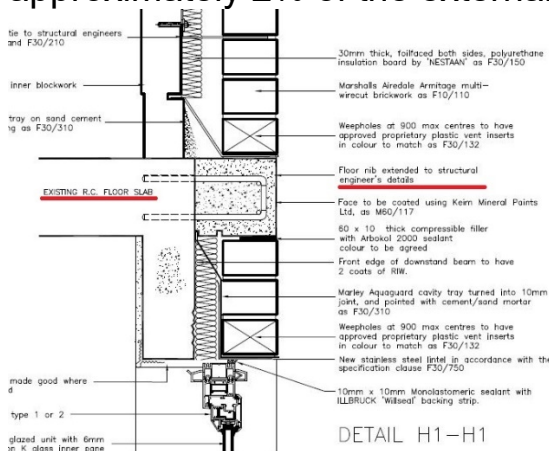
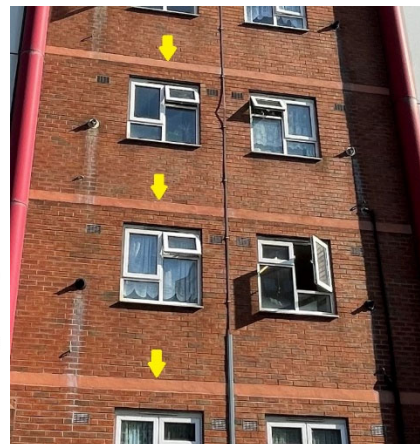
- 5) Insulation to the masonry cavity has been identified as 30mm foil faced PUR tongue & groove boards manufactured by Nestaan. This detail is recorded on an architect drawing.

- 6) The original concrete floor slab was extended and now forms approximately 2% of the external wall surface area.

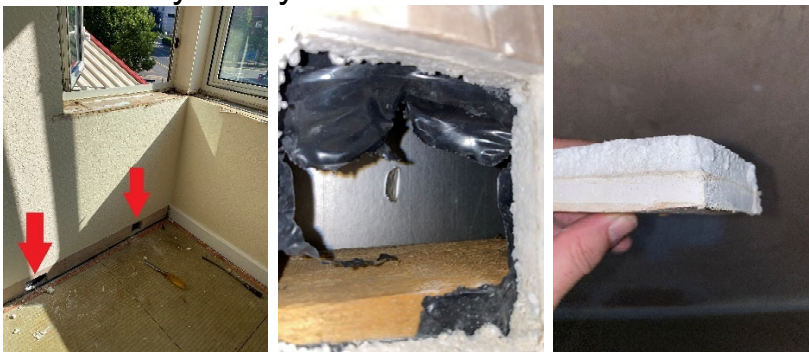
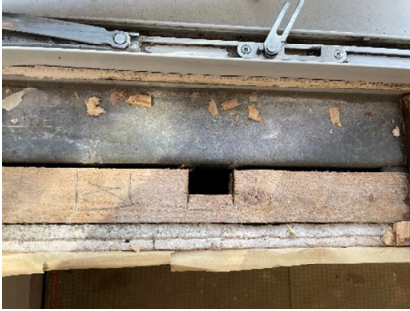
Within a void flat, inspection holes were created behind the skirting board and beneath the window sills to the enclosed balcony / bay window. The inspection holes revealed the following materials within the construction;

- uPVC window cill board with ply beneath.
- 9.5mm gypsum plasterboard with a 10mm polystyrene layer bonded to the rear for basic thermal insulation.
- Damp proof membrane (polythene sheet).
- Timber studwork.
- PUR board.

The borescope could not access beneath or behind the PUR boards or the area where the cavity within the balcony meets the masonry or masonry cavity.

**However, it is recommended that as a precautionary measure further technical advice is sought from a competent fire safety professional or qualified engineer with adequate experience and knowledge in external wall systems. This will confirm if the appropriate level of safety through the correct design and installation of external wall system has been achieved.**

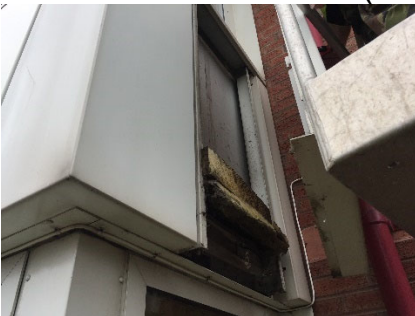
Historic images were provided inhouse which appear to show a horizontal layer of mineral wool between the cantilevered concrete base and PUR board (enclosed balconies).

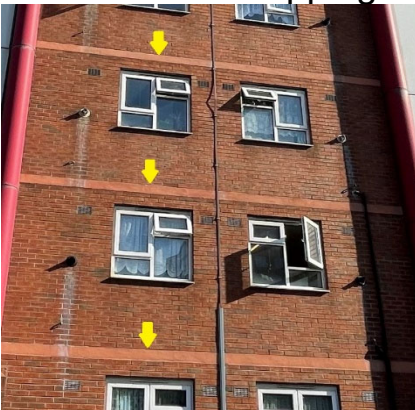
It appears that the extended concrete floor slabs could provide horizontal fire stopping between floors.

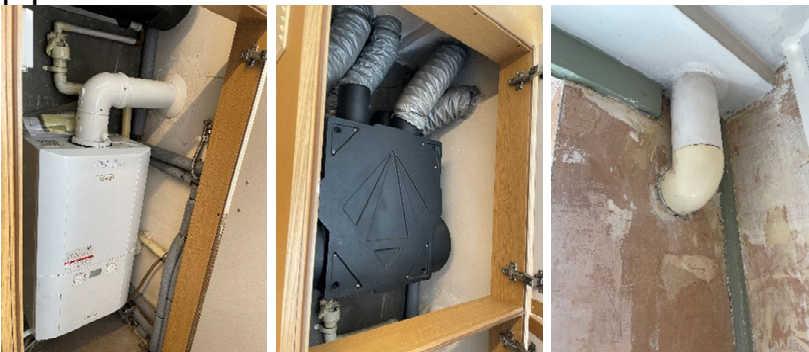
At the time of the assessment it was not determined if cavity barriers are in place around openings for windows, ventilation pipework and flues.

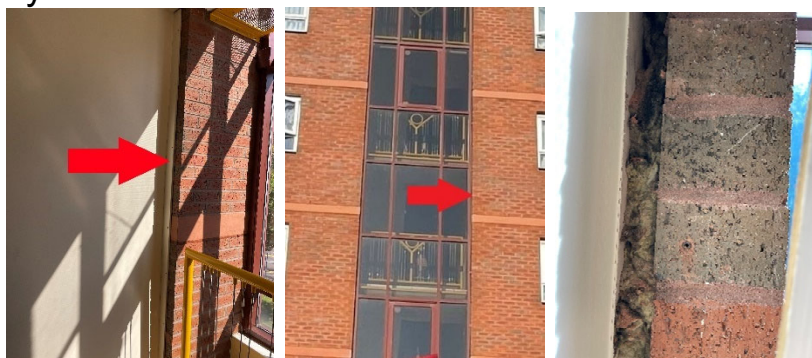
An MDF strip with unknown fire rating was removed to inspect the cavity between the 1-hour party wall between a flat and the stairwell. This is where external masonry returns into the protected front stairwell. The cavity between the two surfaces was insulated with mineral wool. At the time of the inspection it could not be determined if this cavity extended into the cavity of the external wall system.

Additional information was received after the inspection confirming that these cavities are in fact closed off by the return of the blockwork at the window positions. The MDF trim is in place for decorative purposes.

- 13) The fire rating of the MDF strips covering the small cavities between the party walls and external blockwork return to the stairwells on each floor are unknown however it has been confirmed that these cavities have been closed off at the window position by the return of the blockwork. The mineral wool effectively provides additional fire stopping.

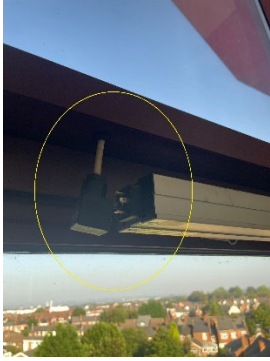
**The actuator to the AOV between the 7<sup>th</sup> & 8<sup>th</sup> floors / rear stairwell was in continuous operation despite the vent remaining shut. This fault was immediately reported to the service contractor who attended the same day to isolate the device.**

06/14	Employ suitably qualified professional / engineer to undertake external wall assessment to confirm suitable design & installation.	N/A	P2	Within 1 - 3 months. Head of Building Safety and Compliance	
07/10	Confirm when the AOV between the 7/8 floors / rear staircase has been repaired.

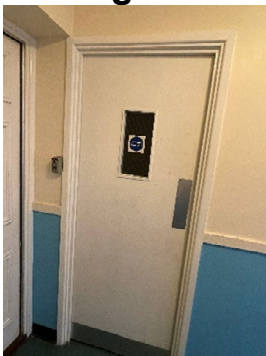
- 26) 8<sup>th</sup> floor communal door by flat 36 slight gap in joinery and cold smoke seal not meeting opposite edge to head.

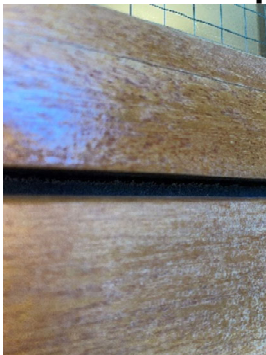
32) 6<sup>th</sup> floor communal door to stairs by flat 26 stairs a gap slightly larger than 4mm was noted however cold smoke seal maintains contact with opposite edge. **Missing screw form centre hinge requires replacement.**

P2	Within 1 - 3 months. Rapid Fire Response JM:11819051	14/09/2023
07/32	6 <sup>th</sup> floor communal door by flat 26 – replace missing screw to centre hinge.

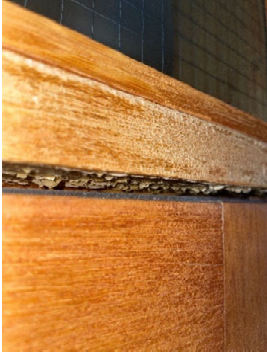
- 37) 1<sup>st</sup> floor communal door by flat 8 excessive gap to head, cold smoke seal not in contact with the opposite edge.

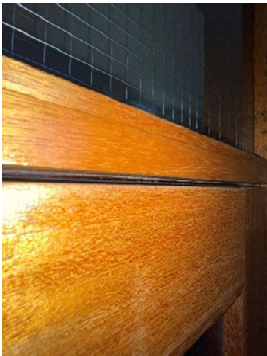
- 38) Ground floor double doors by fire alarm panel – cold smoke seal is not meeting opposite edge between doors.

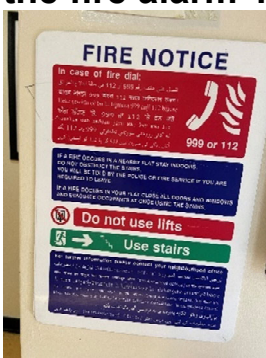
- 2) Fire Action Notices are displayed throughout the building.  
**However, there is no instruction or reference to “on hearing the fire alarm”.**

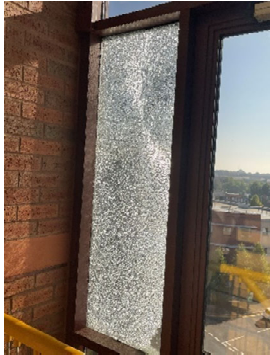
**Glazing to the communal window between the 5<sup>th</sup> – 6<sup>th</sup> floor staircase has shattered. It was noted that an emergency repair film had been applied.**

P1	Within 7-10 days. Team Lead Fire Safety (JB)	27/09/2023
07/14	Replace damaged glazing to communal window 5 <sup>th</sup> / 6 <sup>th</sup> floor front staircase.

P2	Within 1 - 3 months. Glazing Repairs

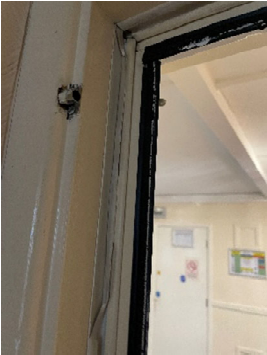
<p>07/23b</p>	<p>Flat 4 – replace damaged batwing seal to entrance door</p>

**b) Flat 4 – bat wing smoke seal part deteriorated on opening side of frame.**

<p>P2</p>	<p>Within 1 - 3 months. Rapid Fire Response JM:11817540 JM:11976950 JM:12070275 JM:12143040</p>	<p>No Access No Access No Access 27/10/2023</p>
<p>07/25</p>	<p>8<sup>th</sup> floor chute room door requires adjustment to overcome latch.</p>

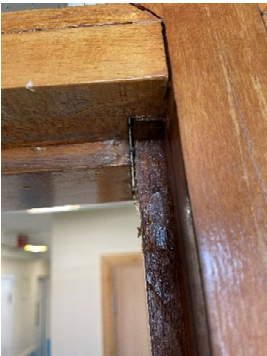
<p>P2</p>	<p>Within 1 - 3 months. Rapid Fire Response JM:11817639 Follow on raised JM:11878298</p>	<p>20/09/2023</p>
<p>07/26</p>	<p>8<sup>th</sup> floor communal door by flat 36 – fire stop gap in joinery with suitable filler. Rehang door to ensure cold smoke seal to head meets opposite edge.</p>

<p>P2</p>	<p>Within 1 - 3 months. Rapid Fire Response JM:11817738</p>	<p>14/09/2023</p>

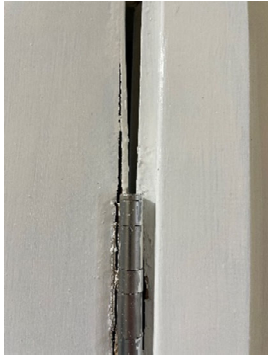
- 27) 8<sup>th</sup> floor service cupboard door missing batwing cold smoke seal to head. Also, excessive gaps to head and lower leading edge. It was also noted that there is a split in the door lip around the top hinge.

07/27	8 <sup>th</sup> floor service cupboard door - replace missing batwing seal to head of frame and repair split near top hinge.

P2	Within 1 - 3 months. Rapid Fire Response JM:11817899	14/09/2023
07/28	8 <sup>th</sup> floor communal door by flat 34 - Rehang door to ensure cold smoke seal to head meets opposite edge.

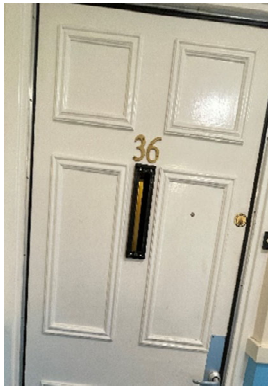
29) 8<sup>th</sup> floor flat 36 entrance door outer letterbox plate is missing.

P2	Within 1 - 3 months. Rapid Fire Response JM:11818003	14/09/2023
07/29	8 <sup>th</sup> floor flat 36 – replace missing outer letterbox plate.

P2	Within 1 - 3 months. Rapid Fire Response JM:11818240	14/09/2023

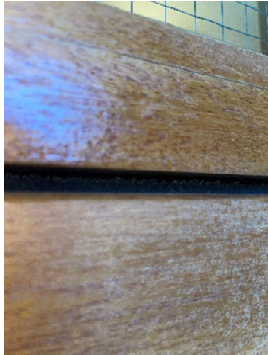
07/31	7 <sup>th</sup> floor communal door by flat 30 - Rehang door to ensure cold smoke seal to head meets opposite edge.

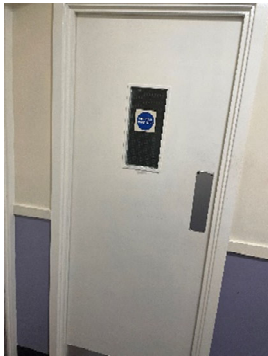
P2	Within 1 - 3 months. Rapid Fire Response JM:11819059	14/09/2023
07/33	5 <sup>th</sup> floor chute room door requires adjustment to overcome latch.

P2	Within 1 - 3 months. Rapid Fire Response JM:11819099	14/09/2023

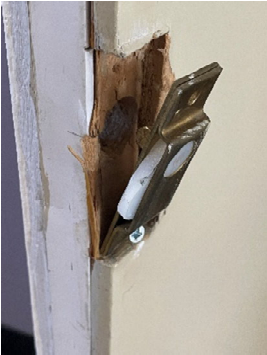
<p>07/34</p>	<p>5<sup>th</sup> floor – lock to dry riser cupboard requires screw to fix.</p>

<p>P2</p>	<p>Within 1 - 3 months. Rapid Fire Response JM:11819166</p>	<p>14/09/2023</p>
<p>07/36</p>	<p>2<sup>nd</sup> floor communal door by flat 12 - Rehang door to ensure cold smoke seal to head meets opposite edge.</p>

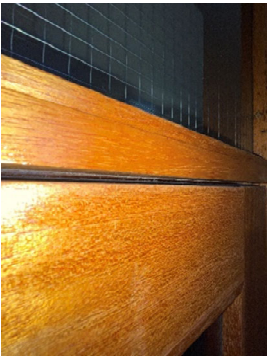
<p>P2</p>	<p>Within 1 - 3 months. Rapid Fire Response JM:11819299</p>	<p>15/09/2023</p>
<p>07/37</p>	<p>1<sup>st</sup> floor communal door by flat 8 - Rehang door to ensure cold smoke seal to head meets opposite edge.</p>

<p>P2</p>	<p>Within 1 - 3 months. Rapid Fire Response JM:11819339</p>	<p>15/09/2023</p>

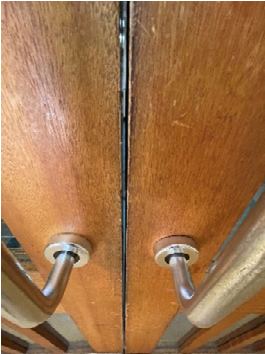
<p>07/38</p>	<p>Ground floor communal double doors. Cold smoke seal is not meeting opposite edge between doors.</p>

<p>P2</p>	<p>Within 1 - 3 months. Rapid Fire Response JM:11819420</p>	<p>15/09/2023</p>
<p>08/05</p>	<p>Replace isolated sounder on the 8<sup>th</sup> floor zone 9</p>	<p>N/A</p>	<p>P2</p>	<p>Within 1 - 3 months. Electrical Compliance Manager</p>	<p><i>Sounder is obsolete attempts being made to source a replacement.</i></p>
<p>12/02</p>	<p>Review fire evacuation notices. Is stay put unless advice being abandoned, and consideration needs to be given to the fact that a communal fire alarm is currently installed and conflicts with stay put unless guidance and fire notice.</p>
