# Fire Risk Assessment

## Lissimore House

**Maria Street, West Bromwich,  
B70 6DR**

**Date Completed: 18/12/2023**

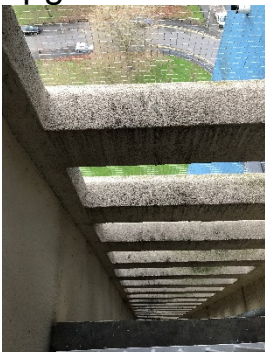
- 8) Open air natural ventilation Along the bin chute lobby area made of concrete construction at the rear of the block, it was noted that netting was present along this section of the premise the netting does not run down to the ground level and does not have easy access combined with sufficient compartmentation within the block and the stay put unless policy the council has reduces the overall risk. However an alternate option should be explored with future upgrades to the premises.

It was noted that netting was present along the rear elevation of the premise Alternate option should be explored with future upgrades to the premies.

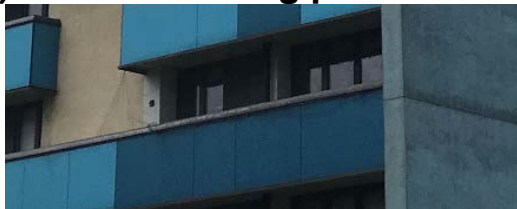
- 11) Flat 9 – Netting placed on the balcony.

*Under no circumstances should netting or screening be attached to balconies as they can support fire spread across the external of the building. Other options should be explored.*

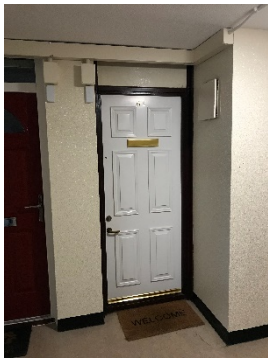
- 21) Access is gained to a sample of properties as part of the fire risk assessment to ensure the doors have not been tampered with by residents etc. Despite best endeavours and 3 separate visits to the block Access was only granted to flat 68 and 30 , flat 68 shown no signs of being tampered with however flat 30 had the use of a draft excluding strip fixed to the top seal of the door.
-

- 30) Flat 30 – flat door does not shut into frame correctly, and a draft exclusion strip has been attached to the top of the door. Door need making good to shut into frame correctly including the replacment or repair of any loose seals.

<p>07/30</p>	<p>Flat 30 – make good door so it shuts in frame correctly, removal of draft excluding strip at top of door and repair any loose sealing.</p>

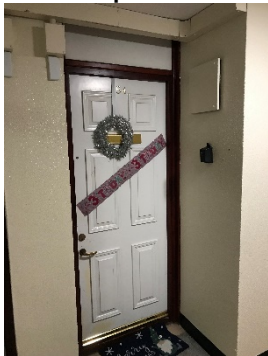
- 22) Noted that due to the time of the year that some festive decorations had been displayed on front entrance doors e.g. Christmas Reefs, on the basis that these decorations remain minimal and do not obstruct the means of escape as this is the case during the FRA, they can remain on a temporary basis. Due to the presence of daily cleaning and caretaking staff to the block the risk of these types of decorations is tolerable, note these are temporary and should be removed in sufficient time once the festive period is over.

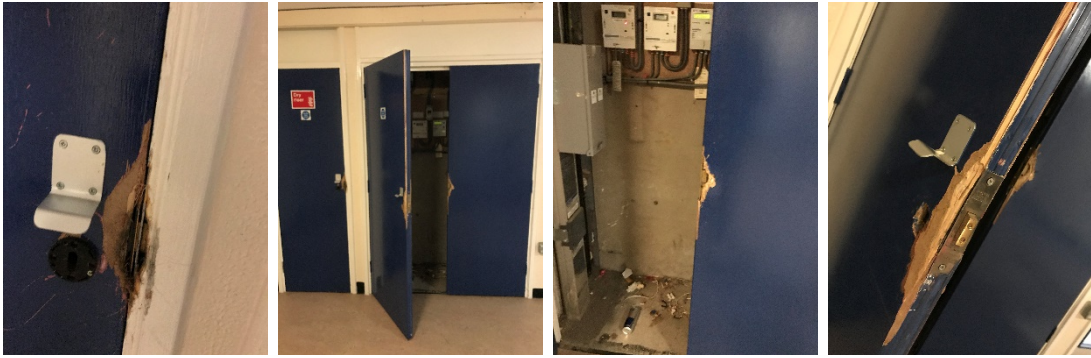
- 15) It is noted that there is some wear and tear was beginning to show on some cold smoke seals on communal doors and communal cupboards.
- 16) Third floor electrical riser/ meter cupboard & dry riser cupboard are damaged around ironmongery and cannot be secured correctly and expose large gaps. This has previously been highlighted and an email was sent while on site to get this resolved as soon as possible.
-

The Thrid floor electrical riser/ meter cupboard & dry riser cupboard are damaged around ironmongery and cannot be secured correctly and expose large gaps. This has previously been highlighted and an email was sent while on site to get this resolved as soon as possible, an order has been placed for the replacment of the damaged doors.

Update\* An order has been made for the replacment of the dammaged doors (see comments bellow)

Hi jane, Repairs can order the joinery to fit a nominal FD30s door with approved ironmongery (includes installing a suited 138 or 54 lock as per existing)

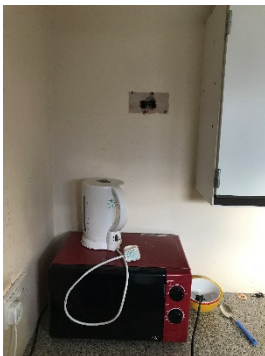
## 17) A hole in the wall within the Ground floor caretaker/welfare room.

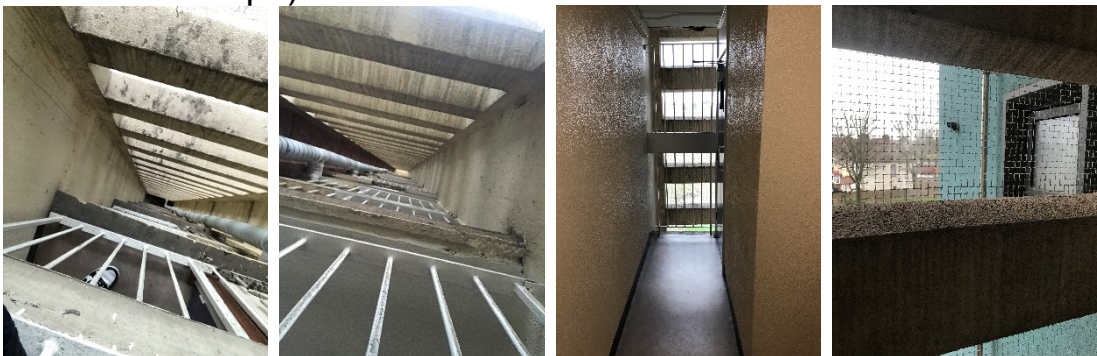
18) The design of the naturally ventilated shaft serving the single escape corridor does present a breach of compartmentation throughout the height of the building from the 1<sup>st</sup> floor up. The potential therefore does exist for smoke logging on all floors within an escape route. This situation is further affected by the close proximity of flat windows to the ventilated shaft, as well as netting of which the combustibility rating is unknown running externally along the same elevation that may add to the spread of flame. Current measures are in place to help mitigate the risk such as stay put unless policy, smoke detection within residents flats to an LD2 standard, notional FD30s doors providing protection from the landing to the flat lobby and protected stair, and external wall render next to shaft has a fire classification of Euro class A2 (NON combustible can be used above 18m). As well as a future sprinkler rollout programme to the block.

Noting that present day regulations would require ventilation to the corridor (ADB) which Lissimore has in the form of natural ventilation to all floors. Meetings have taken place to discuss said issue.

It is the opinion of the fire risk assessor that to reduce the risk even further when future improvement works next take place at the block consideration should be given to improving fire stopping/compartmentation at floor level and/or adopt the design currently present within Mountford House (use of fire rated door and frames separating the bin chute lobby and landing/corridor area within the means of escape).

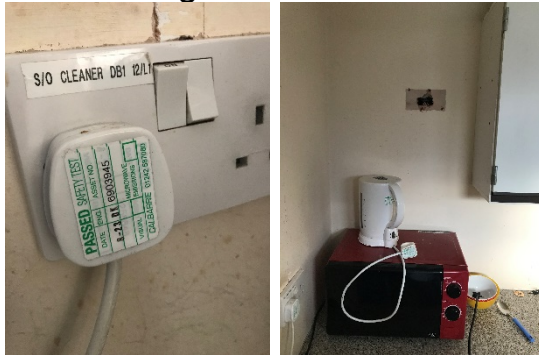
- 6) There is lightning protection installed to the block. Maintenance contracts are in place for lightning conductor testing in accordance with BS 6651.
- 7) Portable heaters are not allowed in any common parts of the premises. Noted that a heater was found within the welfare room
- 8) Gas appliances and pipework (where installed) are subject to annual testing and certification. This cyclical contract is managed by the in-house Gas Team. **Gas is installed and is external**
- 9) Items used within the kitchen/ welfare room have been subject to PAT testing and noted down as being in date.

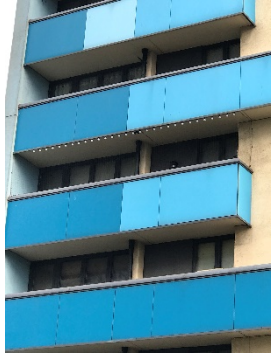
Question/ Ref No	Required Action	Supporting photograph	Priority	Timescale and Person Responsible	Date Completed
06/10	Flat 16 removal of netting from balcony

P3	3-6 months Housing Management

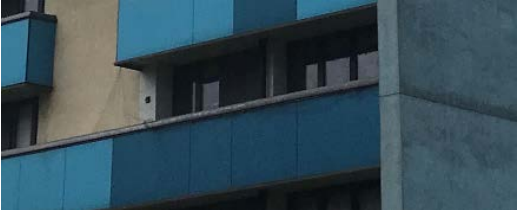
06/11	Flat 9 removal of netting placed on balcony

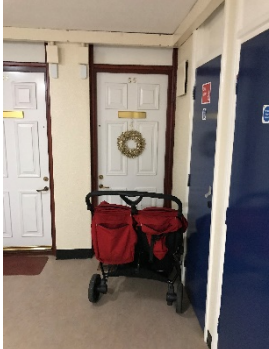
P3	3-6 months Housing Management	
07/29	Removal of the pushchair left within the communal landing area outside flat 55

P2	1-3 months Housing Management

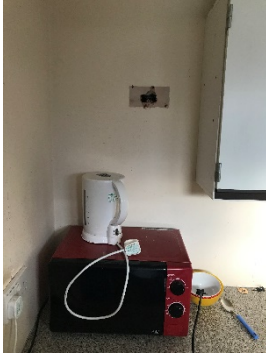
<p>P2</p>	<p>1-3 months Fire Rapid Response</p>	
<p>10/17</p>	<p>Repair the hole in the wall within the ground floor caretaker/welfare room</p>

<p>P2</p>	<p>1-3 months Repairs</p>
