# Fire Risk Assessment

## Lissimore House

**Maria Street, West Bromwich,  
B70 6DR**

**Date Completed: 06/12/2024.**

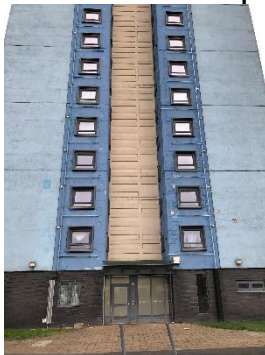
(Front)

There is an entrance/ exit to the front elevation to the block with an additional rear entrance/exit to the rear elevation. Front entrance acts as the main access point to the block.

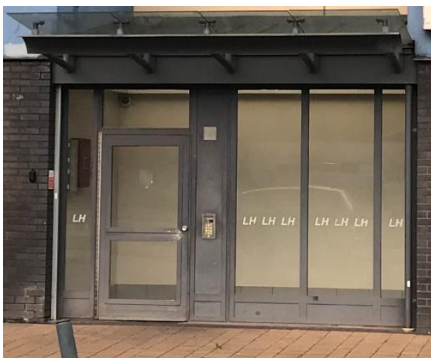
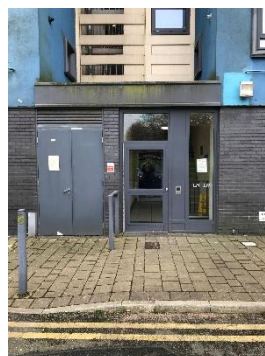
- 2) External facade is made up of four materials 1% brick, 53% render, 28% Glass, and 18% balcony cladding (high density laminate).
- 3) Front and rear entrance/exit is constructed of an aluminium door and frame with double glazing. Front entrance you pass through two sets of doors before entering the ground floor lobby area of the block.

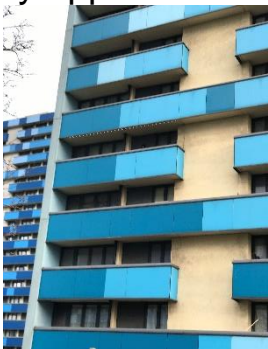
- 4) Residents have access to balconies, Trespa over cladding to a concrete panel between balconies with 100mm rockwool insulation by approved aluminium cladding.

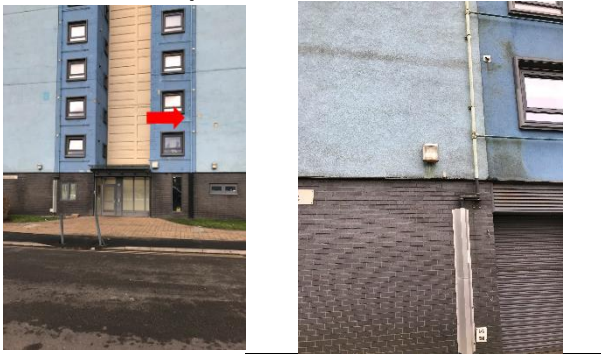
- 9) Gas was noted to be external with isolation points located on the orientation plan.

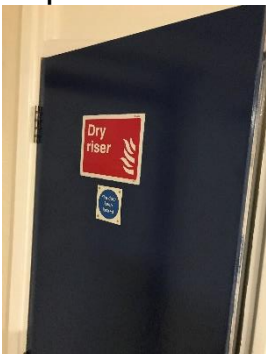
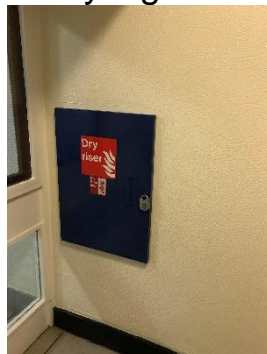
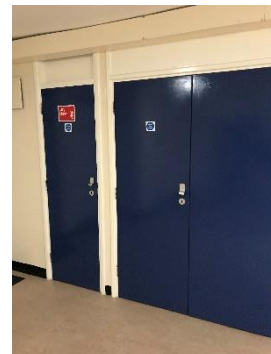
- 15) Dry riser cupboards are notional 44mm, 30-minute fire doors with combined intumescent strips & cold smoke seals throughout the block other than on the ground floor where the dry riser inlet is secured with a padlock behind a metal door. All dry riser cupboards are appropriately signed.

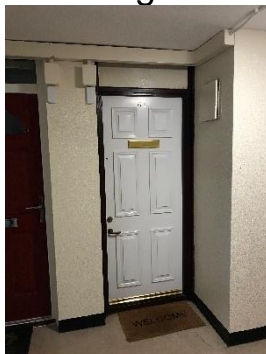
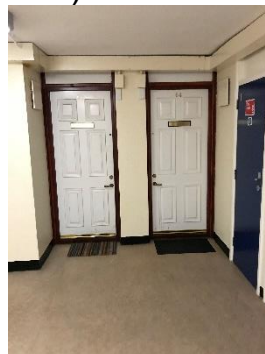
- 19) The building has sufficient passive controls that provide effective compartmentation to support a Stay Put-Unless Policy. Therefore, residents are advised to remain in their flat unless the fire directly affects them, or they are asked to leave by the emergency services.
- 20) Individual flat doors are predominantly nominal 44mm fire door sets with the exception of some nominal timber door sets. All doors are installed with intumescent strips, cold smoke seals and self-closing devices (FD30S).

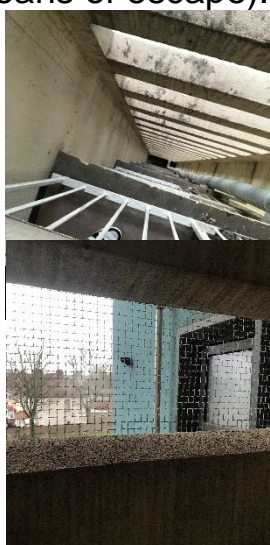
**18) Section within the ground floor bin room had been damaged exposing a shaft running into the compartment above.**

10/18	Bin store - Repair damage and install fire resistant board.

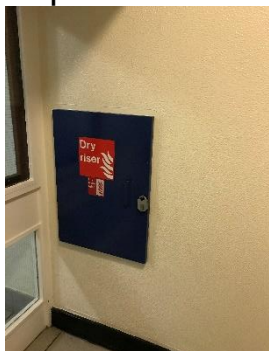
- 1) The dry riser inlet cupboard is located in the ground floor lift lobby and is appropriately signed. The riser is accessed behind a metal cupboard and secured via a padlock.

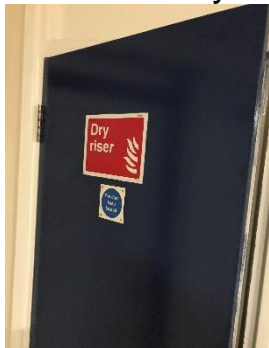
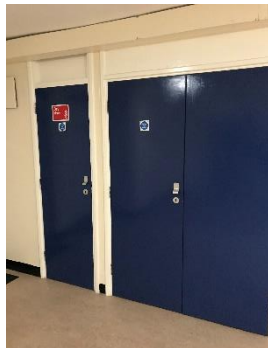
- 2) The riser outlets are available on each floor lobby (1<sup>st</sup> – 16<sup>th</sup>) these are protected via notional 44mm 30-minute fire doors secured by suited 54 key & mortice locks.

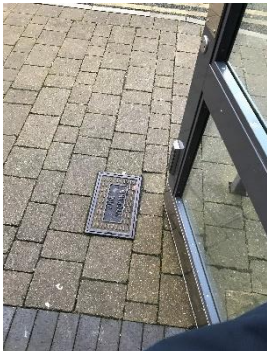
- 6) Fire hydrant can be located at the rear entrance/exit of the building 1m from the door.

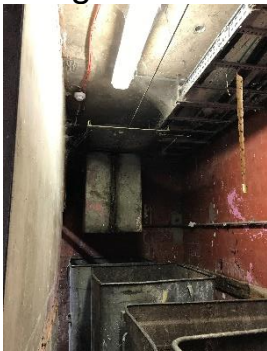
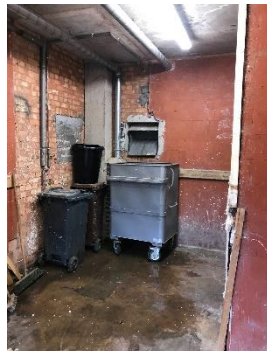
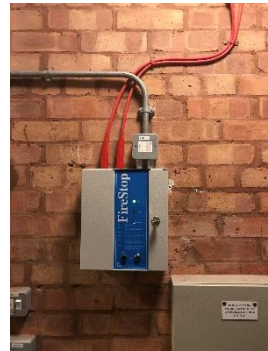
- 7) Bin room is protected by Deluge/sprinkler system and serviced 6-monthly, the controls of which are located within the storeroom on the ground floor.

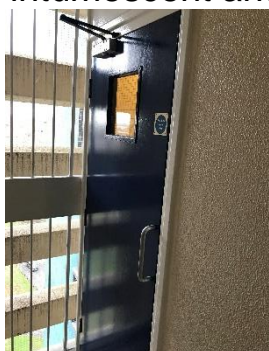
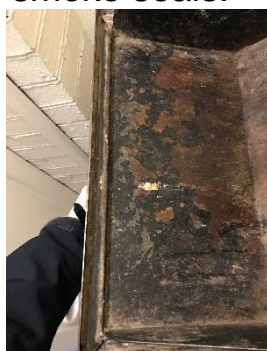
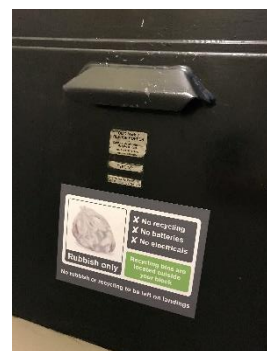
- 2) Refuse hoppers are accessed on each floor secured behind its own dedicated notional 44mm 30-minute door with combined intumescent and cold smoke seals.

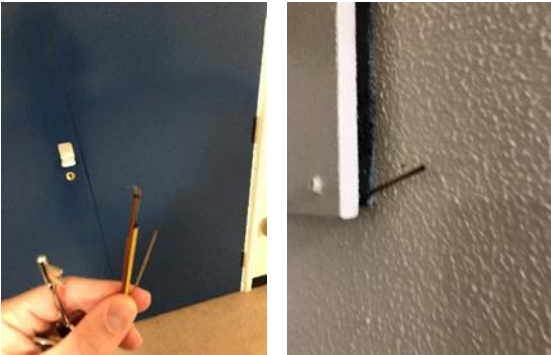
07/21a	Flat 38 – Attach missing self-closing device.	N/A	P2	1-3 months Fire Rapid response	
07/21d	Flat 51 – Attach missing self-closing device.	N/A	P2	1-3 months Fire Rapid response	
07/21e	Flat 16 – No access during FRA, remove timber plank nailed to front entrance door and inspect for further damage.	N/A	P2	1-3 Months Fire rapid Response	
07/32	14 <sup>th</sup> Floor to lift lobby Adjust door so itself closes in frame correctly.	N/A	P2	1-3 months Fire Rapid response	
07/33	9 <sup>th</sup> floor, inscent sticks had been used in communal areas outside each flat , a message should be relayed back to the residents on this floor that this is not acceptable.

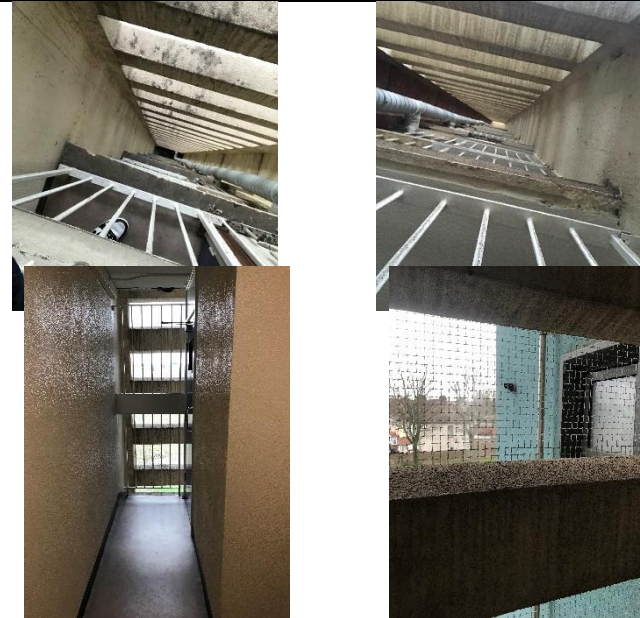
The potential therefore does exist for smoke logging on all floors within an escape route. This situation is further affected by the close proximity of flat windows to the ventilated shaft as well as netting of which the combustibility rating is unknown running externally along the same elevation that may add to the spread of flame.

It is the opinion of the fire risk assessor that to reduce the risk even further, when future improvement works next take place at the block consideration should be given to improving fire stopping/ compartmentation at floor level and/or adopt the design currently present within Mountford House (use of fire rated door and frames separating the bin chute lobby and landing/corridor area within the means of escape).
