Fire Risk Assessment

Allen House

**1-36, West Road,
Great Barr, B43 5PS**

Date Completed: 24/11/2023

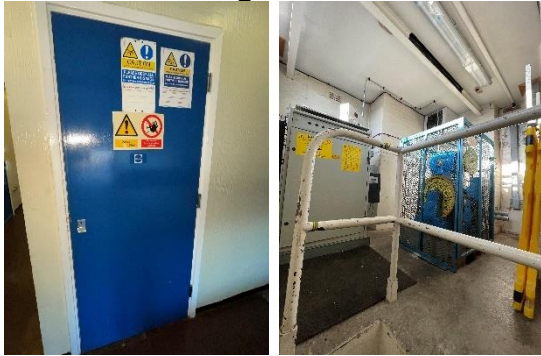
The lift car serves to the 7th floor with the motor room being located on the 8th. The lift system has **no** override facility for firefighters to secure the lift / landing controls.

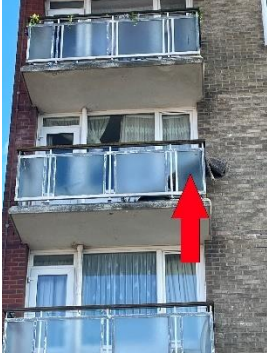
8) Flat 13 – Rolled carpet disposed on balcony.

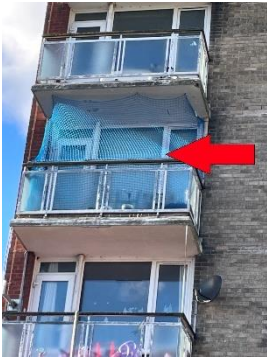
9) Flat 15 - Combustible netting has been installed to the balcony.

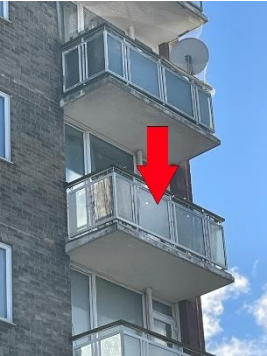
10) Flat 20 – Combustible screening installed to balcony.

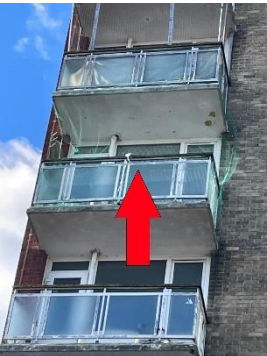
11) Flat 23 – Combustible netting installed to balcony.

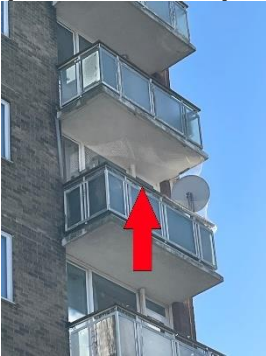
- 12) Flat 24 – Combustible netting installed to balcony (leaseholder).

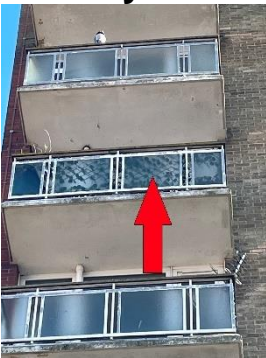
- 13) Flat 25 – Decorative combustible trellis / screening installed to balcony.

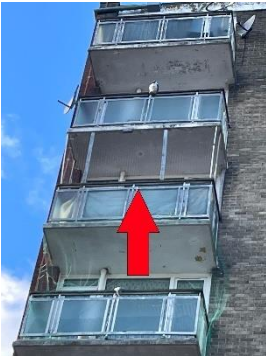
- 14) Flat 27 - Combustible netting installed to balcony.

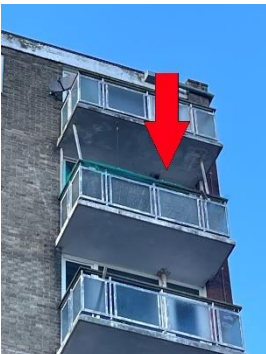
- 15) Flat 30 – Combustible screening / netting installed to balcony.

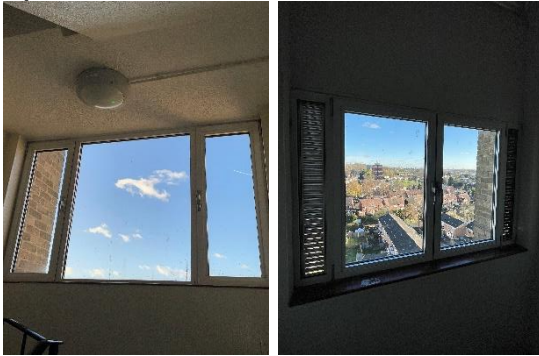
- 11) Communal windows to each stairwell are openable. Louvre vents provide additional ventilation to the rear staircase.

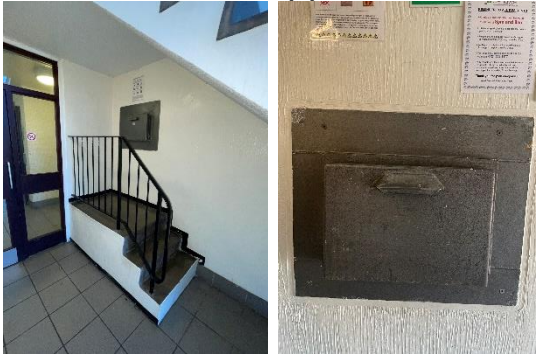
- 12) The refuse chute hoppers are fitted with intumescent strips and smoke seals. Hoppers are in the rear stairwell.

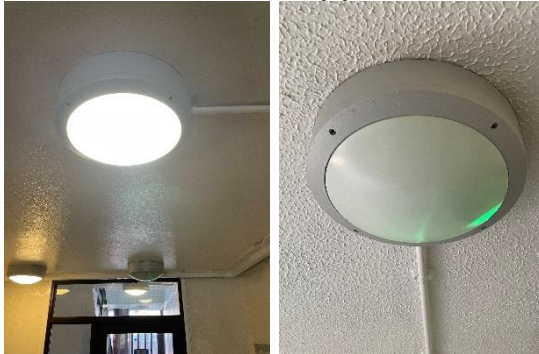
- 15) Emergency lighting is provided to communal landings and stairs. Checks are done on a monthly basis by Sandwell MBC in house electrical team or approved contractor.

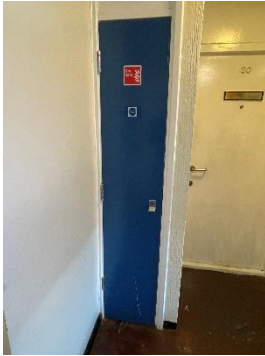
- 16) Dry riser inlet & outlets are on lobbies and housed in cupboards with nominal 44mm 30-minute fire doors with combined intumescent strips & cold smoke seals.

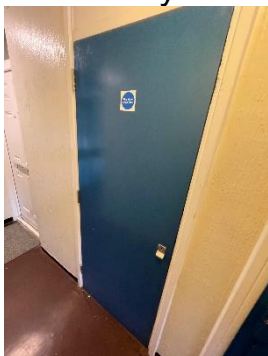
- 17) Service cupboard doors on lobbies are nominal 54mm timber fire doors offering a minimum 30 minutes fire resistance and secured with a mortice type suited lock. Residents have been provided with a key for access to their electricity meters.

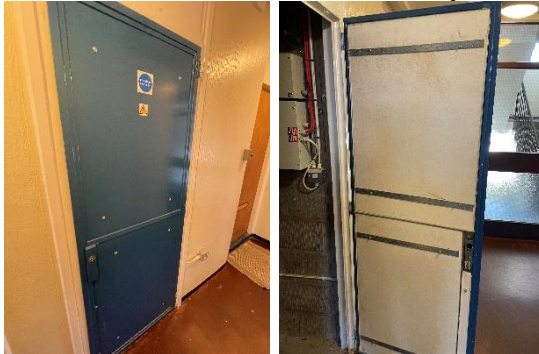
- 18) Some service cupboard doors were noted as steel construction with an internal 30-minute fire resistant board lining. These doors are secured with a suited cylinder lock.

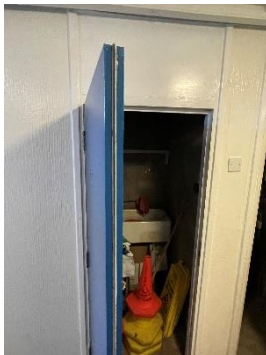
- 20) There is a cleaner's store cupboard in the 1st floor lift lobby secured with a 30-minute nominal fire door and suited 54 key mortice lock.

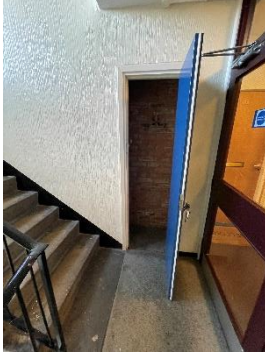
- 21) Void service cupboards were noted in the rear stairwell on floors 1, 4 & 7. All cupboards are secured with nominal 30-minute fire doors with combined intumescent strips and cold smoke seals, with suited 54 key mortice locks.

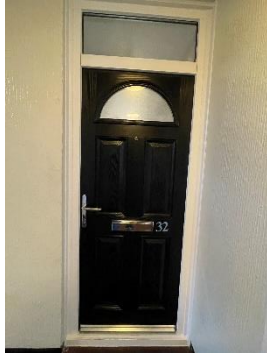
b) Flat 32 – FD30s composite door set was correct.

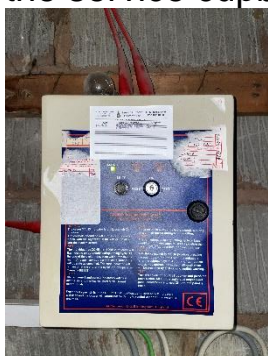
- 3) There is no effective means for detecting an outbreak of fire to communal areas. The reason for this are:
 - I. Such systems may get vandalised.
 - II. False alarms would occur.
 - III. A Stay Put - Unless policy is in place.
- 4) A sprinkler or deluge system is provided to the refuse chute bin store. An approved contractor maintains the system. The frequency for the maintenance checks are twice per year (April and October) of each calendar year. The control panel for the system is located in the service cupboard / ground floor lift lobby.

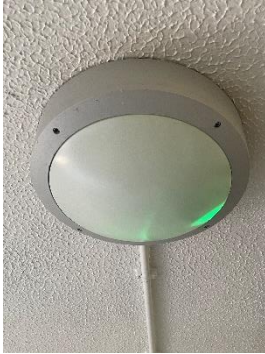
- 1) The premises has a sufficient emergency lighting system in accordance with BS 5266 and has test points strategically located.

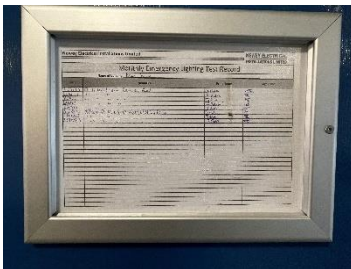
- 2) The self-contained units are provided to the communal landings, stairs and lift motor room.
- 3) All installed equipment is checked and tested on a monthly basis by Sandwell MBC in house electrical team or approved contractor, in accordance with current standards.

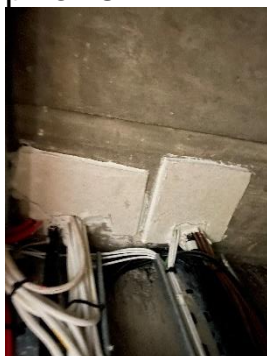
- 6) A variety of methods / materials have been used to achieve fire-stopping including Rockwool, fire rated sponge and intumescent pillows.

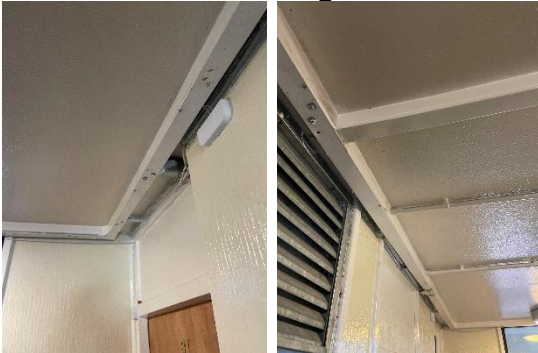
- 16) Metal cable trunking was noted within the communal areas.

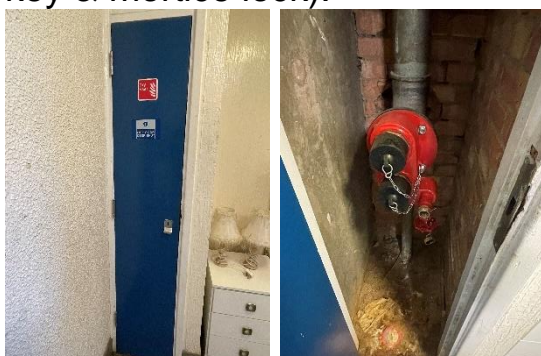
- 1) The dry riser inlet cupboard is in the ground floor lift lobby. It is accessed utilising the key contained in the white box (suited 54 key & mortice lock).

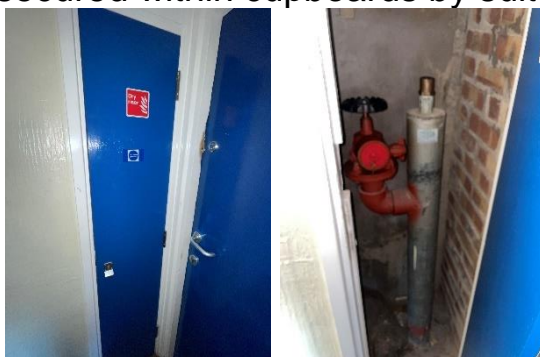
- 2) The riser outlets are available on each floor lobby (1st – 8th) also secured within cupboards by suited 54 key & mortice locks.

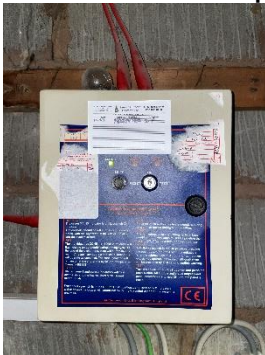
- 6) Bin room is protected by Deluge/sprinkler system and serviced 6-monthly. The control panel is located on the wall within the ground floor service cupboard (suited 138 key & mortice lock).

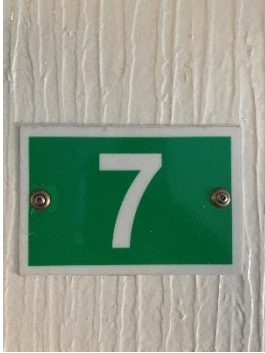
- 5) Floor indicator numbers are fitted to the wall of each floor on the communal staircase.

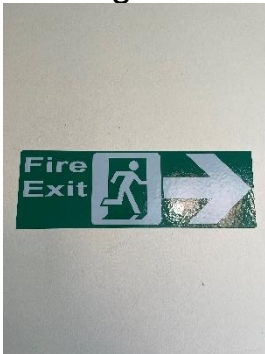
- 6) Directional fire escape signage has been installed throughout the building.

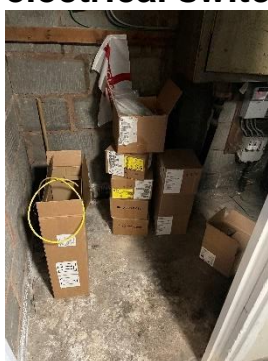
- 1) Residents instructed not to bring L.P.G cylinders into block (Notice displayed in lifts).
- 2) The tenancy conditions, Section 7 – Condition 5.6 stipulates “If you live in a flat or maisonette, you, people living with you and any visitors to your property must not keep or use paraffin oil, petrol, bottled gas appliances or any other explosive, FLAMMABLE or dangerous material in the property. This restriction also applies to any storage facility situated in or attached to the block, which has been provided for your use.”
- 3) No Flammable liquids stored on site by Caretakers / cleaners.
- 4) All store cupboards are kept locked.
- 5) There are no flammable liquids or gas cylinders stored on site.
- 6) **Numerous cardboard boxes containing optical cabling have been stored in the ground floor service cupboard adjacent electrical switchgear.**

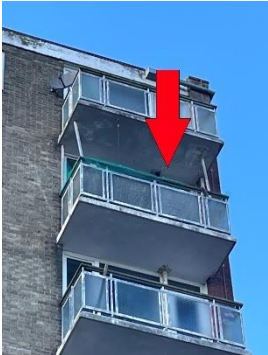
6/15	Flat 30 to remove combustible netting / screening from balcony

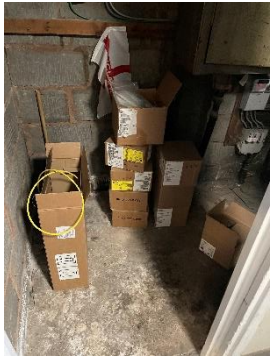
12/4	Install signage to ground floor depicting floor location of all flats within block. (JB to source signage)	N/A	P3	Within 3-6 months Rapid Fire Team	JB to source
14/4	Confirm date of last EICR to landlord's supply is within 5years/	N/A	P2	Within 1-3 months Electrical Compliance Manager.	
18/6	Numerous cardboard boxes stored in ground floor service cupboard

P2	Within 1-3 months Caretakers have removed this on 4/12/23	4/12/23
