Fire Risk Assessment

Allen House

**1-36, West Road,
Great Barr, B43 5PS**

Date Completed: 08/11/2024

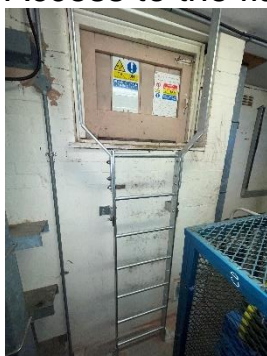
The lift car serves to the 7th floor with the motor room being located on the 8th. The lift system has **no** override facility for firefighters to secure the lift / landing controls.

Access to the flat roof is via a small door within the lift motor room.

Replace plastic trunking for cables in some service cupboards with a metal alternative with intumescent pads or pillows.	 	
Install firefighter override controls to the lift system.	n/a

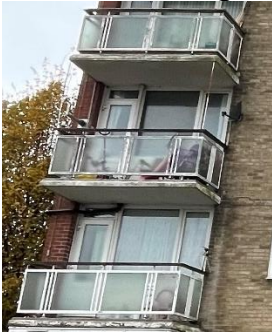
- 8) There appears to be a number of items stored on the balcony of flat 11, 2nd floor . It could not be determined if any those items are combustible. Any combustible items that would contribute to fire loading should be removed to avoid potential fire spread. Email sent to the housing officer for further investigation.

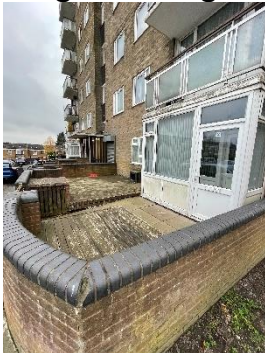
- 9) Timber decking boards installed to the front garden of ground floor flat 2. The decking is sufficient distance from the rear entrance and neighbouring flats therefore deemed to be of low risk.

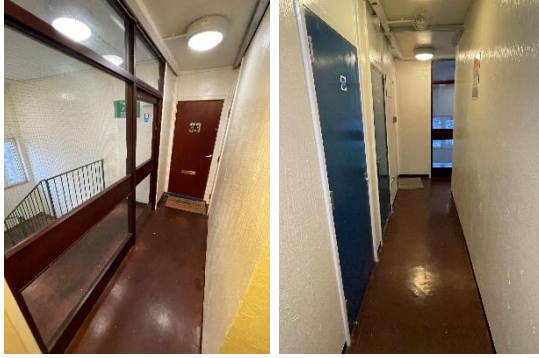
- 3) All flats above the ground floor are within 2 metres of the nearest protected stairwell. The maximum travel distance to an alternative stairwell is 5.6 metres.
 - 4) The corridor lobby on the 8th floor is approximately 970mm wide due to the position of the lift motor room.
-

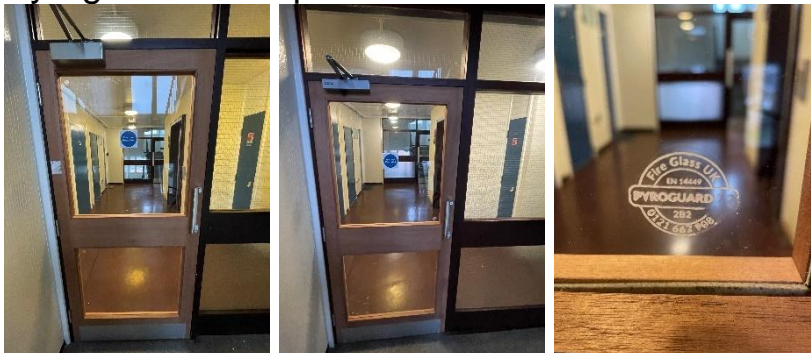
- 8) Nominal communal landing / staircase doors were noted to the 6th floor adjacent flat 27 and to the 3rd floor adjacent flat 15 / rear staircase. Both doors are FD30s 44mm timber hardwood with Pyroguard vision panels.

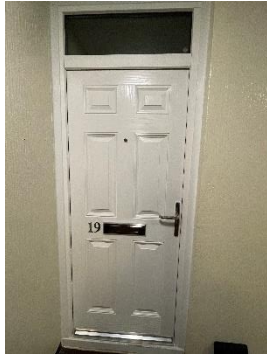
c) Flat 19 – Door is correct.

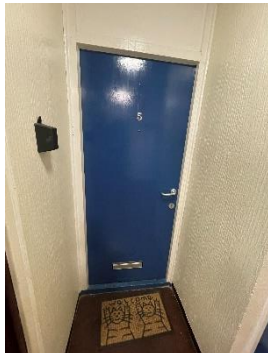
d) Flat 5 – Door is correct.

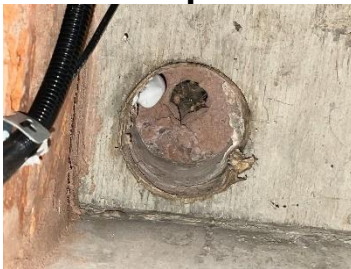
18) 6th floor firestopping required to small hole in ceiling of service cupboard between flat 25 and lift.

P2	Within 1-3 months Fire Rapid Response	
10/18	6 th floor service cupboard next to flat 25 – fire stop hole in ceiling.

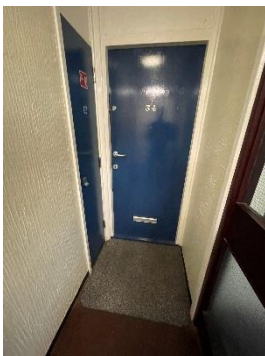
- 3) A floor mat outside flat 34 snags on the dry riser cupboard door. Firefighters would need to remove the mat to access the outlet.

P2	Within 1-3 months Fire Rapid Response	
11/3	Flat 34 to remove floor mat which obstructs access to dry riser cupboard.

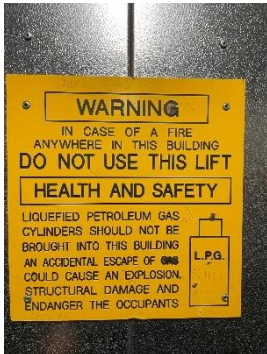
- 3) There is evidence of minor arson to signage in the lift car.

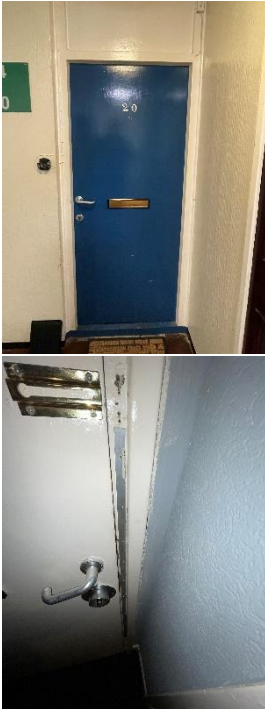
- b) Flat 20 – Significant damage to the frame around the latch resulting in the door failing to fully self-close (the tenant has attempted to repair). Also, the screws to the top hinge are not fully seated. Door and frame set will need to be replaced.
-

Question/ Ref No	Required Action	Supporting photograph	Priority	Timescale and Person Responsible	Date Completed
7/21b	<p>Flat 20 – install new FD30s flat entrance door & frame / transom set replacing existing damaged door / frame.</p> <p><i>Approximate measurements of existing door set. Door 1965 x 833mm Frame 2470 x 930mm</i></p>

P3	Within 3-6 months Repairs

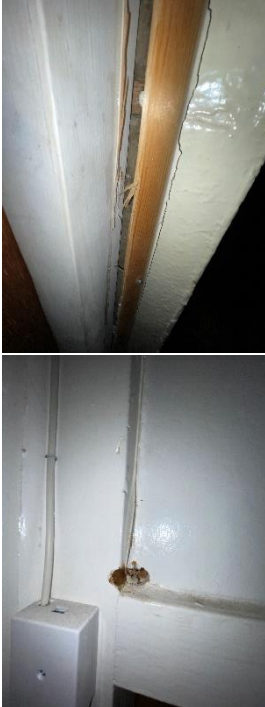
17) 7th floor flat 31 – vertical beading slamming side of frame is coming away from door frame. Fibreoptic cable noted through transom requires firestopping / intumescent mastic.

10/17	7 th floor flat 31 – re-fit vertical bead and fire stop hole in transom were fibre optic cable penetrates.

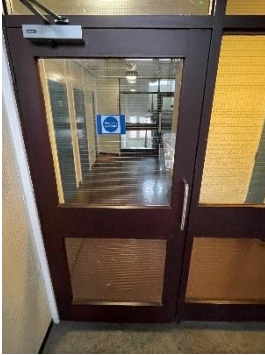
19) 5th floor communal / landing door by flat 23 – excessive gap approximately 15mm slamming edge from handle down. Door may require re-lipping.

10/19	5 th floor communal / landing door by flat 23 – Reduce excessive gap, from handle side down, door may require re-lipping.

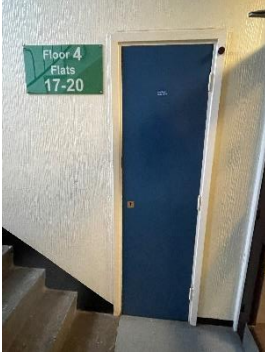
20) 4th floor cupboard on landing is missing screws from all hinges.

P2	Within 1-3 months Fire Rapid Response	
10/20	4 th floor landing service cupboard replace missing screws in hinges.
