Fire Risk Assessment

Meadow Avenue (Aspen)

**Charlemont Farm, West Bromwich,
B71 3EF.**

Date Completed: 25th January 2024

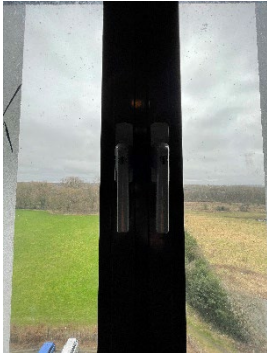
- 11) Communal windows can be opened with the use of a key.

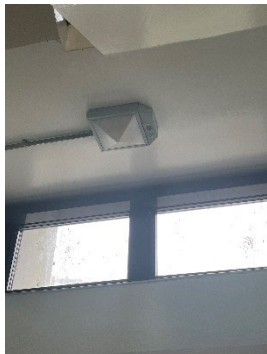
- 13) Emergency lighting is provided to communal landings and stairs. Checks are done on a monthly basis by Sandwell MBC in house electrical team or approved contractor.

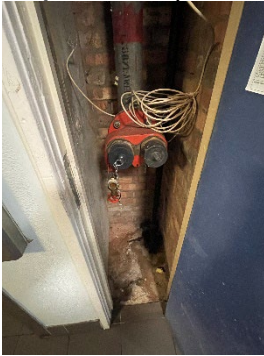
- 15) The dry riser inlet is located within the ground floor dry riser cupboard (twin valve) secured with a type 54 suited mortice lock.

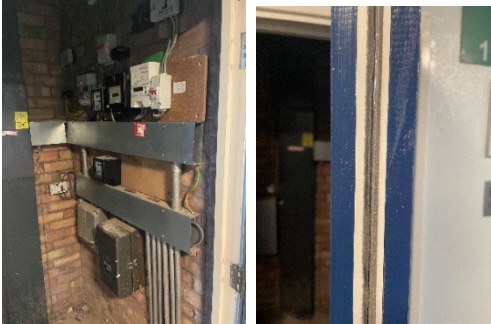
- 16) Service cupboard doors are FD30S rated, secured with type 138 suited mortice locks. Residents have been provided with a key for access to their electricity meters.

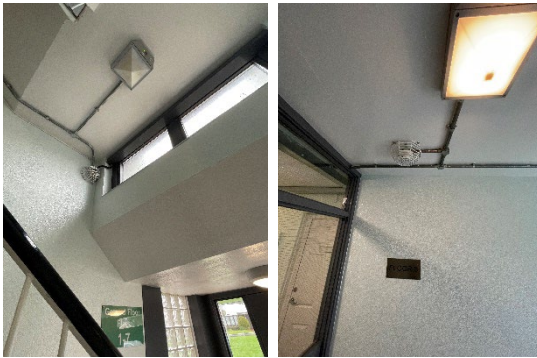
- 1) The premises have a sufficient emergency / escape lighting system in accordance with BS 5266 and has test points strategically located.
- 2) The self-contained units are provided to the communal landings, stairs and lift motor room.

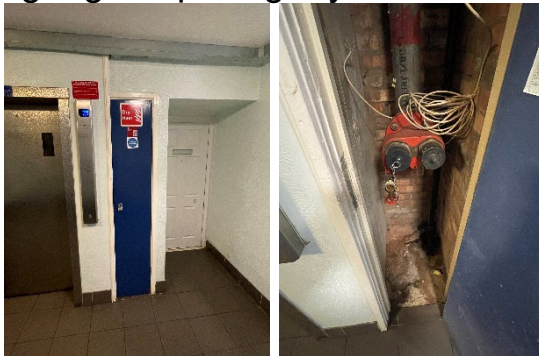
- 1) There is a dry riser that serves the building. The dry riser inlet is located within the ground floor dry riser cupboard (twin valve) secured with a type 54 suited mortice lock. The doors have signage depicting dry riser.

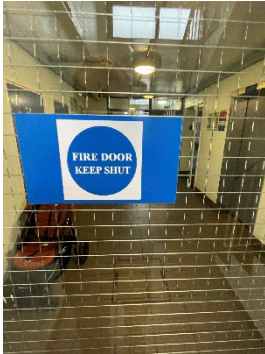
- 1) All fire doors display “Fire Door Keep Shut” where appropriate.

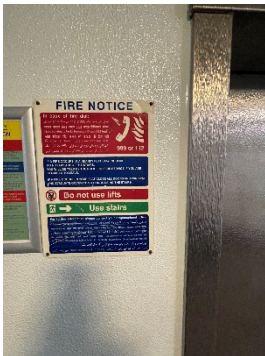
- 2) Fire Action Notices are displayed throughout the building.

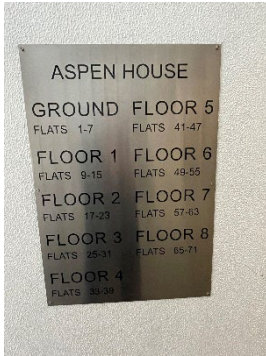
- 4) Signage depicting the floor location of each flat is fitted to the ground floor lobby wall.
-

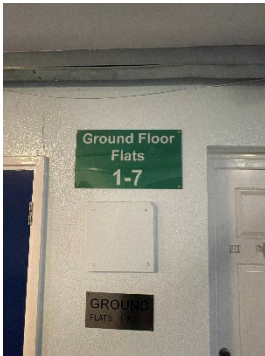
5) Floor indicator numbers are fitted to the wall on each floor.

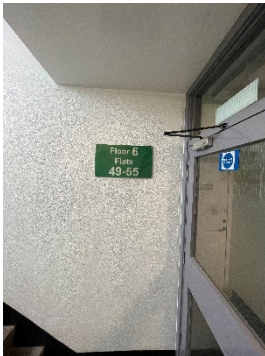
6) Floor indicator numbers are fitted to the wall of each floor on the communal staircase(s)

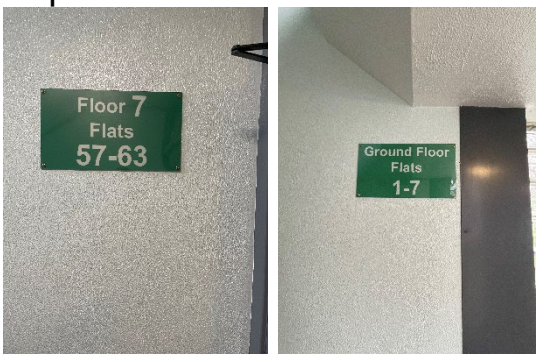
7) Wayfinding signage depicting floor level and flat numbers are located within both staircases and the lift lobby. This meets the requirements within the Fire Safety (England) Regulations 2022.
