# Fire Risk Assessment

## Brookview

**Stanhope Road,  
Smethwick, B67 6HG**

**Date Completed: 17/07/2023**

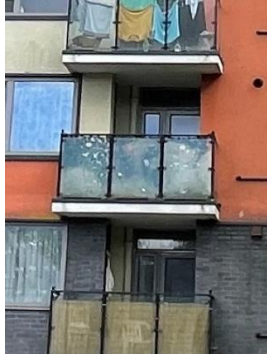
c) 2<sup>nd</sup> floor flat 12 – decorative screening.

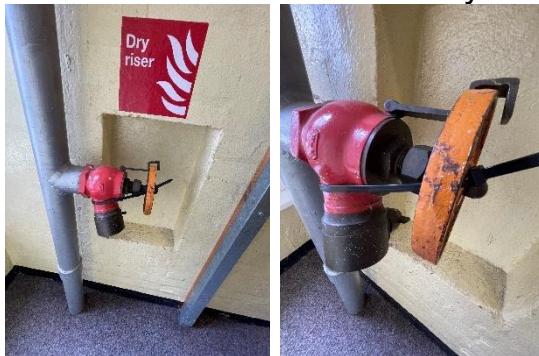
- 16) Dry riser outlets on lobbies are not housed in service cupboards but deliveries are secured by cable tie.

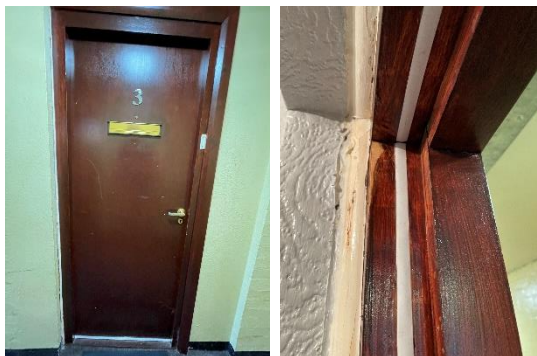
**a) Flat 3 – Nominal timber fire door that requires a cold smoke seal.**

Upgrade flat 3 entrance door to an FD30s rated composite door set as part of door replacement programme.

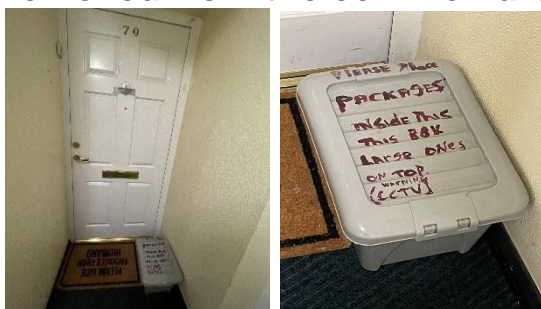
- 24) A plastic tub has been placed in the communal lobby adjacent flat 70 entrance door for the purpose of receiving parcels. The tub is combustible and therefore should be removed from the common area.

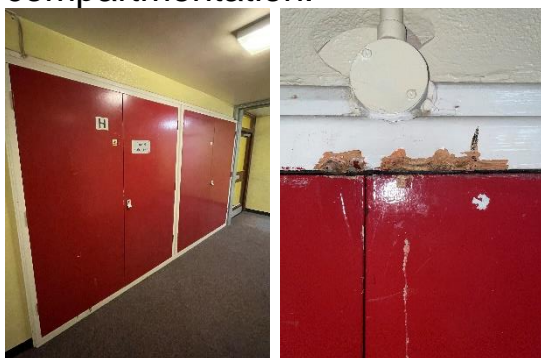
- 4) All communal fire doors are subject to a 12-week check by the Fire Safety Rapid Response Team.
- 5) All service cupboards to communal landings are locked with suited 138 mortice locks. Residents have been provided with a key for access to their electricity metres. Superficial damage was noted to the architrave above the left-hand doors to the ground floor service cupboard however this does not adversely affect compartmentation.

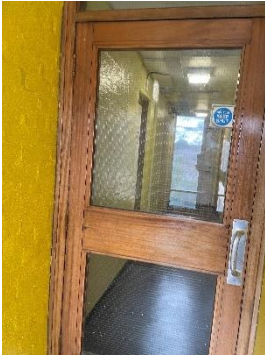
- 12) Floor J – communal door opposite flat 43, excessive gap to head. Smoke seals still meet opposite surface.

P2	Within 1 - 3 months. Rapid Fire Response JM:11975702	10/10/2023
10/12	Floor J opposite flat 43 Re-hang communal door to stairs to correct excessive gap to head.

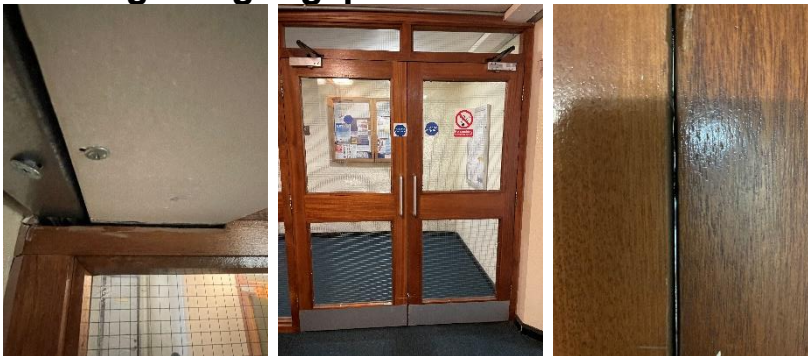
- 24) There is a small gap to the top of the combination frame above communal doors from lift lobby to entrance lobby. Also, the cold smoke seal is worn in parts along leading edge creating a slight gap between the doors.

10/24	Ground communal doors / lift lobby – Replace worn combined cold smoke seal to reduce gap between doors & apply intumescent mastic to gap beneath trunking.

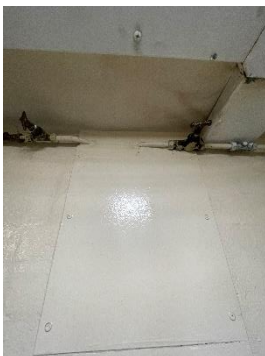
- 25) Access panels to stop taps are fixed to masonry and bedded on Intumescent material.

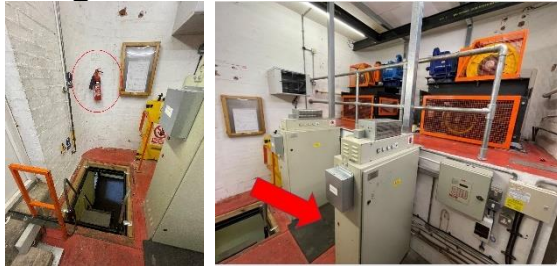
- 6) The CO<sub>2</sub> fire extinguisher within the lift motor room is not easily accessible because the user would have to step across an open floor hatch to gain access. The extinguisher should be mounted on a suitable stand and re-located as per the image below.

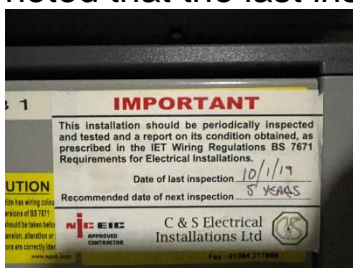
- 2) Hot working is not normally carried out. If essential maintenance requires the use of hot work processes, then corporate policies and procedures are to be followed.
- 3) Portable electrical equipment used as part of the Caretaking / Cleaning regime is subject to annual PAT Testing. This information is held by the Estate Services Manager Bryan Low.
- 4) The fixed electrical installation shall be tested every 5 years. It was noted that the last inspection was 10/01/19.

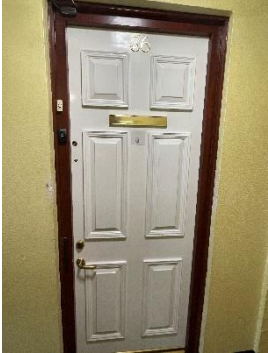
- b) Flat 36 – Overhead self-closing device missing from door.**

<p>P2</p>	<p>Within 1 - 3 months. Rapid Fire Response JM:11975483 JM:11994974</p>	<p>Carded 06/10/2023</p>
<p>7/21b</p>	<p>Flat 36 – install overhead self-closing device to flat entrance door.</p>

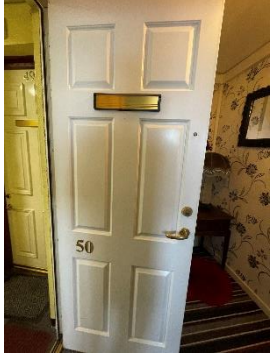
- d) Flat 50 – Overhead self-closing device missing from door.**

7/21d	Flat 50 - install overhead self-closing device to flat entrance door.

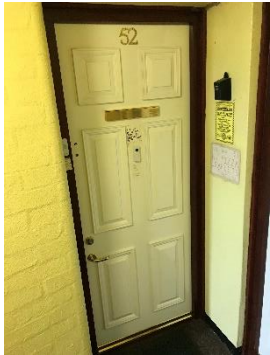
- e) Flat 52 - Overhead self-closing device missing from door.**

P2	Within 1 - 3 months. Rapid Fire Response JM:11975647 JM:12035189	Carded
7/21e	Flat 52 - install overhead self-closing device to flat entrance door. ( <i>PEEP referral at this address</i> )

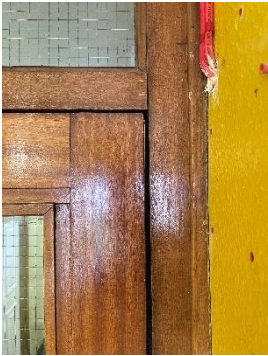
- 11) Floor L – communal door opposite flat 60, excessive gap to leading edge however smoke seals remain in contact with opposite edge.

P2	Within 1 - 3 months. Housing Manager	
10/11	Floor L opposite flat 60 – Re-hang communal door to stairs to correct excessive gap to handle side edge.

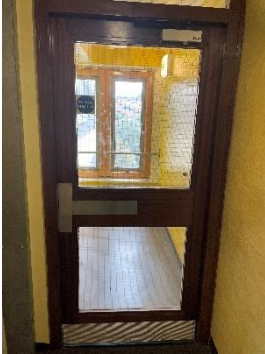
- 13) Floor H – communal door by flat 42 doesn't fully close against stop at the top of the door creating a gap of around 8mm. Door is warped.

10/13	Floor H opposite flat 42 - Replace warped door to stairwell with FD30s certified door set with 30 minute fire resistant vision panels & transom window.

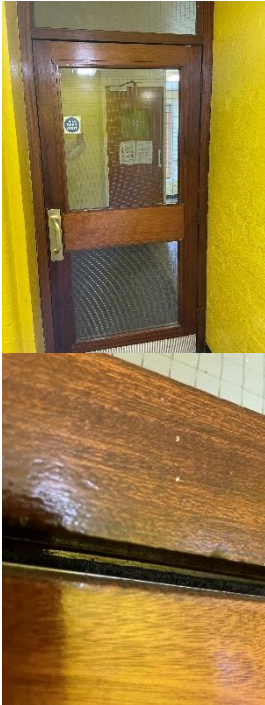
- 14) Floor G – communal door opposite chute room has excessive gap along the head. Cold smoke seal not touching the opposite surface.**

P3	Within 3 - 6 months. Repairs	
10/14	Floor G opposite chute room. Re-hang communal door to stairs to correct excessive gap to head.

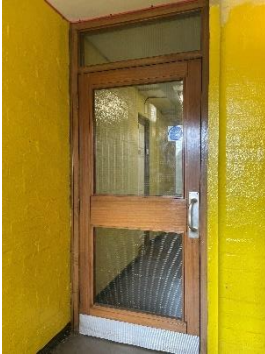
- 15) Floor F – communal stairwell door opposite flat 30 doesn't close fully against the stop because it is warped. There is a gap of around 8mm between the stop and the door.**

10/15	Floor F – communal door to stairwell opposite flat 30 – - Replace warped door to stairwell with FD30s certified door set with 30 minute fire resistant vision panels & transom window.

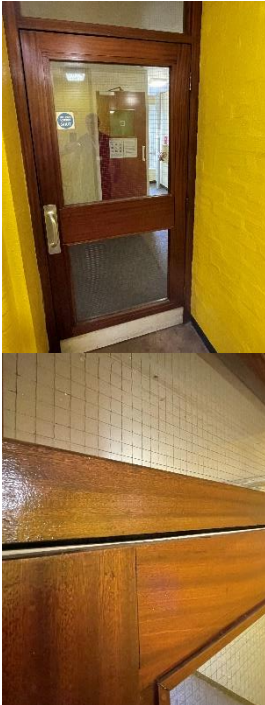
- 16) Floor F – communal door to stairs opposite chute room, excessive gap to head and leading edge. Cold smoke seals are not in contact with opposite edge.**

P3	Within 3 - 6 months. Repairs	
10/16	Floor F – communal door to stairwell opposite chute room – Re-hang door to correct excessive gap to head & handle side

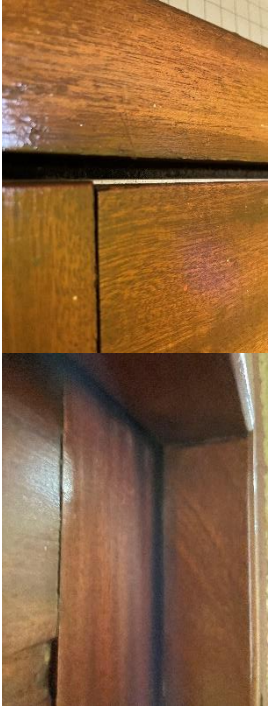
- 17) Floor E – communal door to stairs opposite chute room, door not closing fully against stop also has an excessive gap to head.

10/17	Floor E – communal door to stairwell opposite chute room - Re-hang door to correct excessive gap to head and ensure closes fully against stop.

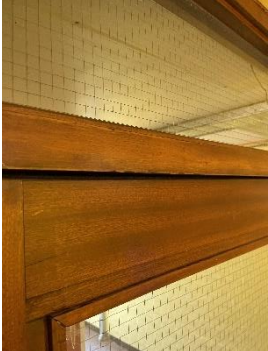
- 18) Floor D – communal door to stairs opposite chute room, excessive gap of approximately 8mm. Smoke seals remain in contact with opposite edge.

P2	Within 1 - 3 months. Rapid Fire Response JM:11976091	10/10/2023
10/18	Floor D – communal door to stairwell opposite chute room - Re-hang door to correct excessive gap to head.

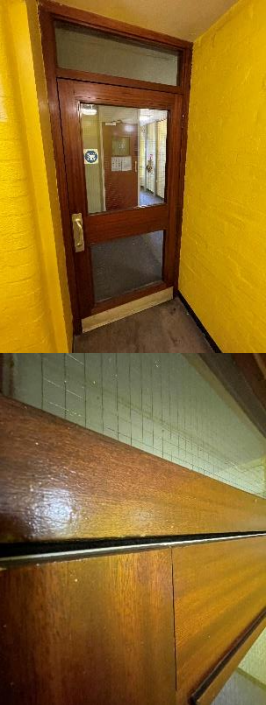
**21) Floor B - communal door to stairs opposite chute room excessive gap to head, cold smoke seal does meet opposite edge.**

10/21	Floor B – communal door to stairwell opposite chute room - Re-hang door to correct excessive gap to head
