# Fire Risk Assessment

## Kynaston House

**Rydding Lane, Millfield's,  
B71 2HD**

**Date Completed: 06/03/2024.**

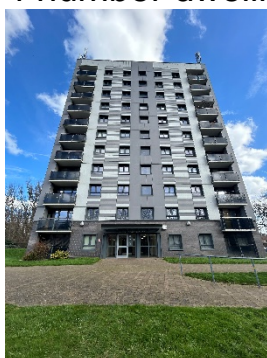
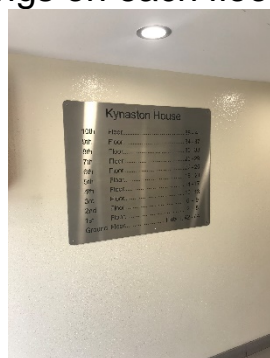
Each floor contains a lift lobby separated from the staircase and flats either side with the use of nominal FD30s timber full height doors.

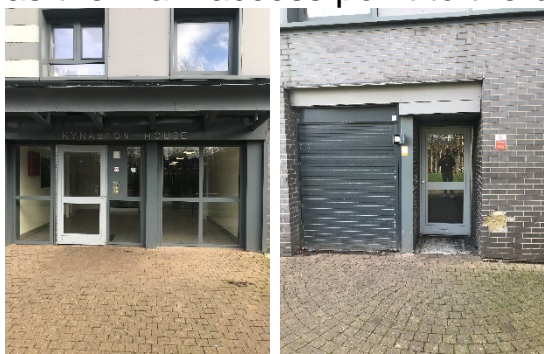
Both front and rear entrances have a door entry system with a fob reader installed. The front entrance only, has a firefighter override by use of a drop latch key.

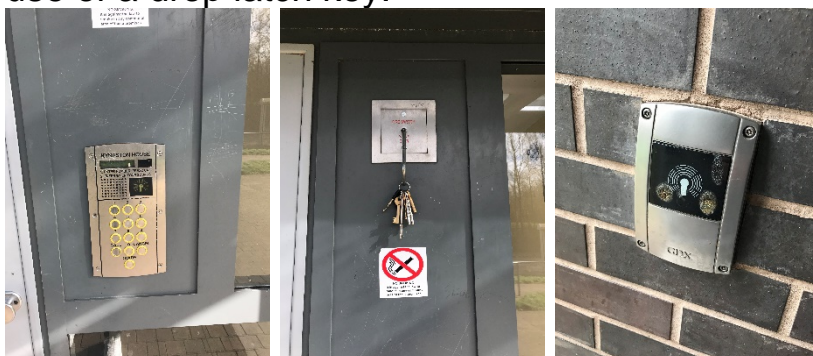
The firefighters white box is located to the right hand side of the main access point to the block.

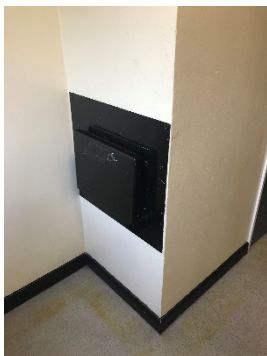
There is a Secure Premise Information Box (PIB) located in the lobby. It is a Gerda box that utilises a standard WMFS suited key. The PIB contains floor plans, vertical plans, orientation plans, information for WMFS and documents for those with vulnerabilities who may require additional consideration if there is a fire incident.

- 11) Access could not be gained to the PIB (Premise Information Box) due to a faulty lock, Gerda the supplier of the box has been notified and an engineer is to make an appointment to make necessary urgent repairs.

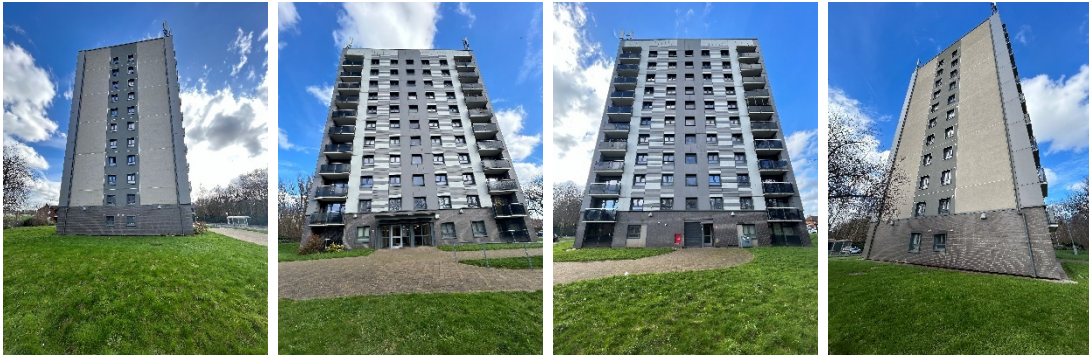
External Façade is made up of Brick (11%), Render (23%) High Pressure Laminate Panels (45%) B-s2,d0, Glass (21%)

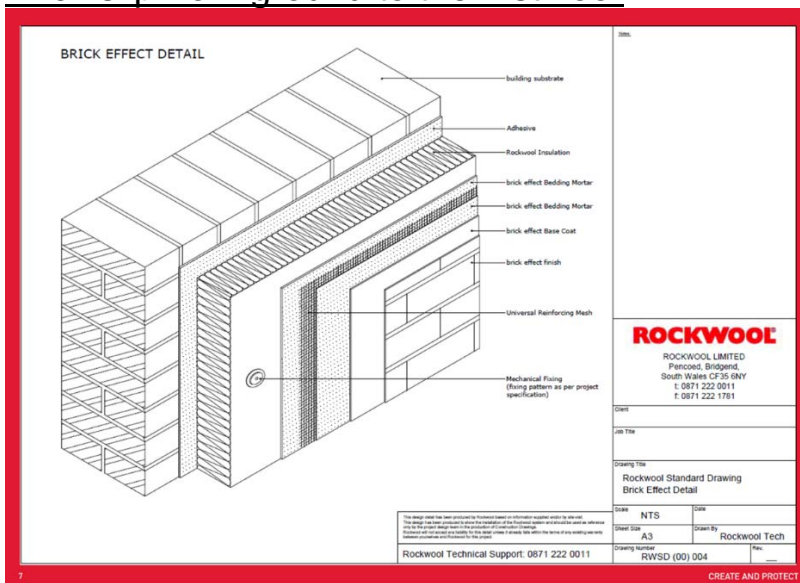
- 3) Side elevations are rockwool insulated render.

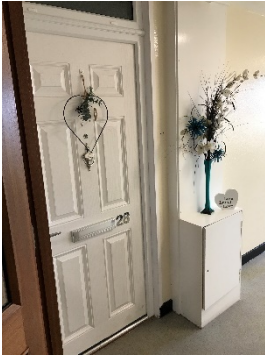
**23) Items left within the communal areas outside flat 28 attempts made to make contact while on site.**

P2	1-3 Months Housing Manager	
07/23	Flat 28 Remove items left in communal area

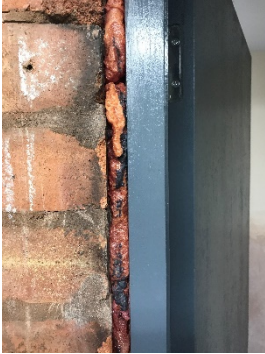
- 13) The use of foam was identified around door frames on the ground floor service cupboard nearest flat 43 this should be removed and enhanced in the next cyclical checks at the block.

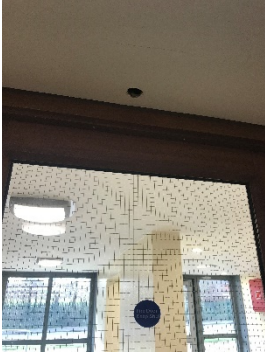
- 14) Hole in ceiling within the lift lobby

10/14	Fire Stoop Hole in ceiling within communal lift lobby nearest flat 1

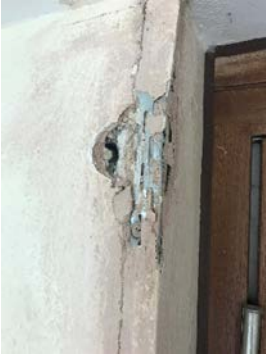
- 21) **Damage to wall near the lift entrance lobby can leave door so that it can't close into frame due to the self-closer getting stuck in the wall.**

07/21	Repair damage to wall in ground floor lobby area and fire stop appropriately

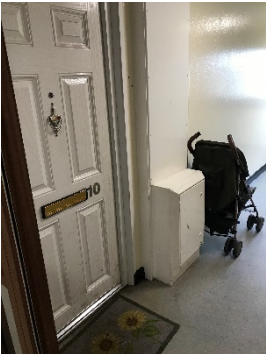
- 22) **3<sup>rd</sup> floor Pushchair left in communal area outside flat 10 attempts made to make contact while on site**

P2	1-3 Months Fire Rapid response	
07/22	3 <sup>rd</sup> floor flat 10 Remove pushchair from communal landing
