# Fire Risk Assessment

## Oak Court

**Acacia Avenue, Yew Tree Estate,  
WS5 4BH**

**Date Completed: 22/02/2024.**

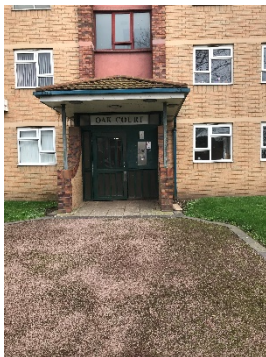
(Front)

There is an entrance/ exit to the front elevation to the block with an additional rear entrance/exit to the rear elevation. Front entrance acts as the main access point to the block.

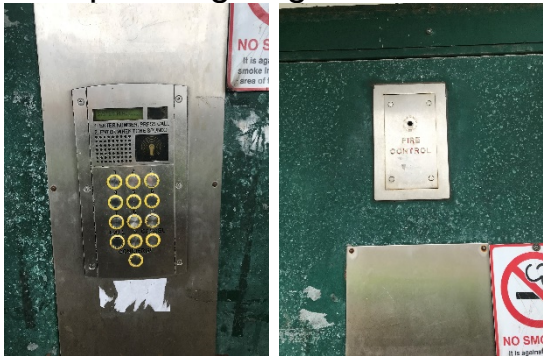
Front and rear entrances have a fob reader installed giving access to the block with the front entrance also utilising an override switch in the form of a drop latch giving access to the fire service.

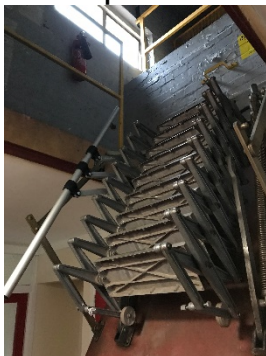
Lift motor room is located within the roof space accessed via a loft hatch and zip ladder from the 7<sup>th</sup> floor

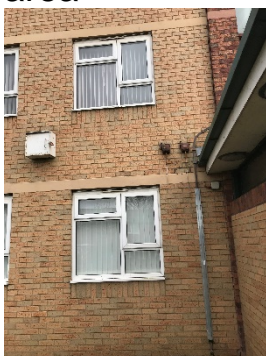
Firefighters white box is located to the left of the main access point of the building. there is also redundant fire fighter control switches in this area

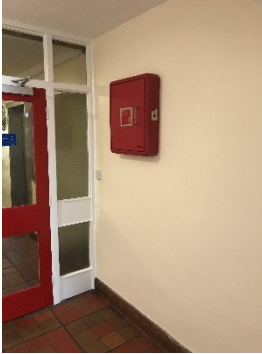
There is a Secure Premise Information Box (PIB) located in the ground floor front entrance lobby under the staircase. It is a Gerda box that utilises a standard WMFS suited key held on each fire appliance. The PIB contains floor plans, vertical plans, orientation plans, information for WMFS and a plan to indicate the location of those with vulnerabilities who may require additional consideration if there is a fire incident (PEEP).

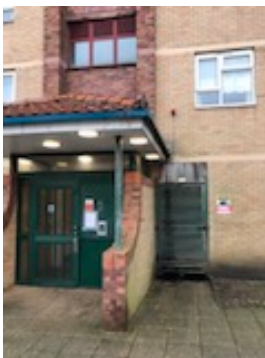
- 3) Bin store is located to the right of the rear entrance/exit to the block and is secured using a bin store padlock constructed of timber with natural ventilation in the form of louver vents on door.

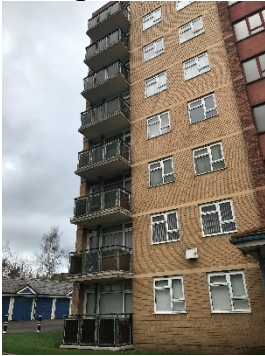
- 4) Residents have access to balconies; balconies are constructed using a cantilevered concrete slab as a base with glass balustrade

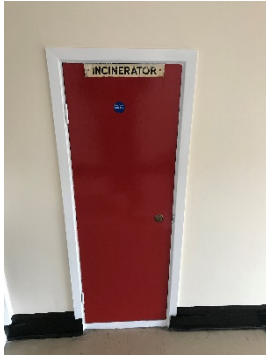
- 18) Noted there is a redundant incinerator cupboard within the communal stairwell

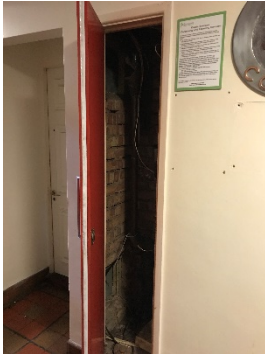
- 19) Noted that there are service cupboards housing stop taps for individual flats protected behind notional 44mm 30-minute fire doors, secured with Budget locks

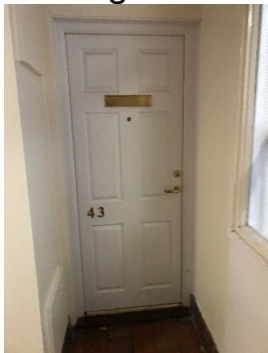
- 21) Individual flat doors are predominantly nominal 44mm composite fire door sets with intumescent strips, cold smoke seals and self-closing devices. Manufactured by Permadoor

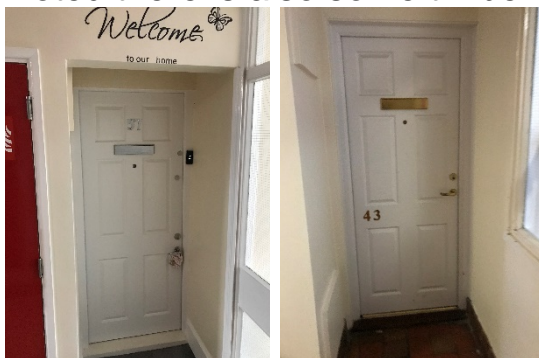
- 7) The fire stopping / compartmentation is subject to a 12-week check by the Fire Safety Rapid Response Team
- 8) Any remedial works arising from the fire stopping / compartmentation check(s) will be actioned immediately by the Fire Safety Rapid Response Team.
- 9) Individual flat doors are predominantly nominal 44mm timber/composite fire door sets with intumescent strips, cold smoke seals and self-closing devices of a Permadoor construction. Noted there is also some timber nominal Blank doors fitted

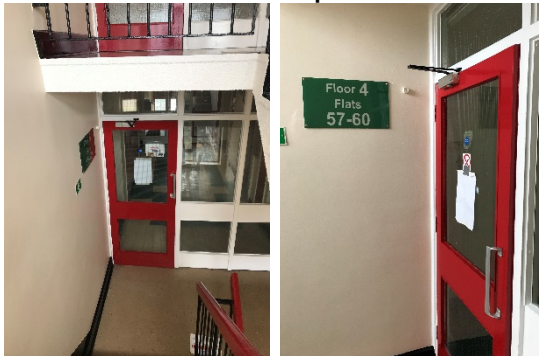
- 10) The communal landing & staircases are protected by use of notional self-closing 44mm 30-minute timber fire doors with vision panels & 25mm stops.

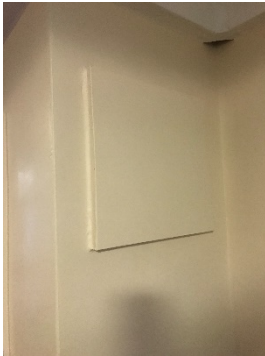
- 11) Access panels to stop taps are fixed to masonry and bedded on Intumescent material. However, in some cases stop taps are housed behind 44mm, 30-minute notional doors.

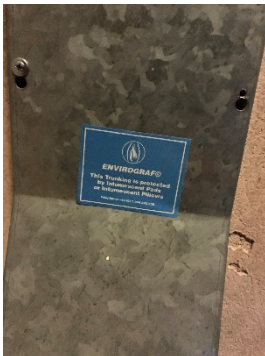
- 12) It was noted that Envirograf trunking had been used within the communal areas to house cabling.

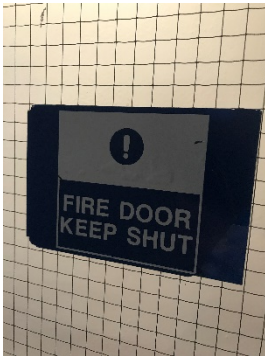
- 1) All fire doors display “Fire Door Keep Shut” where appropriate, communal cupboard doors display fire door keep shut signs rather than fire door keep locked signage however this is considered a trivia risk

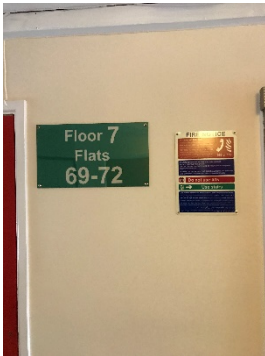
- 4) Signage depicting the floor location of each flat is fitted to the ground floor lobby wall. note the signage had been removed due to the decorating works that was being conducted
- 5) Wayfinding Signage depicting floor level and flat numbers are fitted to the wall adjacent to lift. They meet the requirements set out in the Fire Safety (England) Regulations 2022 noted that during the risk assessment decorating works was taking place and some signs had been removed in order to paint the walls behind (please see email below)

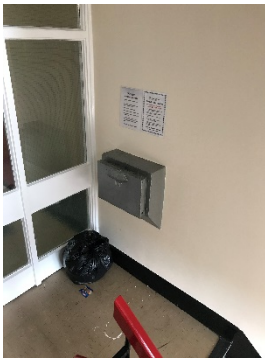
- 1) There is a regular Cleaning Service to the premises.
- 2) Refuse hoppers are accessed on each floor within the front stairwell, rubbish had been left in communal areas however was removed while on site

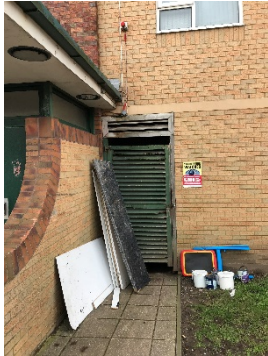
- 3) Refuse containers regularly emptied bin store located at the rear elevation of the block. Noted that the items left outside the bin store have been removed

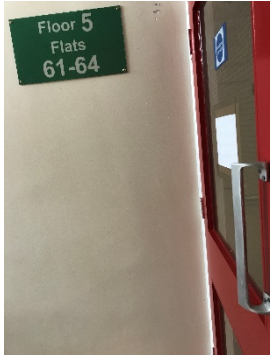
- 29) **Handle to 5<sup>th</sup> floor rear staircase is loosely fasten attached to door requires tightening**

07/29	5 <sup>th</sup> floor rear staircase secure handle to door correctly

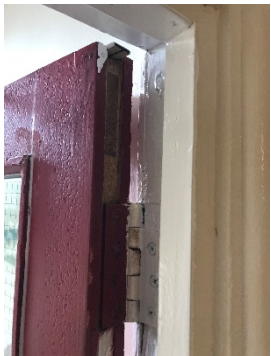
- 31) 2<sup>nd</sup> floor communal door nearest flat 52 missing intumescent strip from top hinge side of door

P3	3-6 months Fire rapid response	
07/31	2 <sup>nd</sup> floor nearest flat 32 replace missing intumescent strip from top hinge side of door

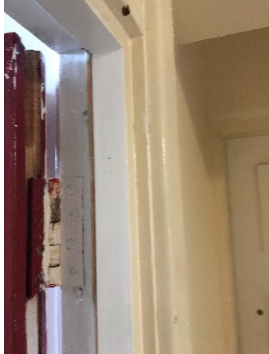
- 32) 1<sup>st</sup> floor Communal door nearest flat 46 missing intumescent strip form top hinge side of door

07/32	1 <sup>st</sup> floor communal door nearest flat 46 replace missing intumescent strip
