# Fire Risk Assessment Scott House

Langdale Road Great Barr, B43 5RD

**Date Completed:** 21/10/2024

**Current Risk Rating = Tolerable**

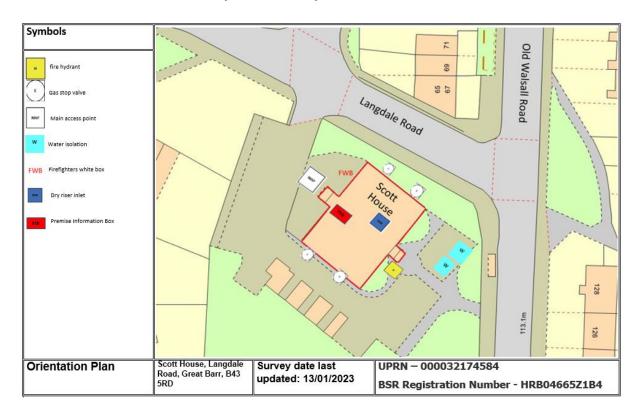
#### On arrival Information (for WMFS)

There is a firefighter's box externally to the right-hand side of the main entrance to the front of the building. The box contains keys for the building and is secured with a bridge-door padlock.

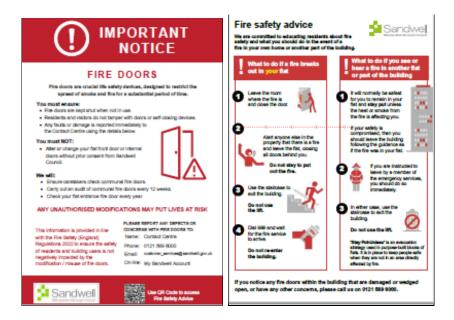
Information regarding use of fire doors and the Stay Put – Unless fire evacuation strategy is provided to residents.

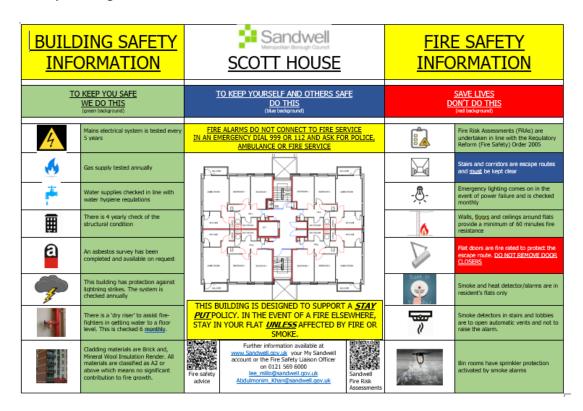
8) Information regarding building safety is contained within a Building Safety Notice. This is affixed to the wall on the ground floor lift lobby of high-rise blocks.
