Fire Risk Assessment

Sheapcoate House

**Beaconview Road, West Bromwich,
B71 3PP**

Date Completed: 29/01/2024

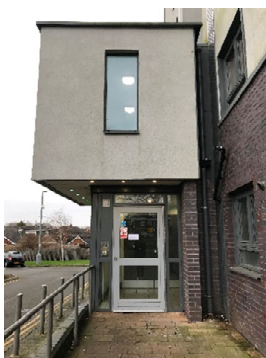
(Left side MAP)

There is an entrance/ exit to the left side elevation to the block with an additional entrance/exit to the right side elevation (from the main road). The left side elevations entrance acts as the main access point to the block.

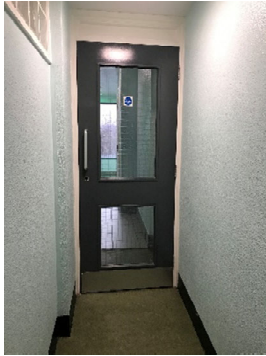
There is a “viewing pod” located on the 1st for that acts as a viewing pod/ waiting room, this is secured with the use of notional 44mm timber FD30s doors secured with a suited key.

- 15) Noted the store cupboard located within the 1st floor viewing pod is missing any intumescent strips and cold smoke seals, due to this door being a 44mm notional FD30 timber door the regular checks by cleaning and caretaking services, additional notional door protecting the viewing pod from the means of escape and level of risk being minimal this is deemed as tolerable however however with future upgrades to the block some consideration should be made to upgrading the doors to fully certified FD30s door.

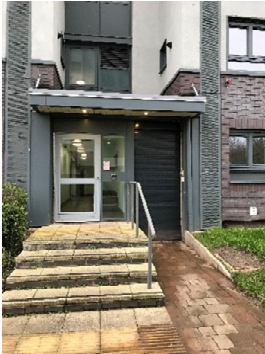
- 5) Bin store located at the side elevation to the block near the secondary entrance/ exit to the building, this is secured with a steal shutter.

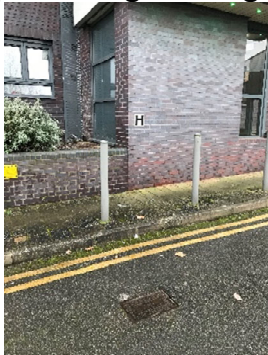
- 10) Gas was noted to be external, secured behind corrugated panelling, with gas isolation points located on the orientation plan.

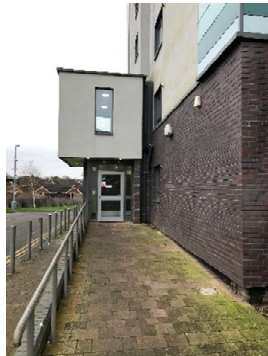
- 11) Noted there is a communal viewing Pod on the first floor above the Main access point to the block

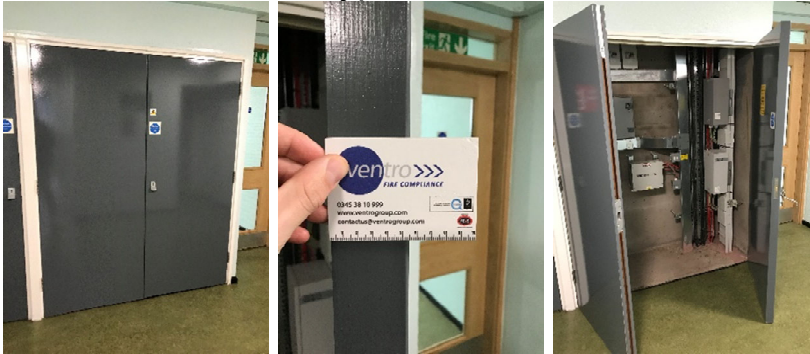
- 15) Service cupboards are notional timber 54mm double FD60s doors, secured with type 54 suited mortice locks.

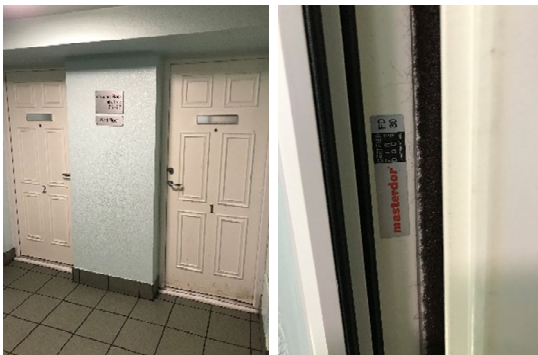
- 18) Individual flat doors are predominantly Manse Masterdoor 44mm FD30s composite doors sets with intumescent strips and cold smoke seals.

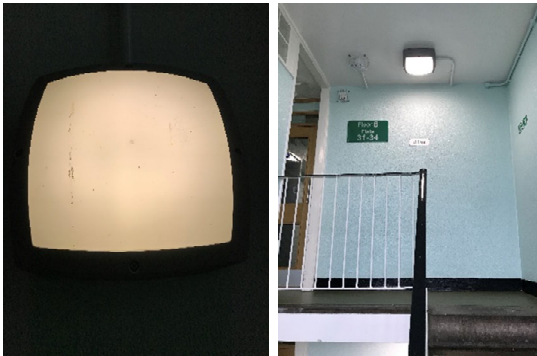
- 1) The premises has a sufficient emergency lighting in accordance with BS 5266 and has test points strategically located.
- 2) The units are provided to the communal landings, stairs and lift motor room.

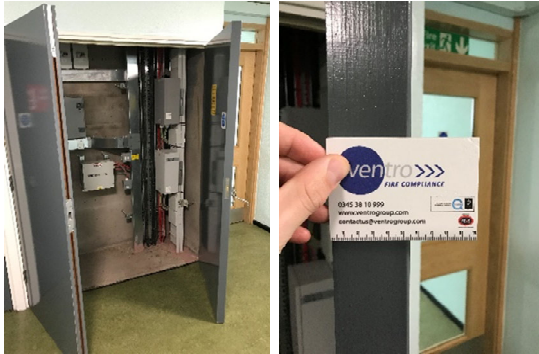
- 11) Cupboard doors within the communal areas such as residents meter cupboards/ electrical risers cupboards are notional 54mm FD60 timber fire door sets with intumescent strips, cold smoke seals.

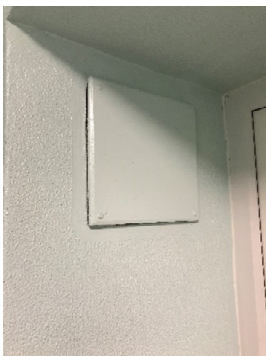
- 13) Access panels to stop taps are fixed to masonry and bedded on Intumescent material.

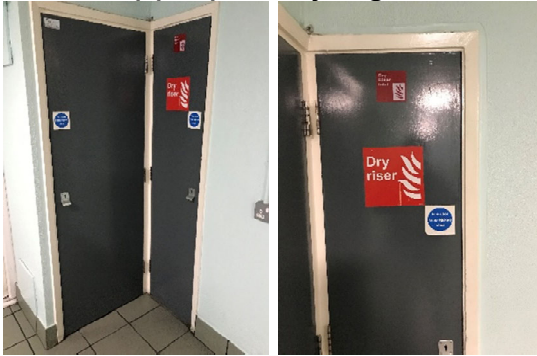
- 1) The dry riser inlet cupboard is located in the ground floor lift lobby and is appropriately signed

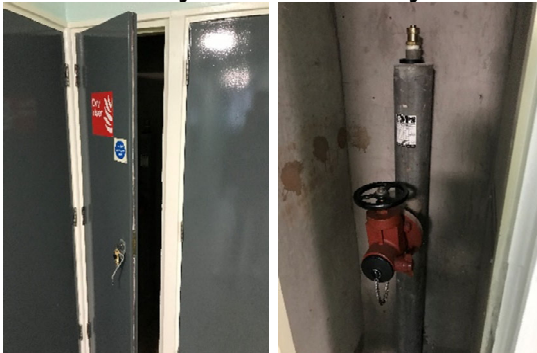
- 2) The riser outlets are available on each floor lobby (ground – 8th) these are protected via nominal 44mm 30-minute fire doors secured by suited 54 key & mortice locks.

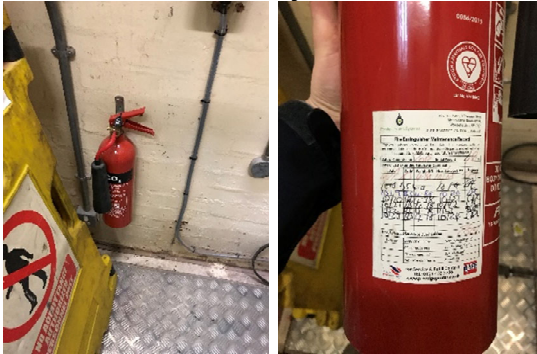
- 5) Portable fire extinguisher (CO2) is provided to the lift motor room. Maintenance contracts in place for maintenance of the extinguisher. The frequency for the maintenance checks are once of each calendar year last check was conducted October 2023

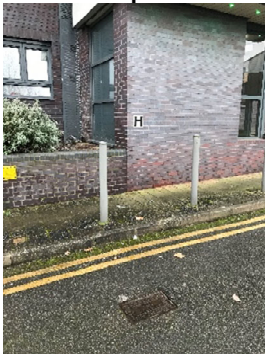
- 7) Fire hydrant can be located at the side elevation nearest the main access point to the building

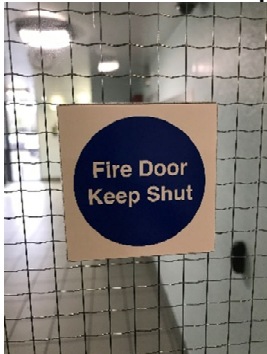
- 1) All fire doors display “Fire Door Keep Shut” or “Fire Door Keep Locked where appropriate.

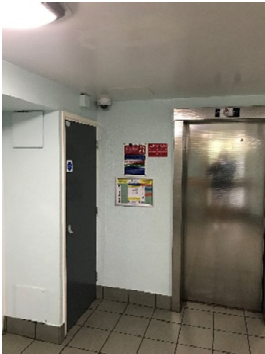
- 2) Fire Action Notices are displayed throughout the building.

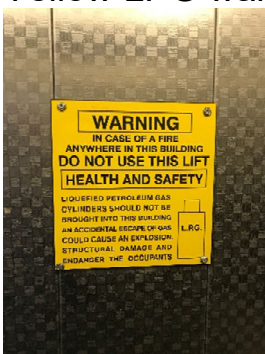
- 3) Yellow LPG warning signs are displayed within the lift car.

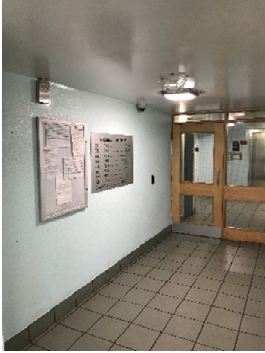
- 4) Signage depicting the floor location of each flat is fitted to the ground floor lobby wall.

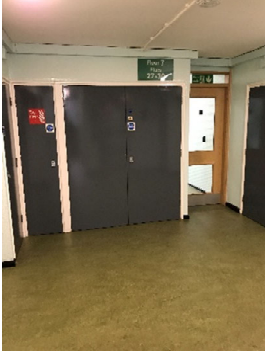
- 5) Wayfinding Signage depicting floor level and flat numbers are fitted to the wall adjacent to lift. They meet the requirements set out in the Fire Safety (England) Regulations 2022

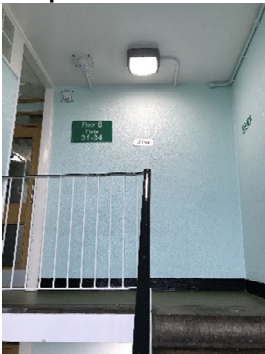
- 6) Wayfinding Signage depicting floor level and flat numbers are fitted to wall of each floor on the communal staircase(s). They meet the requirements set out in the Fire Safety (England) Regulations 2022

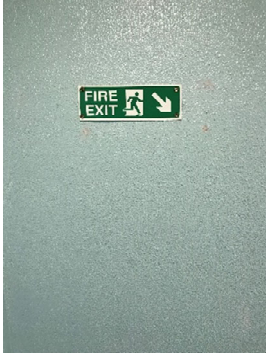
7) The fire escape routes use directional fire signage

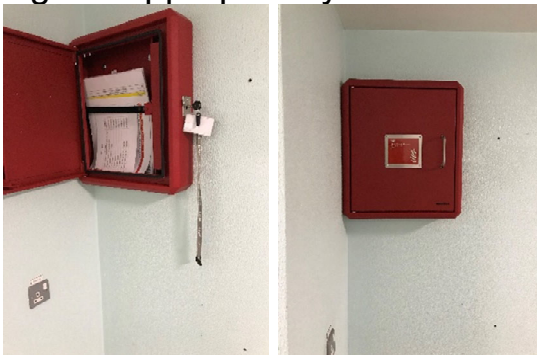
8) Premise information box is located in the main entrance lobby and signed appropriately

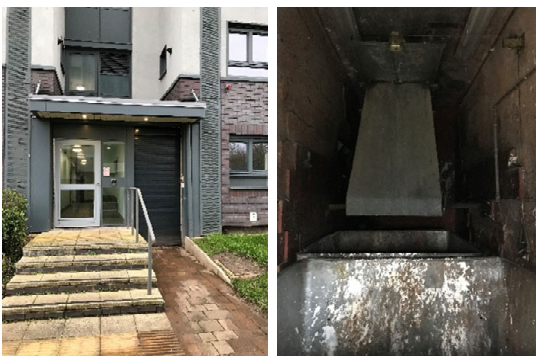
- 1) There is a regular Cleaning Service to the premises.
- 2) Refuse hoppers are accessed on each floor secured behind its own dedicated nominal 44mm 30-minute door with combined intumescent and cold smoke seals.

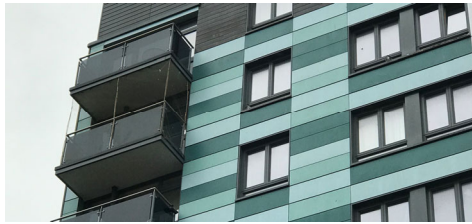
- 6) It was noted that some balconies may have had combustible materials in the form of hanging washing this is deemed acceptable risk due to the likelihood of a fire starting in this area being low and combined with the temporary nature of the activity
- 7) Aluminium faced timber composite windows to residents flat windows/balcony doors and communal windows

Question/ Ref No	Required Action	Supporting photograph	Priority	Timescale and Person Responsible	Date Completed
06/12	Flat 29 removal of netting from balcony

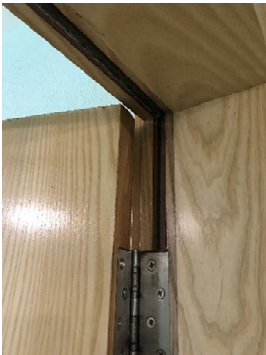
- 22) 4th floor missing cold smoke seal at top corner hinge side**

P3	Housing Manager 3-6 months	
07/21	Ground floor Replacement of missing cold smoke seal to lift lobby communal door	N/A	P2	Fire Rapid Response 1-3 months	
07/22	4 th floor Replacement of cold smoke seal missing from communal door to lift lobby
