Fire Risk Assessment

Stanton House

**Beaconview Road, West Bromwich,
B71 3PW**

Date Completed: 29/01/2024

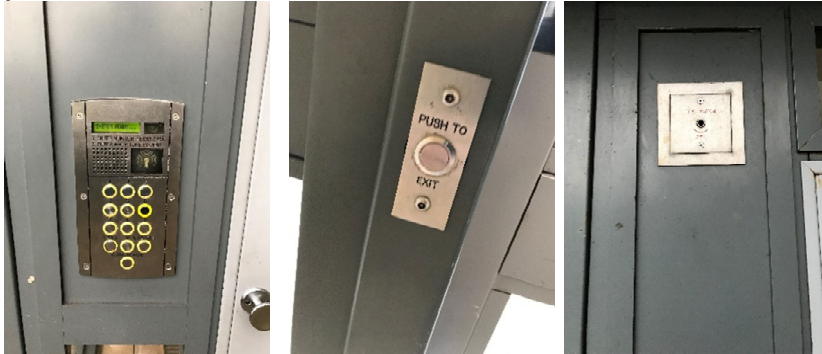
Both entrances utilise fob access in order to gain entry to the block with the main access point also having access to a firefighters override system in the form of a drop latch switch. Both entry/exit points use a push to exit button.

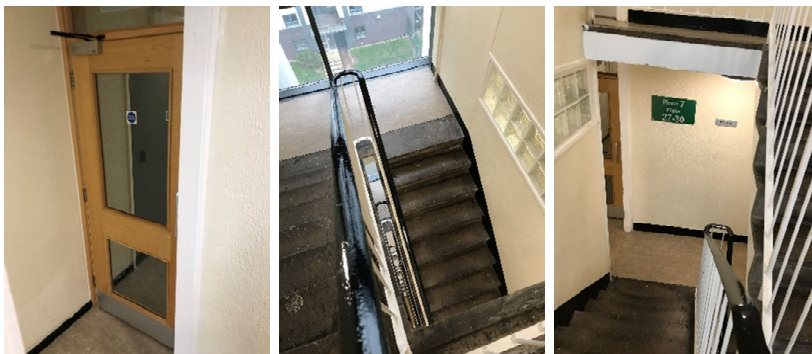
The block has a single protected staircase serving all floors of the block with floor identification numbers on the wall of each floor. The staircase is protected using notional 44mm FD30s doors with combined intumescent and smoke seals.

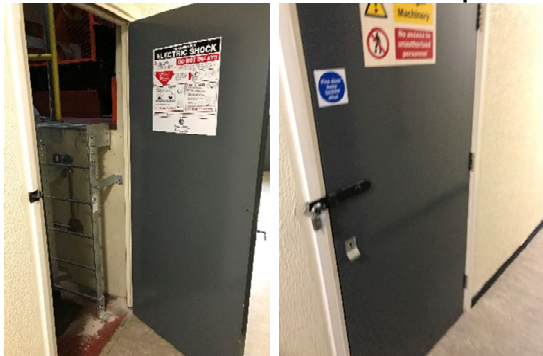
The block has lift access that serves from the ground to the 7th floor with the lift motor room being accessed via a full height nominal timber 54mm FD60s door secured with a pad lock and a suited lock.

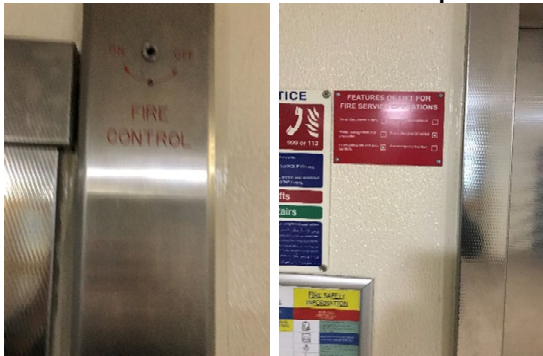
Lift has a fire fighter control switch located on the ground floor near the lift cart in the form of a drop latch system.

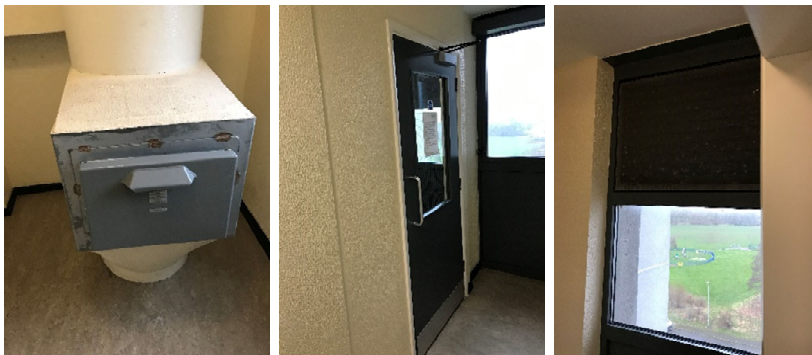
Residents have access to a bin chute system that serves every floor of the block secured behind notional 44mm FD30s doors with combined intumescent and smoke seals and is naturally ventilated

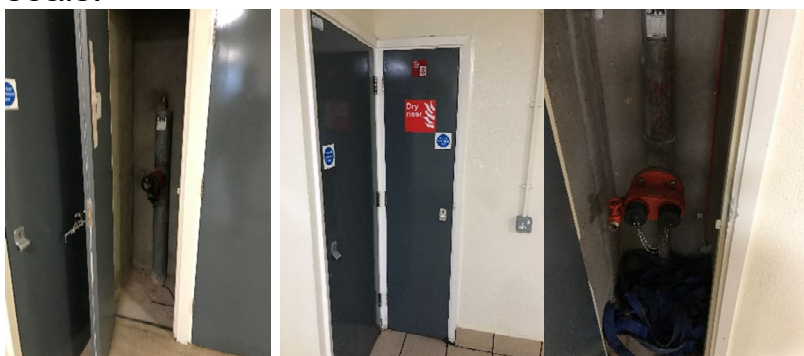
There is a dry riser that serves all floors of the block with a dry riser inlet cupboard located on the ground floor door that is adequately signed and secured, each floor of the block contains a dry riser protected via notional 44mm FD30s doors with combined intumescent strip and smoke seals.

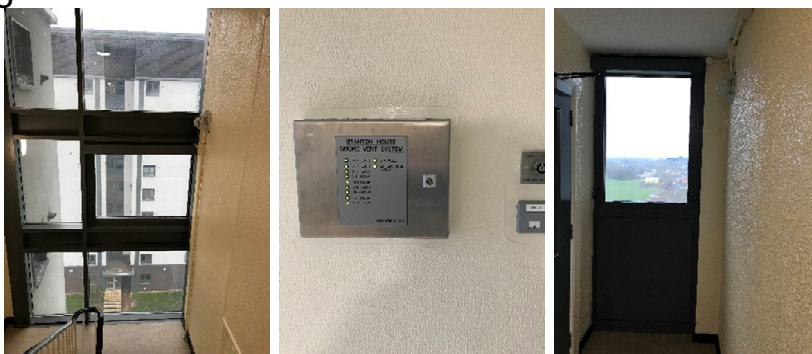
AOV's are in operation on all floors within the corridor nearest the bin chute and within the protected staircase with the control panel on the ground floor nearest the main entrance

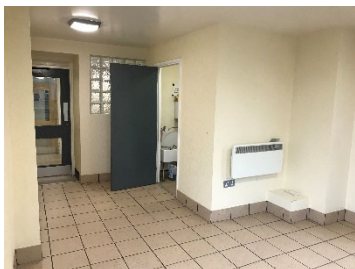
There is a “viewing pod” located on the 1st for that acts as a viewing pod/ waiting room, this is secured with the use of notional 44mm timber FD30s doors secured with a suited key.

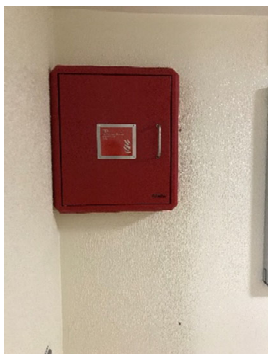
There is a Secure Premise Information Box (PIB) located in the lobby. It is a Gerda box that utilises a standard WMFS suited key. The PIB contains floor plans, vertical plans, orientation plans, information for WMFS and documents for those with vulnerabilities who may require additional consideration if there is a fire incident. Keys for WMFS will also be held within the PIB.

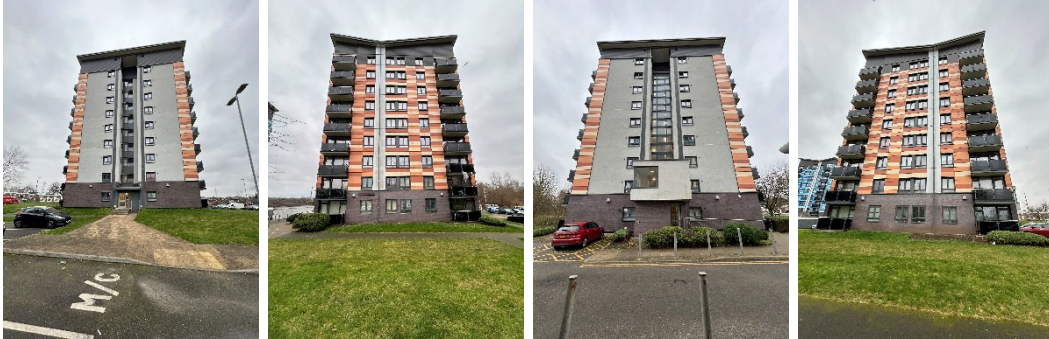
- 1) The block was constructed of concrete frame with masonry infill (Wates) last refurbished in 2015 with the addition of an external wall system the external facade consists of Brick/ Brick slips high-density laminate board, rockwool insulated render.

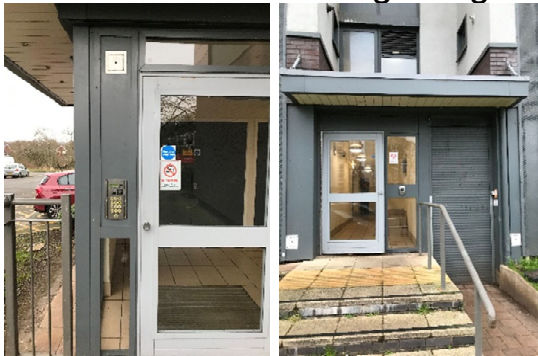
- 3) Front and rear entrance/exit is constructed of an aluminium door and frame with double glazing.

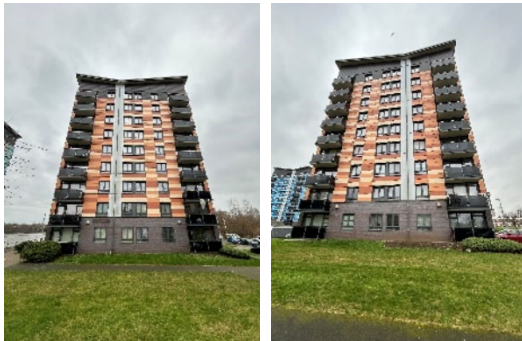
- 4) Residents have balcony access coming from their individual flats on the front and rear elevations of the block

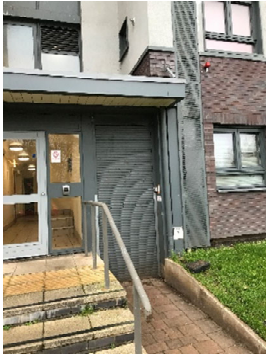
- 5) Bin store located at the side elevation to the block near the secondary entrance/ exit to the building, this is secured with a steal shutter.

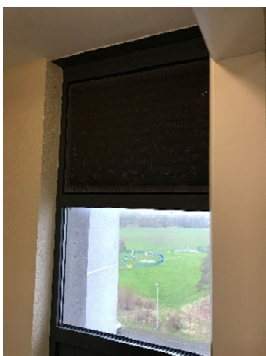
- 8) Natural ventilating to the bin chutes in the form of louver vents

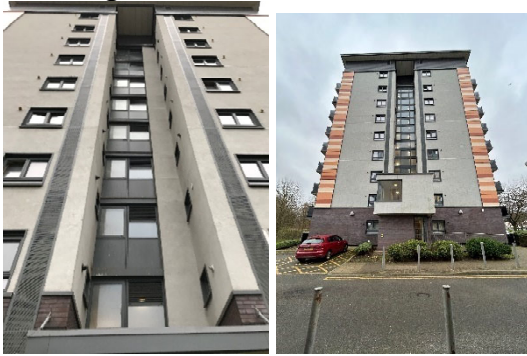
- 9) AOV's serving all floors run along the side elevations of the building.

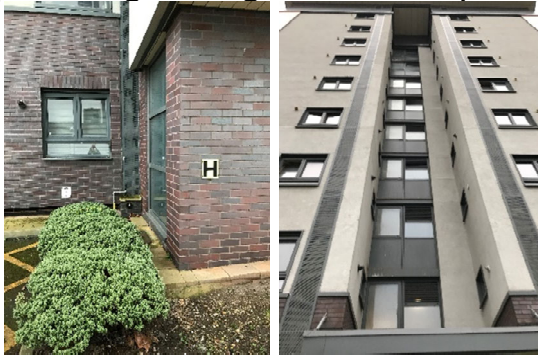
- 10) Gas was noted to be external, secured behind corrugated panelling, with gas isolation points located on the orientation plan.

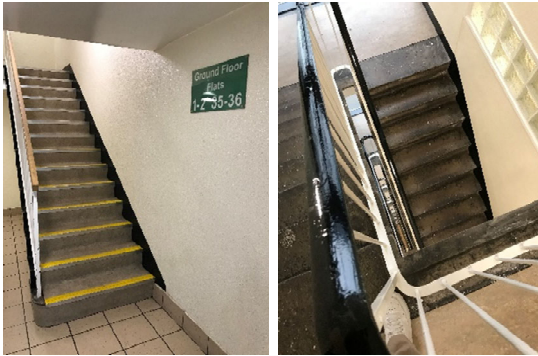
- 1) The site has a single staircase that provides a means of escape and that is sufficient width.

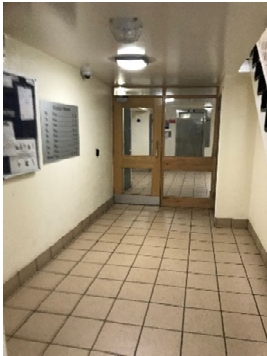
- 2) All corridors are of adequate width (at least 1050mm) and will be maintained clear to that width as a minimum.

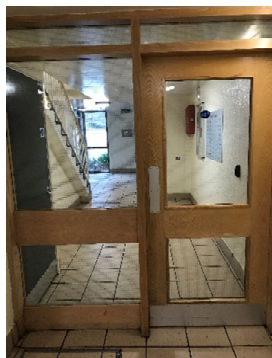
- 3) There are no corridors that form part of a dead-end exceeding travel distances within the means of escape.
 - 4) The means of escape are protected to prevent the spread of fire and smoke by means of nominal/notional fire doors and good compartmentation between lobby areas, staircases, and dwellings.
 - 5) The communal landing / staircases are protected by use of nominal/ notional 44mm timber FD30s fire doors with vision panels.
-

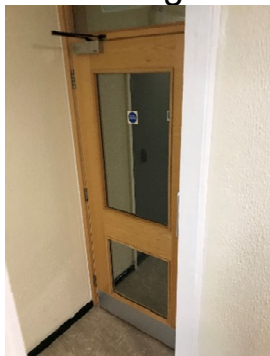
- 6) All communal doors are fitted with automatic closing devices that are checked on a regular basis by Caretaking Teams as part of their checks. Defective closing devices are replaced either by the Caretaking Team(s) or the in-house repairs team(s).

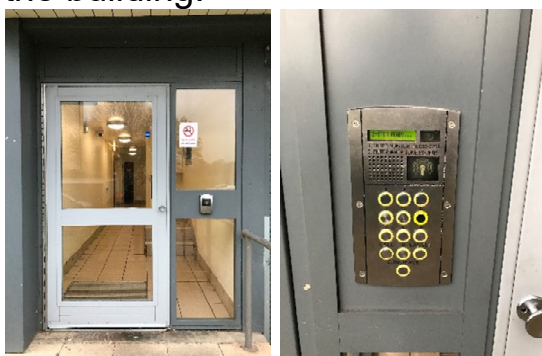
- 7) All communal fire doors are subject to a 12-week check by the Fire Safety Rapid Response Team.
- 8) The final exit doors have door entry systems installed. These systems are designed to fail safe i.e. door unlocked in the event of a power failure. This prevents residents being locked in or out of the building.

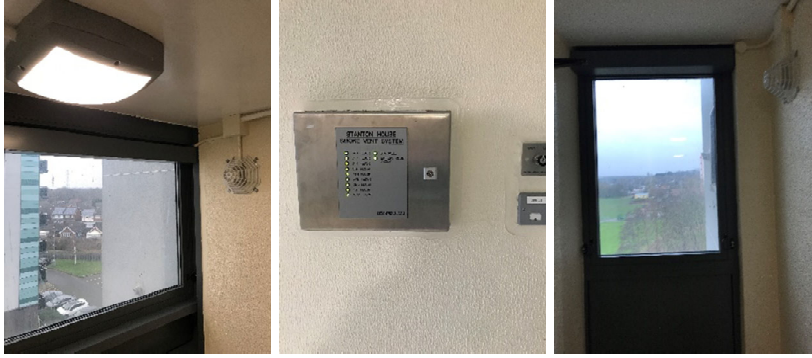
- 9) Automatic smoke ventilation is employed. This is tested, inspected and maintained by a competent procured contractor in accordance with BS7346. The frequency for the maintenance checks are twice per year (April and October) of each calendar year.
-

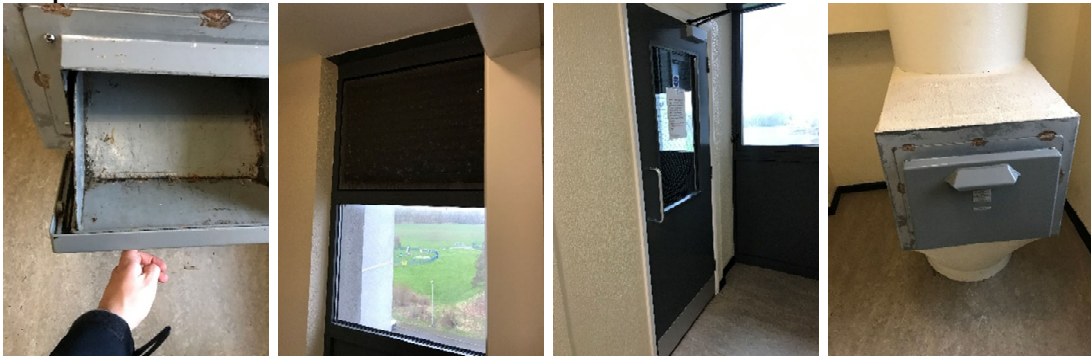
10)The chute room has natural louvre vent / screen allowing ventilation to the chute rooms. These areas are secured behind a 44mm notional FD30s timber door with vision panels intumescent strips and cold smoke seals.

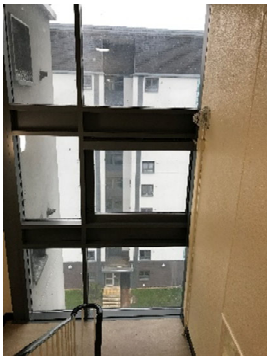
11)Communal windows can only be opened by operating the automatic smoke vents.

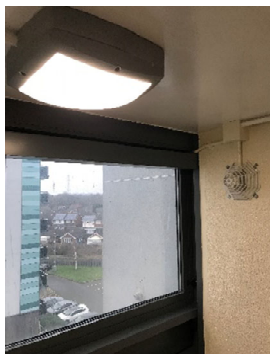
- 13) Emergency lighting is provided to communal landings and stairs. Checks are done on a monthly basis by Sandwell MBC in house electrical team or approved contractor.

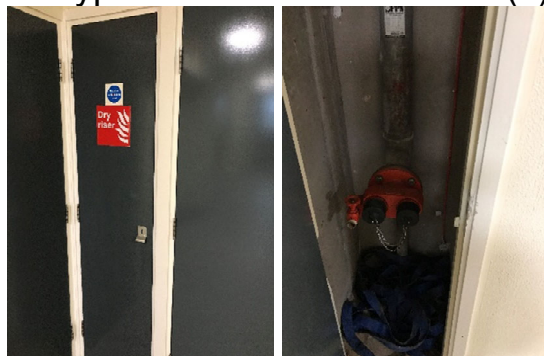
- 14) Dry riser cupboard doors are timber 44mm nominal FD30s with intumescent strips and cold smoke seals, kept locked / secured with type 54 suited mortice lock(s).

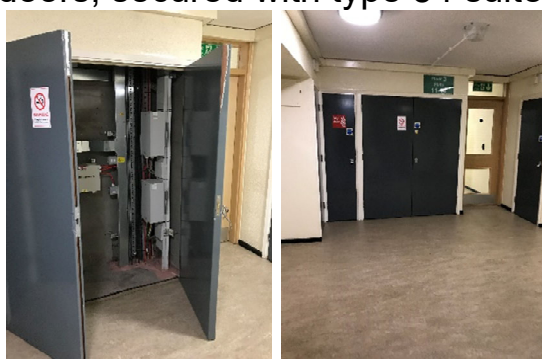
- 15) Service cupboards are notional timber 54mm double FD60s doors, secured with type 54 suited mortice locks.

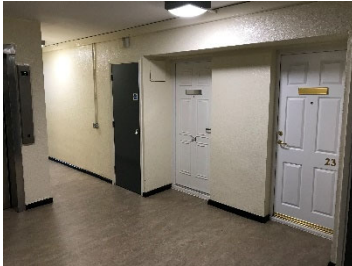
- 18) Individual flat doors are Manse Masterdoor 44mm FD30s composite doors sets with intumescent strips and cold smoke seals.

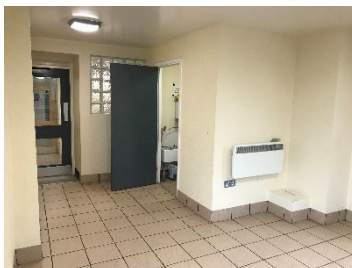
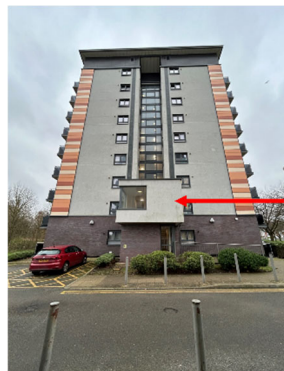
- 20) Communal viewing pod located on the first floor secured with a 44mm timber nominal door with intumescent strips, cold smoke seals and vision panels is secured with a type 34 mortice lock that residents have access this room remains relatively sterile with the cleaners cupboard also being within this area.

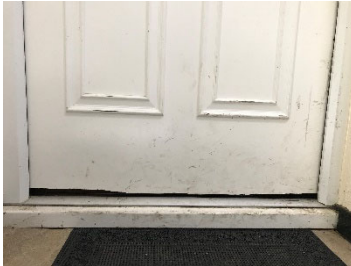
- 21) Large gaps along the bottom edge of door where it is visible to see into the flat from hallway no access granted on day of risk assessment email has been sent to GA.

Update: Email from GA confirming that this has been added to the emergency door list and for someone to attend 07/02/2024

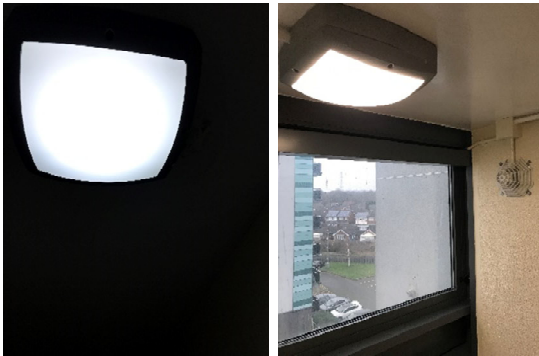
- 1) The premises has a sufficient emergency lighting in accordance with BS 5266 and has test points strategically located.
- 2) The units are provided to the communal landings, stairs and lift motor room.

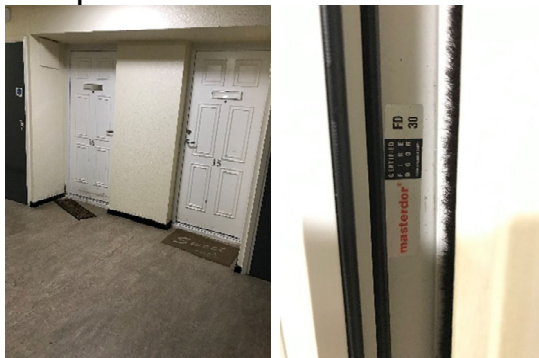
9) Individual flat doors are a Manse Masterdoor 44mm FD30s composite fire door construction.

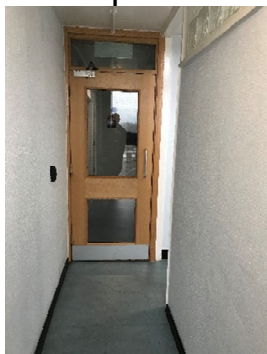
10) corridors / staircases are protected by use of FD30s fire doors with vision panels.

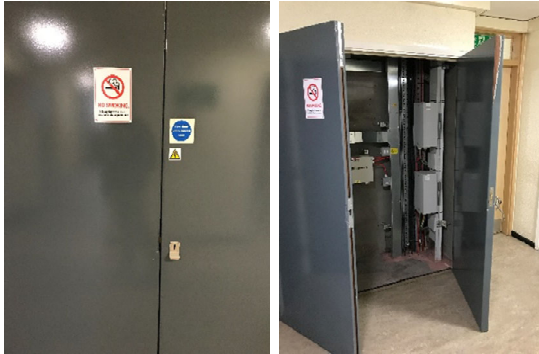
- 11) Cupboard doors within the communal areas such as residents meter cupboards/ electrical risers cupboards are notional 54mm FD60 timber fire door sets with intumescent strips, cold smoke seals.

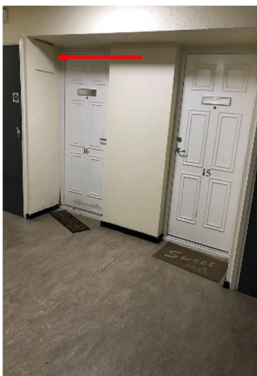
- 13) Access panels to stop taps are fixed to masonry and bedded on Intumescent material.

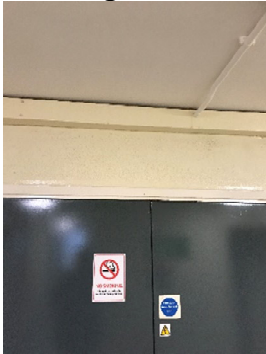
- 14) It was noted that metal trunking had been utilised to house cabling in communal areas

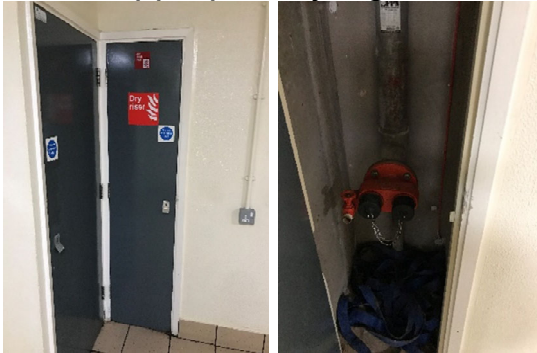
- 1) The dry riser inlet cupboard is located in the ground floor lift lobby and is appropriately signed

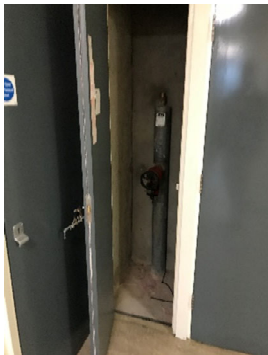
- 2) The riser outlets are available on each floor lobby (ground – 8th) these are protected via nominal 44mm 30-minute fire doors secured by suited 54 key & mortice locks.

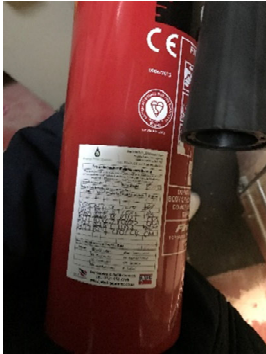
- 5) Portable fire extinguisher (CO2) is provided to the lift motor room. Maintenance contracts in place for maintenance of the extinguisher. The frequency for the maintenance checks are once of each calendar year last check was conducted October 2023

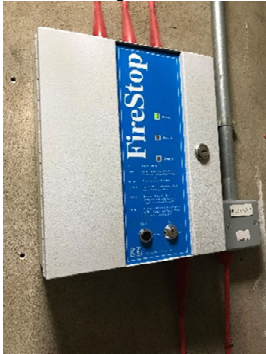
- 6) Bin room is protected by Deluge/sprinkler system and serviced 6-monthly, the control panel is stored under the stairs

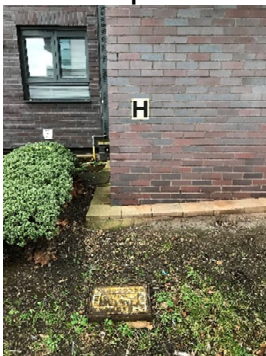
- 7) Fire hydrant can be located at the side elevation nearest the main access point to the building
