# Fire Risk Assessment

## Hamstead House

**Coniston Crescent,  
Great Barr, B43 5NT**

**Date Completed: 27/11/2024**

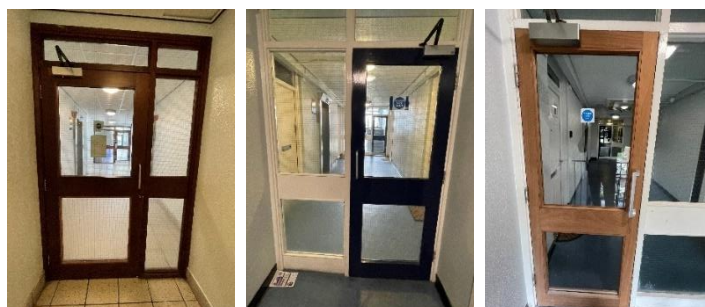
It has been recognised that all of the landing / staircase notional doors in this block have been upgraded with combined intumescent strips & cold smoke seals to enhance their original design and minimise departures from today's standards. It was noted that a replacement nominal FD30s timber fire has been installed on the 10<sup>th</sup> floor.

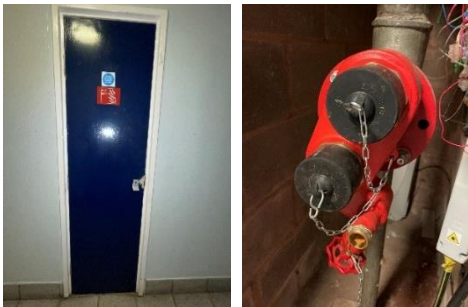
- 1) The dry riser inlet cupboard is located within the ground floor adjacent the service cupboard and community room and is secured with a suited 54 type mortice lock.

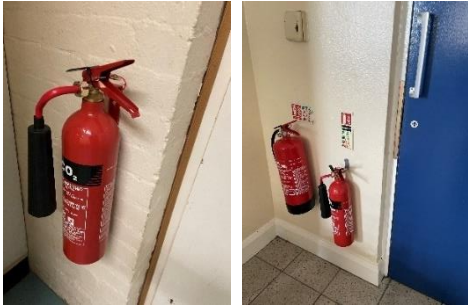
- 5) Portable fire extinguisher (CO2) is provided to the lift motor room and caretakers office. A further CO2 plus Foam fire extinguisher has been provided to the community room along with a fire blanket to the community room kitchen. Fire extinguishers and associated equipment are inspected, serviced, and maintained by a competent person/contractor in accordance with the relevant British Standards, BS5306-3.

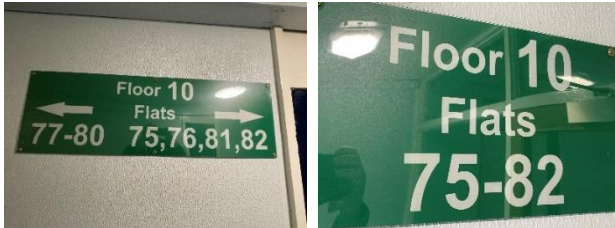
- 5) Photoluminescent wayfinding signage illustrating floor level and flat numbers are fitted to the walls on all floors and to the wall of each landing on the communal staircase. Signage that meets the requirement of ADB and Fire Safety (England) Regulations 2022.

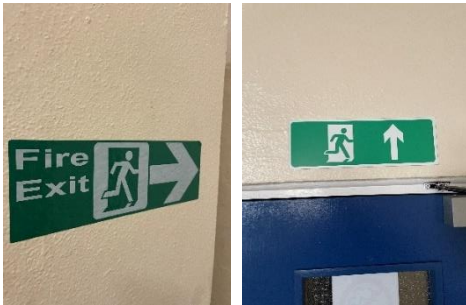
- 6) The fire escape routes generally do not use directional fire signage in accordance due to simplicity of layout however, fire escape signage has been installed to the community room, caretakers' office, and front & rear entrances at ground floor level.

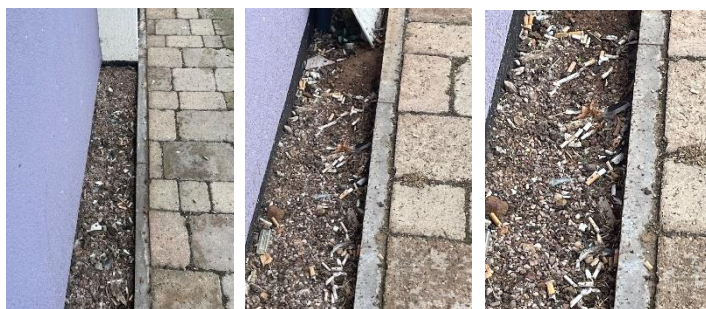
- 1) Smoking is prohibited within any communal parts of the building in line with Smoke Free England legislation.
- 2) Although some 'No Smoking' signage has been fitted. Additional 'No Smoking' signage is required in prominent locations in the building. See section 12/07.
- 3) There was evidence of carless disposal of cigarettes outside of the building. It is not known if this is by an individual or if cigarettes are disposed of through windows of flats above. This should cease immediately; letters should be sent to all residents asking them to dispose of smoking materials appropriately to minimise the risk of fire occurring. (Email sent to Housing).

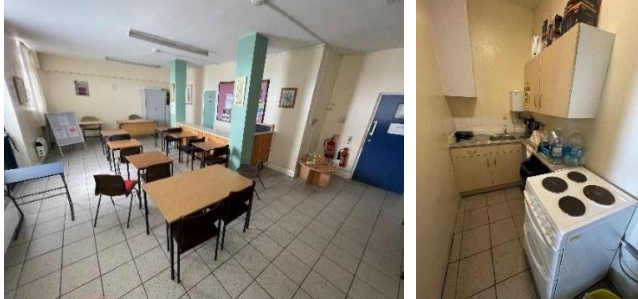
- 5) There is a community room located on the ground floor which is used for general meetings and social events such as Bingo. The room is equipped with a kitchenette, serving area and a quantity of tables & chairs.

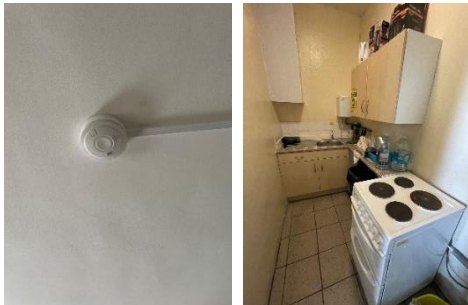
- 6) Smoke detection is present along with a CO<sup>2</sup> & Foam fire extinguisher, there is also a fire blanket within the kitchenette.

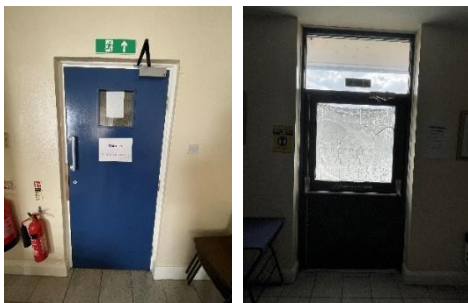
- 7) There are 2 exits from the room, one is operated by a push bar and measures approx. 1000mm, this leads to a place ultimate safety. The other exit door is approx. 750mm and opens inwards. This leads to a place of relative safety (protected communal corridor). Because the inward opening door does not open in the direction of escape the flow rate for the community room is limited to 60 persons.
