Fire Risk Assessment

Hackwood House

Hartlebury Rd, Oldbury,
B69 1EG

Date Completed: 22/05/2024.

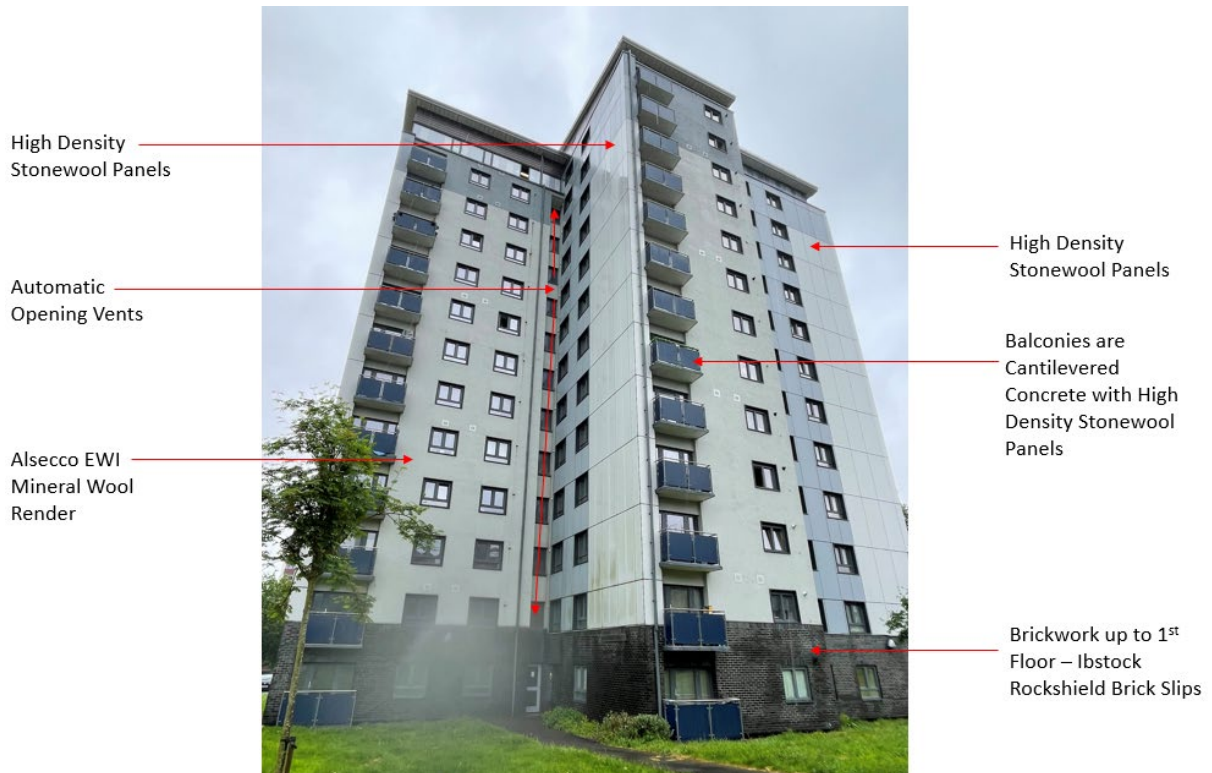
However, the presence of anti-bird netting to 2 x flat balconies, timber trellis & plastic greenhouse to 1 x balcony and screening to another could, potentially support the external spread of flame and therefore is an unnecessary risk.

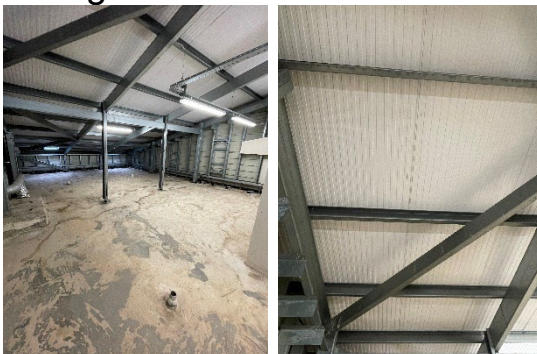
2) The steel framed pitched roof with aluminium standing seam PIR/PUR core panels was constructed over the original flat roof during the 2018/19 refurbishment works.

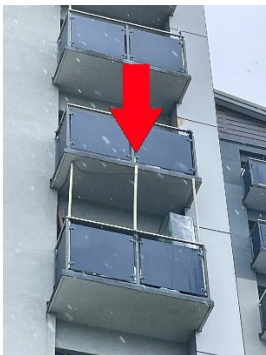
- 5) **Flat 33 / 6th floor – Installed netting to balcony and plastic greenhouse has the potential to support the surface spread of flame.**

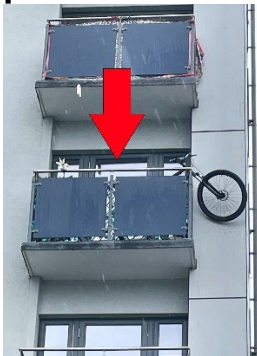
7) Flat 26 / 4th floor – Installed timber trellis to balcony has the potential to support the surface spread of flame.

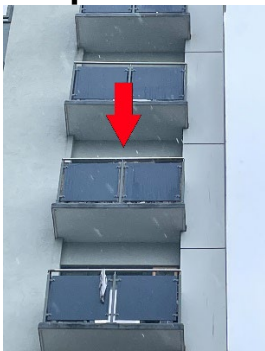
9) Flat 44 / 7th floor – Installed willow screening to balcony has the potential to support the surface spread of flame.

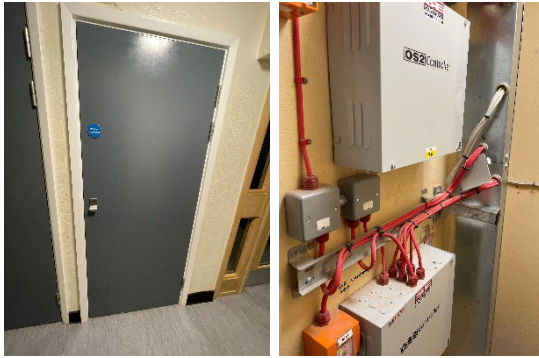
- 13) Individual override / reset controls for each corridor AOV are located in service cupboards on each floor (single door secured with a 54 lock). It should be noted that the system installed is fully automated and each vent is independently controlled by a localised smoke detector. Once smoke has cleared the system will automatically reset. The individual override / reset panels are flashing fault on all floors. The manual override & reset was functioning during the inspection. Contracts manager notified 22/5 by email.
-

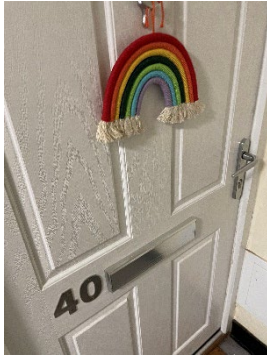
- c) 7th floor flat 40 – combustible decoration on flat entrance door.

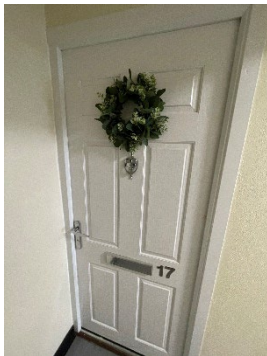
- d) 3rd floor flat 17 has a combustible wreath on the flat entrance door.

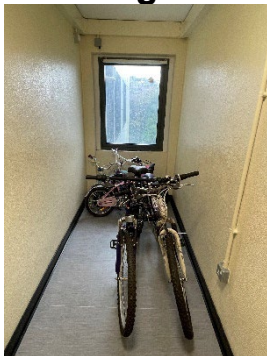
- e) 3rd floor by flats 18, 19, 20 – 5 bicycles in corridor blocking access to the AOV.

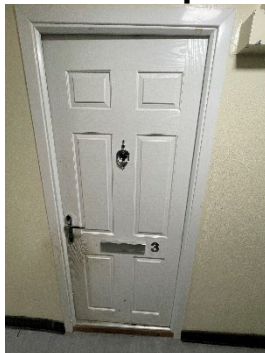
- f) Flat 3 – Entrance door not reliably fully self-closing onto catch / requires adjustment.

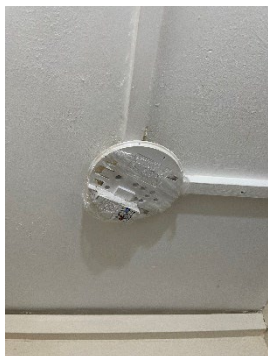
- 3) **Flat 13 – A hardwired smoke detector head has been removed from the hallway ceiling. The backing plate and second detector in hall remain.**

8/3	Flat 13 – replace / re-install missing hardwired smoke detector head in hallway.

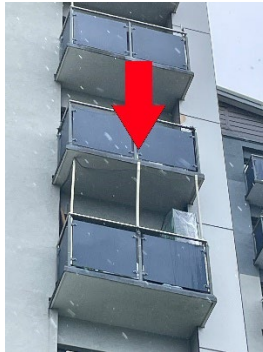
Question/ Ref No	Required Action	Supporting photograph	Priority	Timescale and Person Responsible	Date Completed
6/5	Flat 33 to remove netting & plastic greenhouse type structure from balcony.

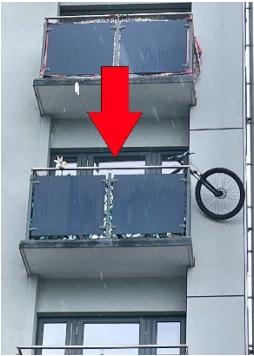
P2	Within 1-3 months Housing Manager	
6/7	Flat 26 to remove timber trellis that is installed to balcony.

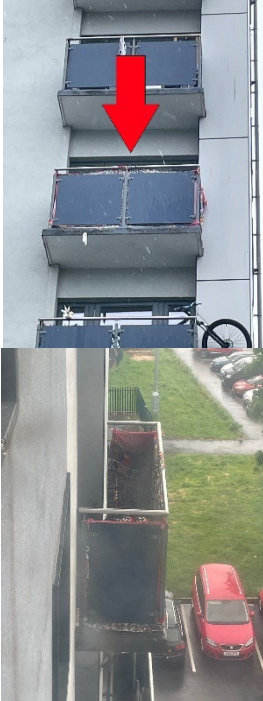
6/8	Flat 32 to remove installed screening material that is installed to balcony.

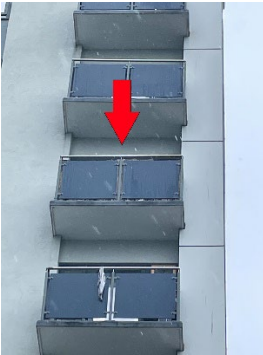
P2	Within 1-3 months Housing Manager	
6/9	Flat 44 to remove willow / timber screening installed to balcony.

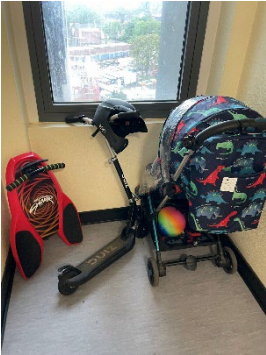
- a) **9th floor by flats 54,55,56 – Childrens toy, scooter and push chair left in corridor blocking access to the AOV.**
It has been noted that an action was created for what appears to be the same pushchair during the previous FRA (September 2022). The occupier of flat 55 agreed to remove the pushchair.

7/14a	Childrens toy, scooter and pushchair to be removed from corridor outside flats 54, 55, 56. <i>(Similar pushchair was flagged in same place 2022 FRA)</i>

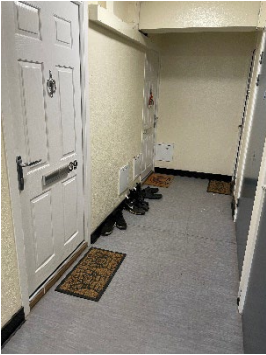
- b) **7th floor outside flats 39 & 40 – several pairs of shoes in corridor which are potential trip hazards in the means of escape.**

P2	Within 1-3 months Housing Manager	
7/14b	Several pairs of shoes to be removed from the means of escape outside flats 39 & 40

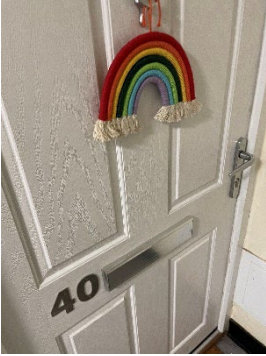
P2	Within 1-3 months Housing Manager	
7/14c	Combustible decoration to be removed from flat 40 entrance door.

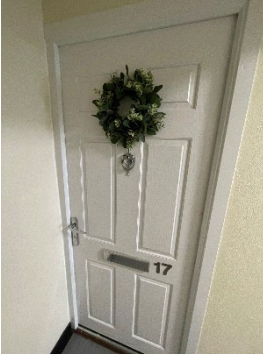
7/14d	Flat 17 to remove combustible wreath from entrance door.

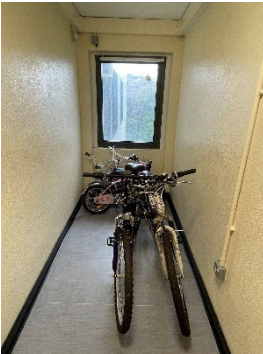
P2	Within 1-3 months Housing Manager	
7/14e	5 x bicycles to be removed from corridor outside flats 18,19,20.

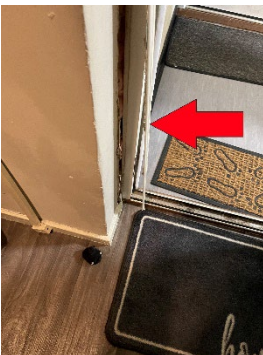
- a) **Flat 55 - Entrance door not reliably fully self-closing onto latch / requires adjustment. Also, the trim has come away from the left side of the door frame. It was noted that pink PU foam has been used in the cavity behind.**

P2	Within 1-3 months Housing Manager	
7/19a	Flat 55 / 9 th floor – Adjust self-closer to ensure door positively engages latch. Also, remove pink PU foam and replace with suitable product (rockwool) then re-fit trim.

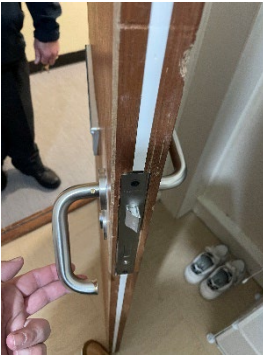
- d) Flat 13 – There is no cold smoke seal installed to door or frame and, the external door handle rotates almost 360 degrees which is clearly defective and requires replacement.

P2	Within 1-3 months Fire Rapid Response	
7/19d	Flat 13 / 2 nd floor – install combined intumescent / cold smoke seal to door. Also, replace defective lock / handle with thumb turn type device.

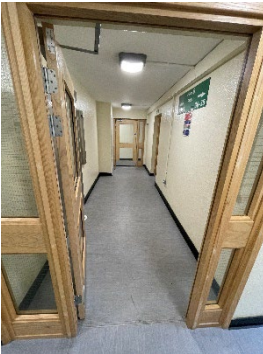
11) 6th floor communal door by flat 35 fails to self-close when fully opened.

P2	Within 1-3 months Electrical Compliance Manager	
10/11	6 th floor communal door by flat 35 requires adjustment to ensure its capable of self-closing from all angles.

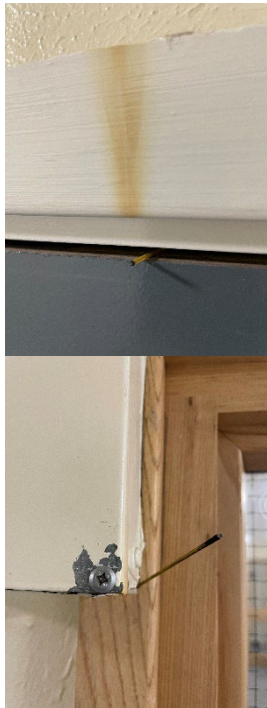
- 6) **There is evidence of scorching to several surfaces in various communal locations on the 10th floor. Some of the scorching may be historic due to inappropriate use of Incense sticks which was raised as a concern in the previous FRA to this (September 2022).**

However, Incensed sticks were once again noted wedged in various places on the 10th floor all of which were found to be extinguished. All used incense sticks should be removed and residents to all 6 flats on this floor should be contacted and reminded that the use of incense sticks within the communal area is prohibited.

14/4	Confirm EICR to the landlord's supply has been completed within the last 5 years.	N/A	P2	Within 1-3 months Electrical compliance manager.	
14/6	Remove the remains of all incense sticks from the common areas and inform residents of all 6 flats on the 10 th floor refrain from using these in the communal areas. <i>The same action was raised in the previous FRA dated 09/2022</i>

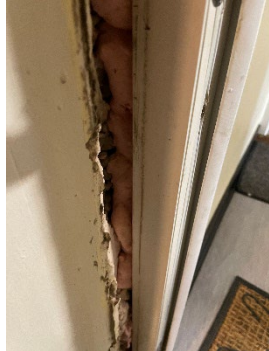
Observations	
<p>PU pink fire foam filler was noted around the flat entrance door frames to the ground floor unfinished void flats and flat 13 entrance door. Removing and replacing this foam with a more suitable product should be considered during door replacements or future refurbishment works.</p>
