Fire Risk Assessment

Thompson Gardens

**1-89, Hales Lane,
Smethwick, B67 6RX**

Date Completed: 28/08/2024.

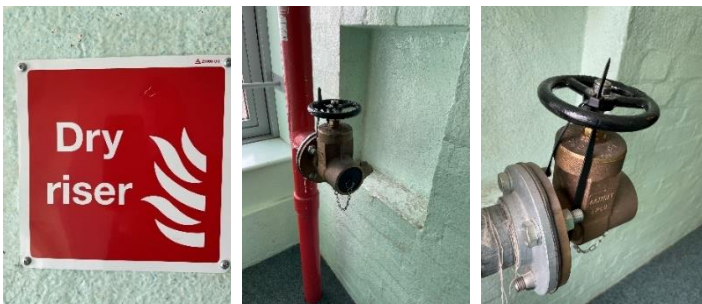
Dry riser outlets are available on each floor lobby. Each outlet is secured in the off position by cable tie.

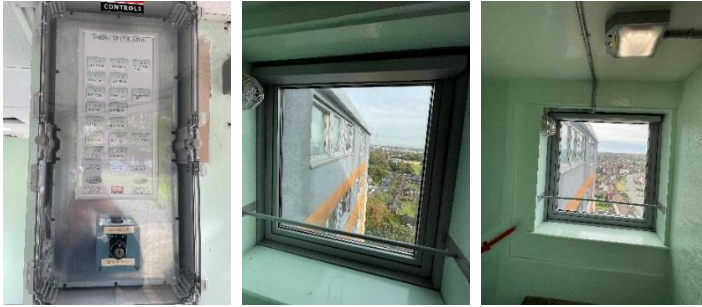
Automatic opening vents are installed to each floor lobby adjacent the dry riser outlet and on staircases floors B, G, L, M. The information panel & override switch are located on the left as you access the main entrance.

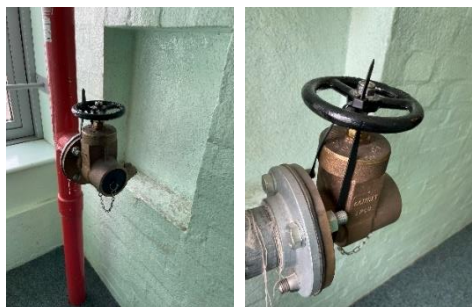
- 16) Dry riser outlets on lobbies are not housed in service cupboards but deliveries are secured by cable tie.

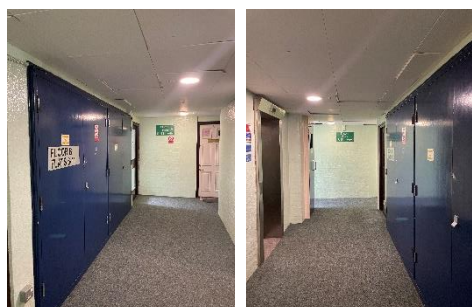
- 17) Service cupboards are 54mm nominal fire doors with individual intumescent strips and cold smoke seals, secured with type 54 suited mortice locks.

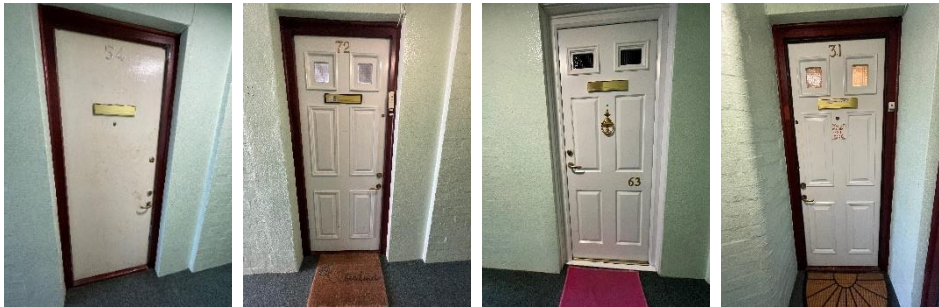
20) Individual flat doors are FD30s composite fire door sets with intumescent strips, cold smoke seals and self-closing devices. The majority of doors are manufactured by Permadoor. Flats 6, 41, 51, 52, 53 are manufactured by IG Doors. Flat 54 is a nominal timber flush 30-minute fire door.

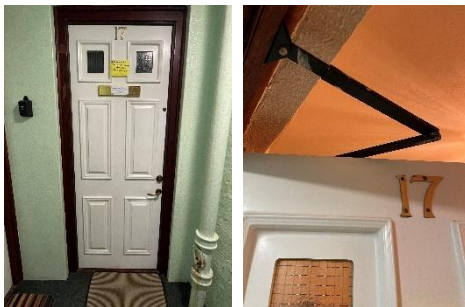
d) Flat 17 – Door was correct.

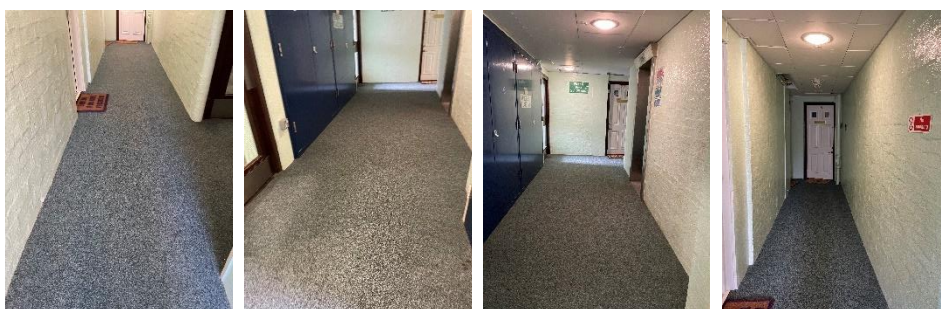
24) At the time of the assessment, it was noted that landing floors were fitted with carpet. It should be confirmed that carpets have been procured in accordance with BS 5287: 1988 specification for assessment and labelling of textile floor coverings and & BS 4790 Fire Test to Textile Floor Coverings.

Due to these carpets have been procured by SMBC utilising third party approved contractors. Therefore, it is understood that carpets fitted meet the approved standard.

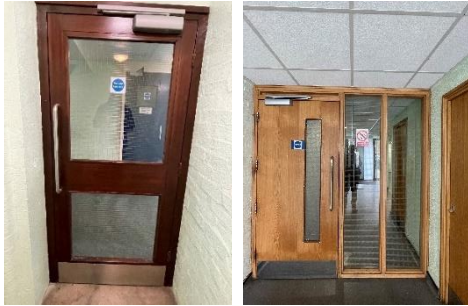
- 6) The communal landings & staircases are protected by use of notional self-closing 44mm 30-minute timber fire doors with vision panels. It is recognised that these doors do not meet today's benchmark of a certified FD30s fire door install. However, because they were installed at the time of the building's construction and to the standard of that time they are deemed as acceptable so long as the doors are free of damage and function as they were intended to do so.

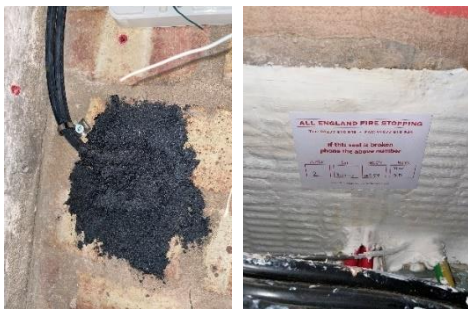
- 14) A variety of methods / materials have been used to achieve fire-stopping including Rockwool, fire rated sponge and intumescent pillows.

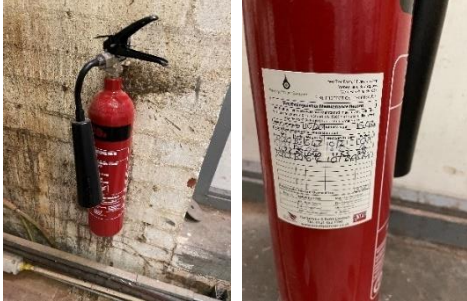
- 5) Portable fire extinguisher (CO2) is provided to the lift motor room. Maintenance contracts in place for maintenance of the extinguisher. The frequency for the maintenance checks are once (October) of each calendar year.

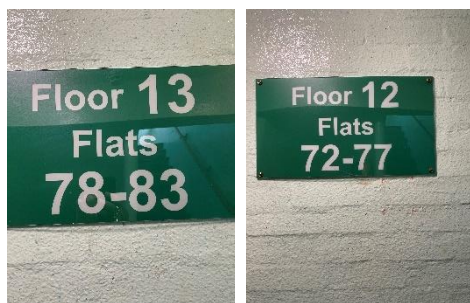
- 7) Since the previous FRA, Photoluminescent wayfinding signage depicting floor level and flat numbers has been fitted to wall of each floor on the communal staircase(s).

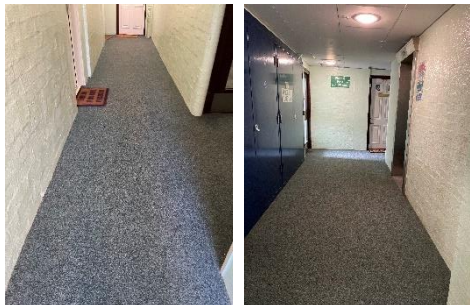
- 9) At the time of the assessment, it was noted that landing floors were fitted with carpet. It should be confirmed that carpets have been procured in accordance with BS 5287: 1988 specification for assessment and labelling of textile floor coverings and & BS 4790 Fire Test to Textile Floor Coverings.

Due to these carpets being fitted by SMBC, its assumed that it meets the necessary standard set out above. See section 7/ 24 for further information. N.B, this has been recorded in the action plan.

At the time of the assessment, it was noted that landing floors were fitted with carpet. It should be confirmed that carpets have been procured in accordance with BS 5287: 1988 specification for assessment and labelling of textile floor coverings and & BS 4790 Fire Test to Textile Floor Coverings.

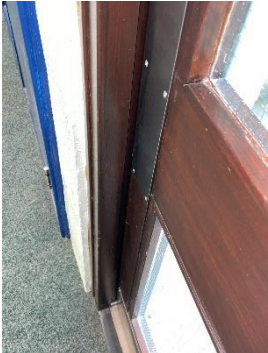
<p>P2</p>	<p>Within 1-3 months Repairs</p>	
<p>10/08</p>	<p>Floor L (10) – Communal door to stairwell by flat 63, leaf is warped and requires replacement. <i>Previously recorded on the FRA, awaiting Joinery</i></p>

Some notional communal stairway doors show signs of wear and tear due to age. Consideration should be given to upgrade all doors with certified FD30s door sets as part of future programmed works.

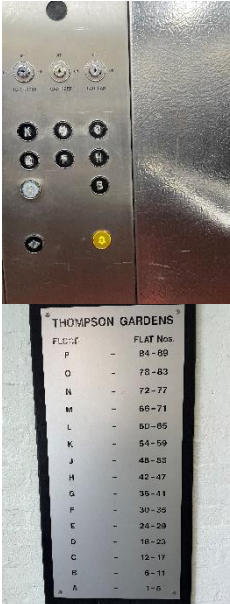
<p>P2</p>	<p>Within 1-3 months Fire Rapid Response</p>	
<p>12/05</p>	<p>The wayfinding signage is inconsistent throughout the building. (See main report) The mixture of signage could cause confusion, particularly in an emergency. Therefore, signage should be reviewed to read the same in order to maintain consistency throughout the building.</p>
