Fire Risk Assessment

Thompson Gardens

**1-89, Hales lane,
Smethwick, B67 6RX**

Date Completed: 16/10/2023

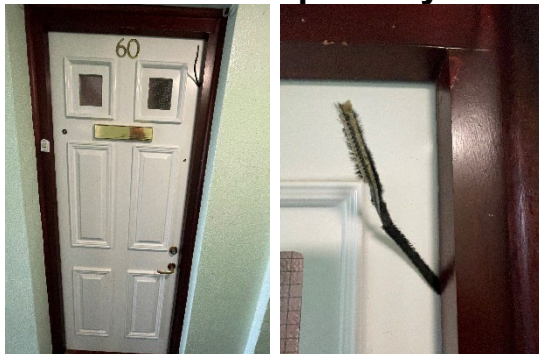
f) Flat 60 – Access not gained but it appeared that the cold smoke seal was partially detached.

| Question/ Ref No | Required Action | Supporting photograph | Priority | Timescale and Person Responsible | Date Completed |
|---|--|--|---|--|---|
| 7/21f | Flat 60 floor L (10 th) Replace cold smoke seal. (access not gained during FRA) | | P2 | Within 1-3 months Fire Rapid Response JM:12141939 JM:12294550 | |
