Fire Risk Assessment

Heronville House

**Sedgley Rd East,
Tipton, DY4 7TX**

Date Completed: 18/06/2024

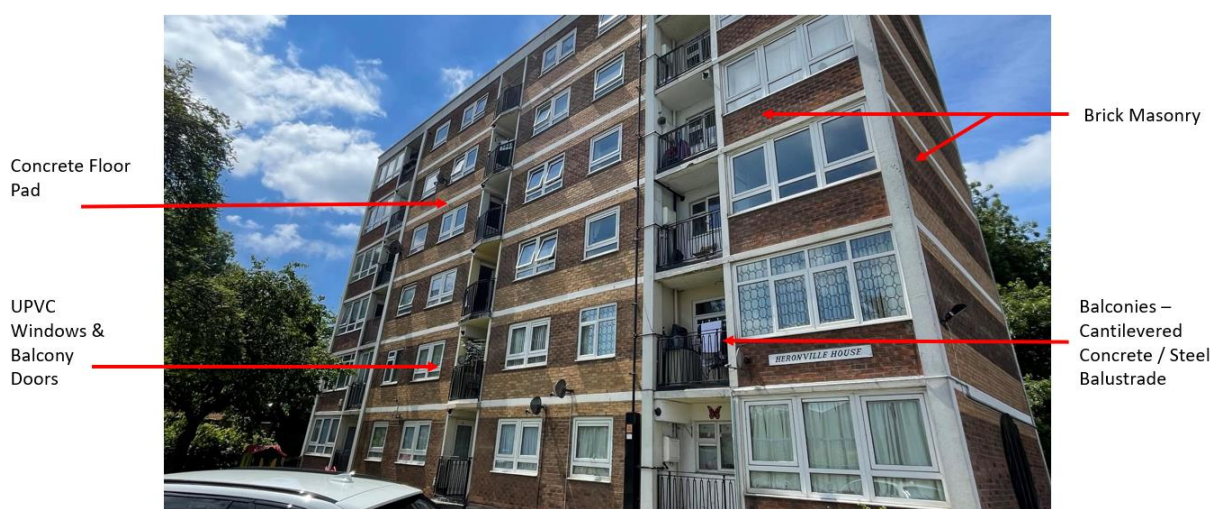
The addition of screening to one balcony and the build-up of combustible waste on another could potentially, support the surface spread of flame in those areas which is an unnecessary risk. Once this is removed the level of risk presented by materials present to the external envelope of this building would become trivial.

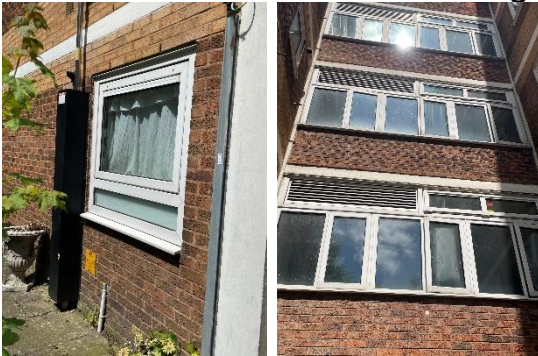
3. Only those flats to the left of the main entrance (3 per floor & same side of service cupboards) have access to balconies. Balconies are cantilevered concrete with steel balustrades.

- A. Flat 112 (5th floor) Screening that is likely to be combustible has been installed to balcony.

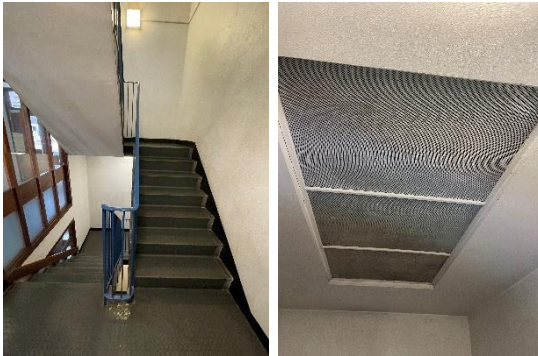
- 1) The site has a single staircase that provides a means of escape and is 1000mm in width. There is a ventilation grill at the head of the staircase

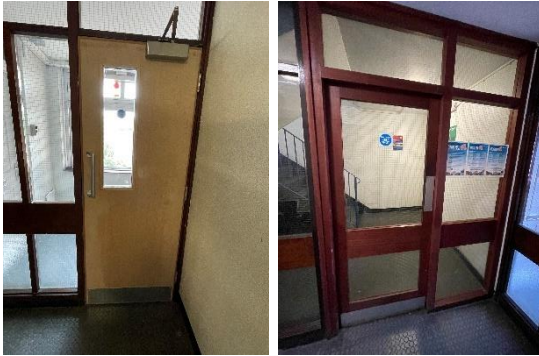
5) The communal lobbies / landing / staircases are protected by use of notional FD30s fire doors with vision panels.

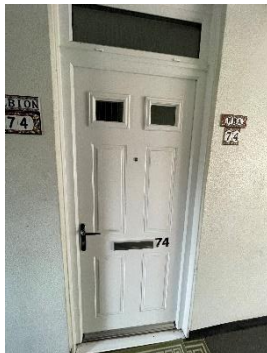
- a) Flat 74 – Door is correct

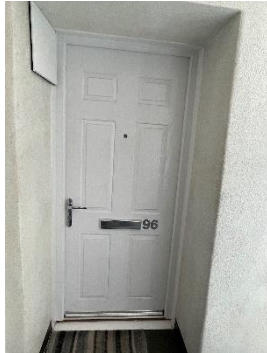
- c) Flat 96 – Door is correct.

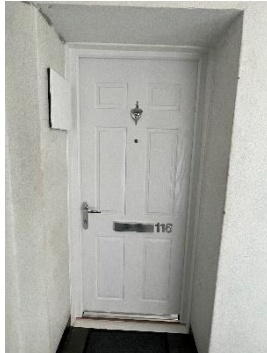
- d) Flat 116 - Door is correct.

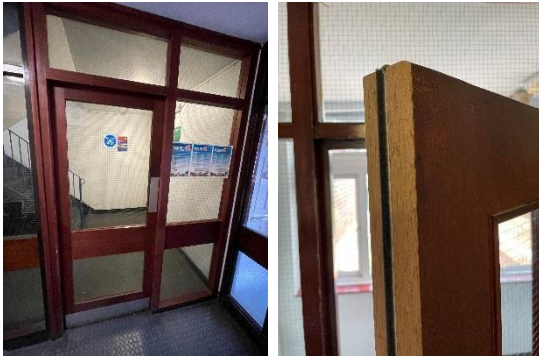
- 7) The communal corridors, landing & staircases are protected by use of notional self-closing 44mm 30-minute timber fire doors with vision panels & 25mm stops, along with 30 minute notional hardwood fire screens with GWPP glazing (stairwell). It is recognised that these doors do not meet today's benchmark of a certified FD30s fire door /screen install however, because they were installed at the time of the building's construction and to the standard of that time they are deemed as acceptable so long as the doors /screens are free of damage and function as they were intended to do so. It has been recognised that all of the landing / staircase notional doors in this block have been upgraded with combined intumescent strips & cold smoke seals to enhance their original design and minimise departures from today's standards. Were minor shortcomings have previously been identified, actions have been created for corrective works for example, some doors have been re-lipped with hardwood.

Observations	
Some notional communal landing doors show signs of wear and tear due to age. Consideration should be given to upgrade with certified FD30s door sets, combination frames / screens as part of any future refurbishment works.

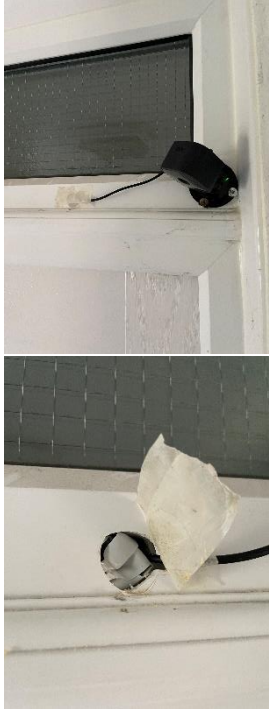
7/21b	Flat 84 to remove camera from entrance door. Housing officer to arrange temporary repair via Fire Rapid Response Team and refer for door set replacement via Repairs (recharge).

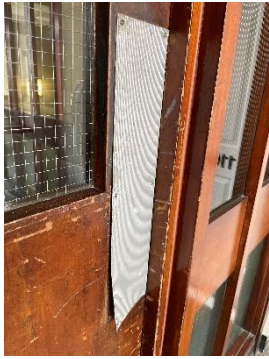
P2	Within 1 to 3 months. Housing Manager
10/9	5 th floor communal door by flat 110 – re-fix corner of aluminium push plate.

P2	Within one to 3 months Fire Rapid Response Team
