Fire Risk Assessment

Wallace House

Badsey Rd, Oldbury,
B69 1ER

Date Completed: 10/06/2024.

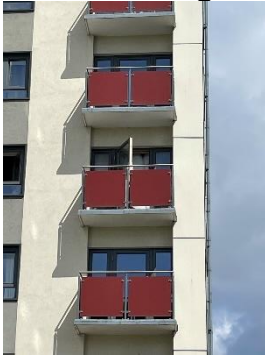
- 4) Each flat within the block has access to an individual balcony. The balconies are constructed utilising a cantilevered concrete with steel and high density Stonewool Panels.

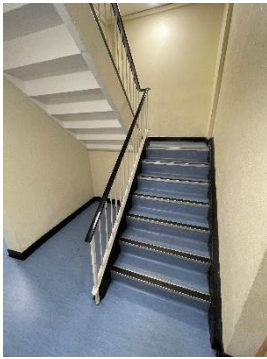
- 1) The site has a protected staircases that provides a sufficient means of escape which is 1020mm in width from balustrade to wall.

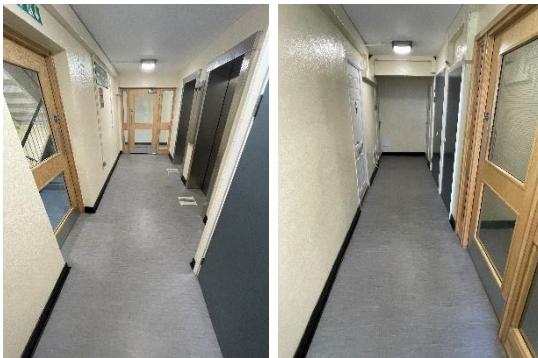
- 2) All corridors are of adequate width (at least 1050mm) and will be maintained clear to that width as a minimum.

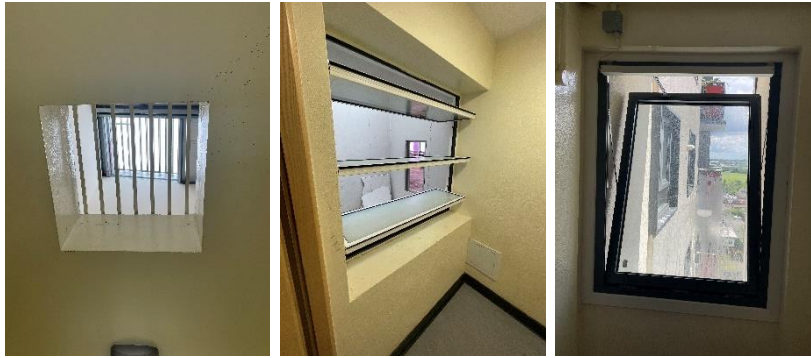
- 9) Automatic smoke ventilation is employed. This is tested, inspected and maintained by a competent procured contractor in accordance with BS7346. The frequency for the maintenance checks are twice per year (April and October) of each calendar year. Communal windows can only be opened by operating the automatic smoke vents.
 - 10) Automatic opening vents have been installed to the head of protected staircase and in each corridor above the ground floor. It was noted that the opening vents in the 12th floor corridors are of a different design to other corridors within the building.
-

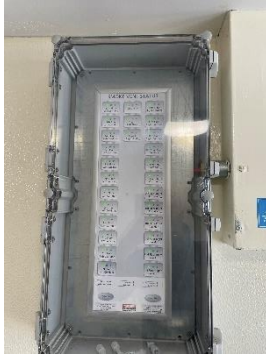
- 13) **There's a repeater panel located on the wall of the ground floor lobby that provides the status of the system.**
-

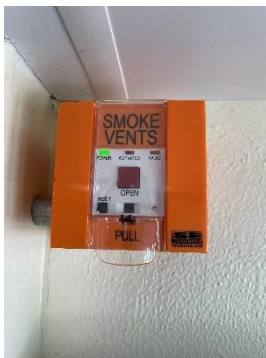
- 14) The manual override and master reset for the entire system is located next to the repeater panel.

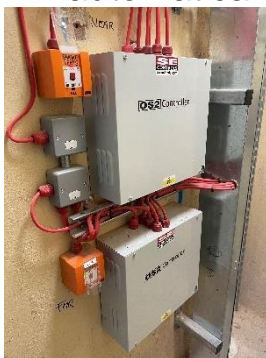
- 15) Individual override / reset controls for each corridor AOV are located in service cupboards on each floor (single door secured with a 54 lock). It should be noted that the system installed is fully automated and each vent is independently controlled by a localised smoke detector. Once smoke has cleared the system will automatically reset.

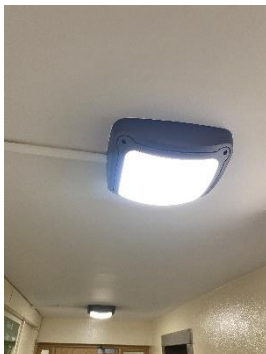
- 18) Emergency lighting is provided to communal landings and stairs. Checks are done on a monthly basis by Sandwell MBC in house electrical team or approved contractor.

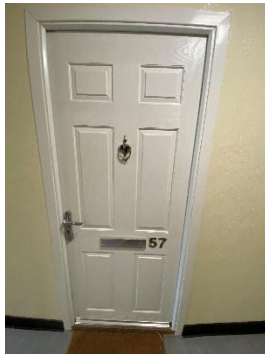
- a) Flat 57 – Door was correct.

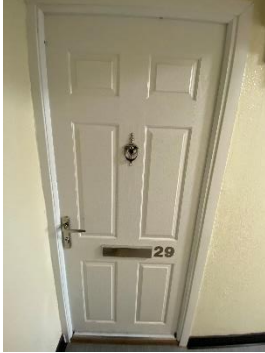
c) Flat 29 – Door was correct.

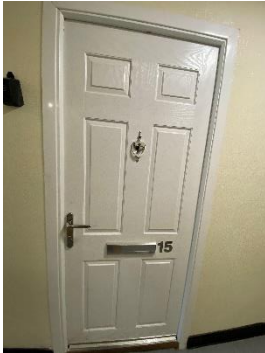
d) Flat 15 – Door was correct.

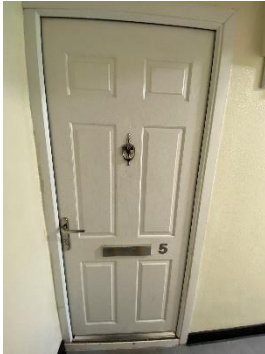
e) Flat 5 – Door was correct.

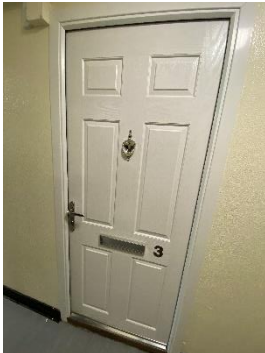
f) Flat 3 – Door was correct.

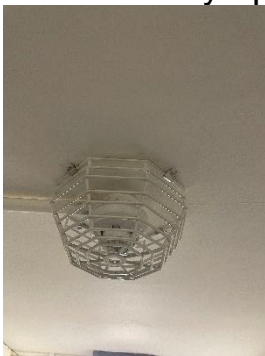
- 3) There is no effective means for detecting an outbreak of fire to communal corridors, lobbies, landings and stairs. The reason for this are:
 - I. Such systems may get vandalised.
 - II. False alarms would occur.
 - III. A Stay Put - Unless policy is in place.
- 4) Smoke detectors linked to the Automatic Opening Vents have been installed to the common parts of the building. The vents will automatically open when smoke has been detected.

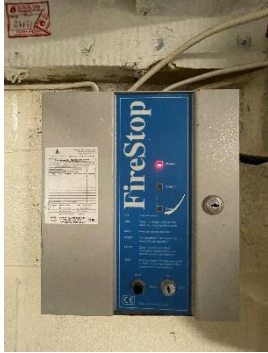
- 5) A fire suppression system is provided to the refuse chute bin store. An approved contractor maintains the systems. The frequency for the maintenance checks are twice per year (April and October) of each calendar year.

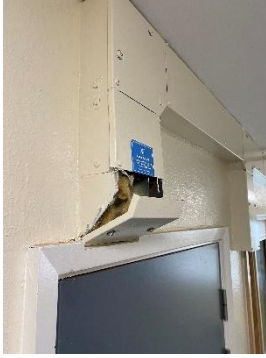
- 6) **Cover to cable trunking by flat 36 is open and requires securing.**
-

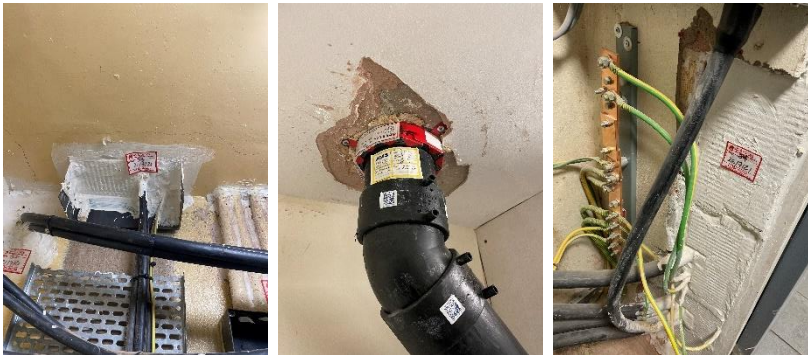
- 7) A variety of methods / materials have been used to achieve fire-stopping including Rockwool, intumescent collars and intumescent fire batts.

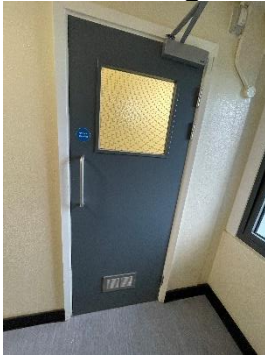
- 12) Doors to chute rooms are nominal FD30s with vision panels and ventilation grill with intumescent baffle.

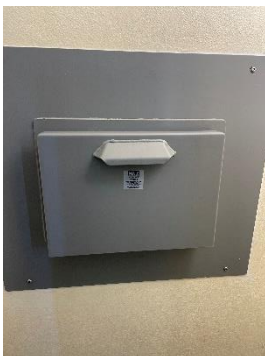
- 13) Refuse hoppers on all floors are Dartford Metalcrafts type LC conforming to BS1703: 2005 with 4 ¼ hours fire rating to BS476 part 22 and smoke containment to BS476 part 31.1. The hoppers were installed 23/02/23.

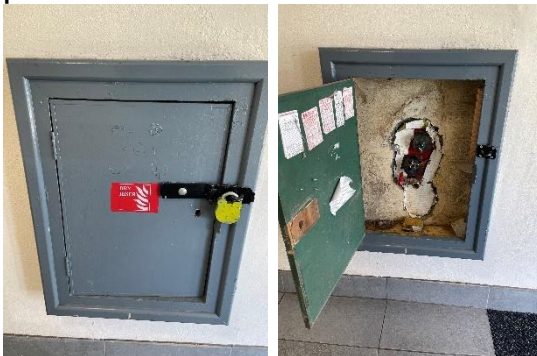
- 1) The riser inlet is located within the ground floor lobby, inside a dry riser cabinet and is secured with a firefighter's suited bridge door padlock.

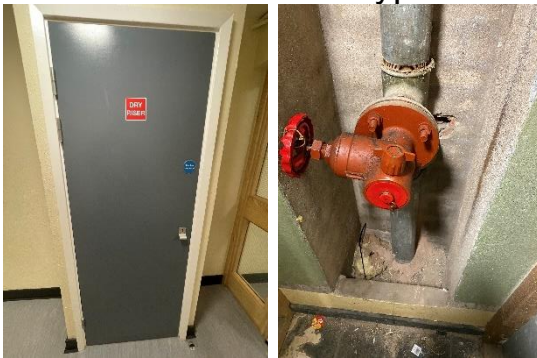
- 2) The Dry riser outlets are available in cupboards on each floor above ground adjacent the stairwell door. The cupboards are secured with a suited type 54 key mortice lock.

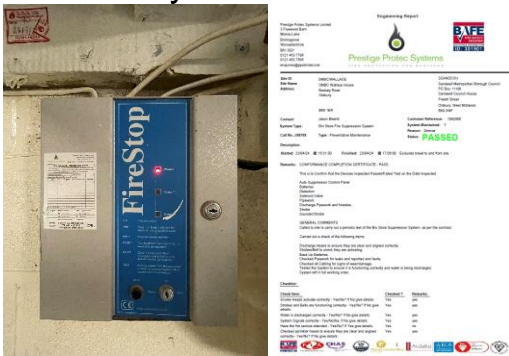
6) The bin store is protected by fire suppression system and serviced 6 - monthly.

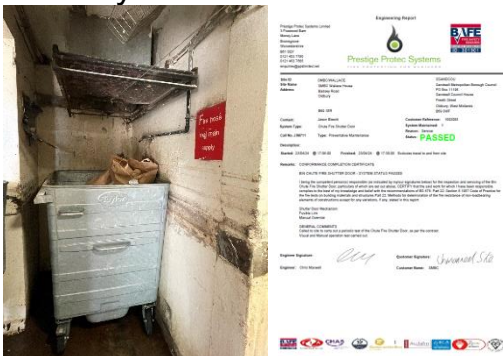
7) There's an automatic closure plate installed to the refuse chute. The system can also be manually operated and is serviced 6-monthly.

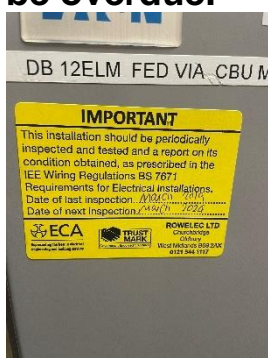
- 2) Hot working is not normally carried out. If essential maintenance requires the use of hot work processes, then corporate policies and procedures are to be followed.
- 3) Portable electrical equipment used as part of the Caretaking / Cleaning regime is subject to annual PAT Testing. This information is held by the Estate Services Manager Bryan Low.
- 4) The fixed electrical installation shall be tested every 5 years. **The last inspection was noted as March 2019 therefore may now be overdue.**

14/4	Confirm EICR to landlord's supply has been completed within the last 5 years or has been scheduled.

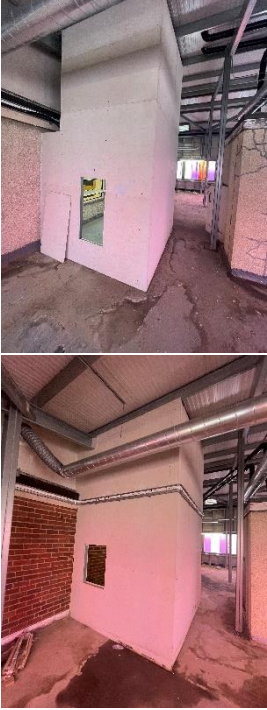
- 11) **Access panels were noted as missing from both ventilation shafts on the 12th floor. Once the repairs to the AOV (below) are completed access panels should be re-instated.**

7/11	Re-instate access panels to each ventilation shaft on the 12 th floor. <i>(Repairs / Inspection to the AOVs may need to be completed first)</i>

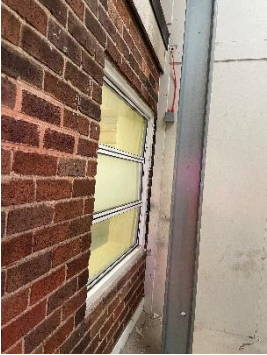
- 12) **The automatic opening vent adjacent flat 69 / 12th floor didn't open when tested during this FRA. Further inspection revealed that the AOV wasn't connected to power and the actuator appeared to be missing. WMFS will need to be informed via their portal if longer than 24hrs to repair. *WMFS have been informed, order raised to correct the defective, 6-8 weeks lead time.***

P2	Within 1-3 months Fire Rapid Response	
7/12	AOV by flat 69 / 12 th floor is not functioning and requires actuator & connecting to system.

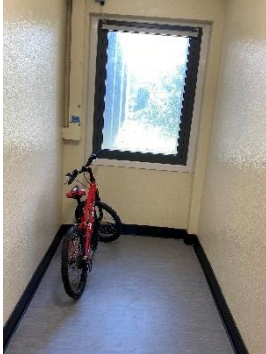
7/16	Remove bicycle from communal corridor by flats 15,16,17.

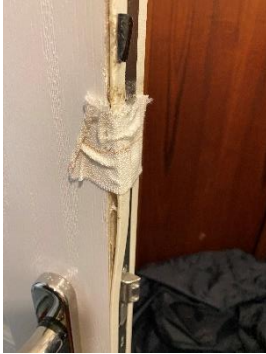
- b) Flat 49 – Trim is coming away from slamming edge. Tenant has made a temporary repair; door was observed closing correctly.

P2	Within 1-3 months Housing Manager	
7/21b	Flat 49 – Refix trim on slamming edge of entrance door.

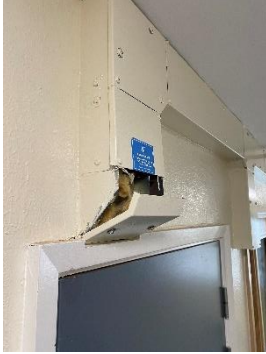
P2	Within 1-3 months Fire Rapid Response	
10/6	Refit cover to trunking by flat 36.
