Fire Risk Assessment

Wyrley House

**Sedgley Rd East,
Tipton, DY4 7TT**

Date Completed: 18/06/24

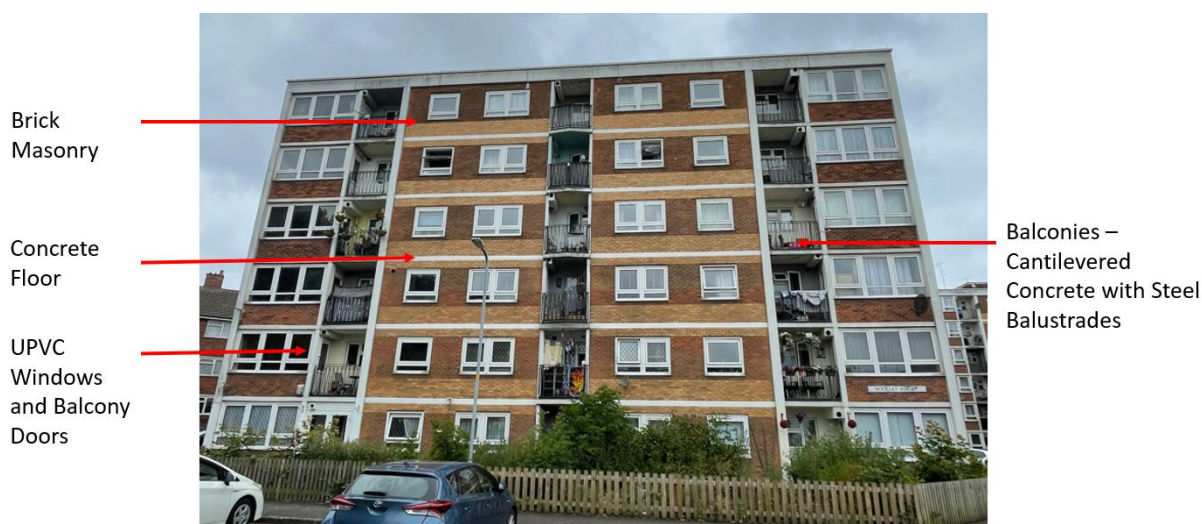
The addition of screening to two balconies could potentially support the surface spread of flame in those areas which is an unnecessary risk. Once this is removed the level of risk presented by materials present to the external envelope of this building would become trivial.

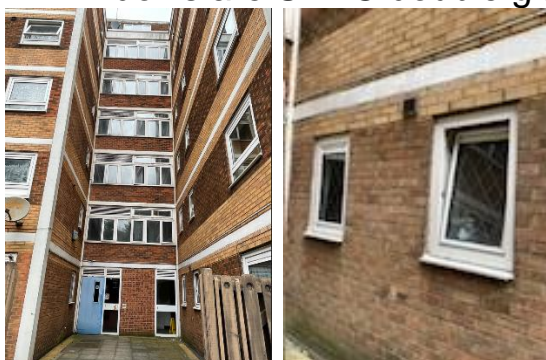
3. Only those flats to the left of the main entrance (3 per floor & same side of service cupboards) have access to balconies. Balconies are cantilevered concrete with steel balustrades.

- A. **Flat 224 (4th floor) has timber / willow screening installed to balcony. This has the potential to support the external spread of fire.**

06/3b	Flat 206 – Remove large sheet from balcony. Sheet is potentially used as screening as can be seen on historic images of the block.	 	P2	Within 1 to 3 months. Housing Manager	
07/20b	Flat 220 – re-instate self-closing device to flat entrance door. Assess lock / repair or replace, if necessary, as tenant states door locks him out when self-closes	 	P2	Within 1 to 3 months. Rapid Fire Response

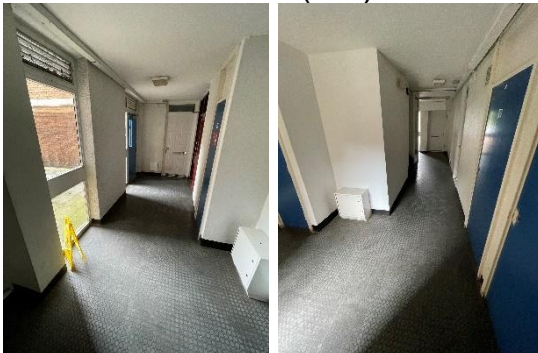
- 2) All corridors are of adequate width (at least 1050mm) and will be maintained clear to that width as a minimum.
- 3) Within the means of escape there is a single corridor that forms a dead end and is located on the ground floor. However, the corridor is protected with fire resisting construction, has natural ventilation via a louvre vent, is a place of relative safety and leads to a final exit door. The maximum travel distance along the corridor is 13 metres (from flat 182 to the final exit) as per the guidance at the time 1962 - 71. All doors within the corridor are notional FD30s with the flat entrance doors being FD30s rated composite door sets. Flats 182, 184, 186 all have balconies that could be used as an alternative means of escape, flat 188 is immediately adjacent the final exit door (1m).

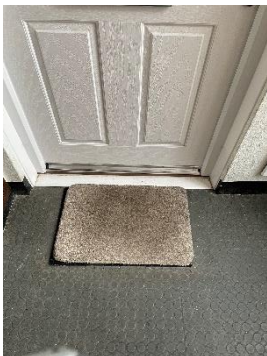
- 17) The fire rating of individual door mats outside flat entrance doors is unknown.

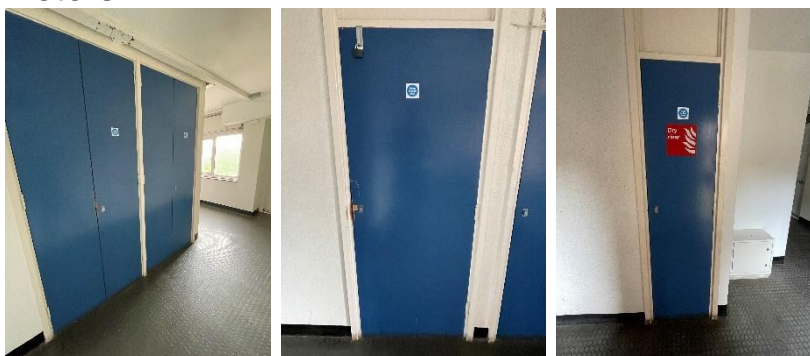
- 5) A variety of methods / materials have been used to achieve fire-stopping including Rockwool and intumescent pillows.

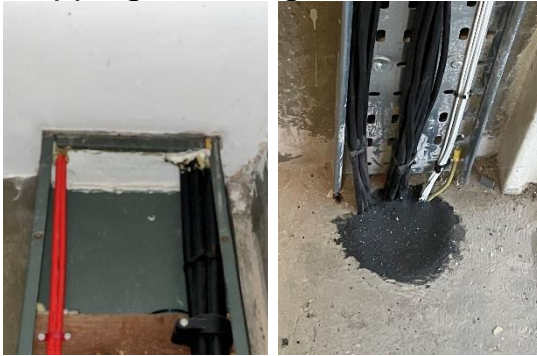
- 6) There is a minimal amount of foam present where power cables penetrate through the slab from the service cupboard to the service cupboard above (ground to 1st floor). This has not been removed due to the close proximity of live terminals within the mains distribution board. Where the cables enter the 1st floor service cupboard above the penetration has been suitably fire stopped.

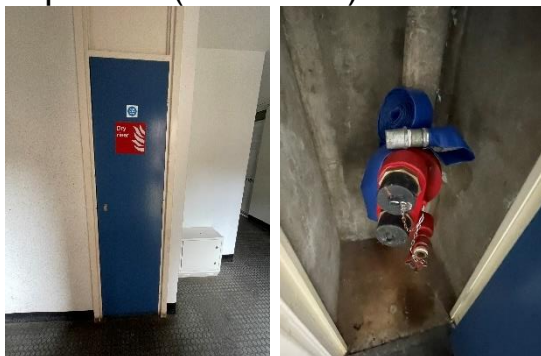
- 1) The dry riser inlet cabinet is located in the ground floor dry riser cupboard (twin valve) secured with a suited cylinder lock.

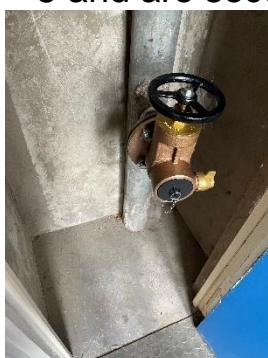
- 2) The outlets are contained within the dry riser cupboards on floors 1 – 5 and are secured with suited cylinder lock.

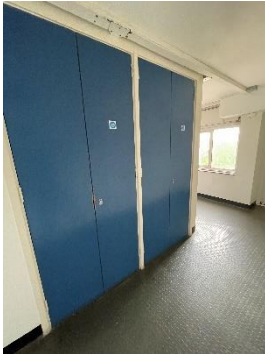
- 5) The electrical installation i.e. risers are contained within dedicated service cupboards that are secure and protected by means of a FD30S door.
