Fire Risk Assessment

Wesley Court

**Southbank Rd, Oldbury,
Cradley Heath, B64 6LQ**

Date Completed: 21/10/22

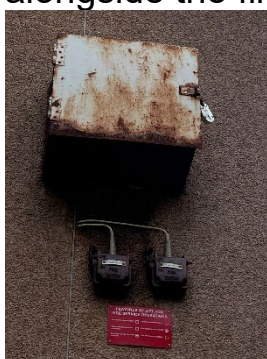
The Firefighters white box is to the right-hand side of the front entrance, alongside the firefighters lift override switch.

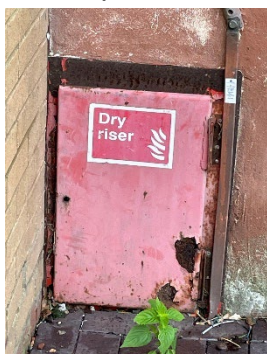
The dry riser inlet is located on the side elevation adjacent the bin store. Stood in front of the main entrance this is to the right-hand side of the block / Woodcroft Close.

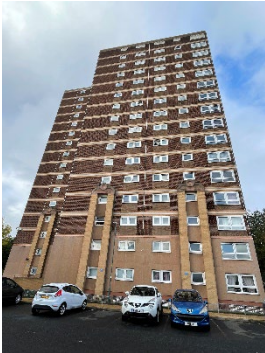
1. Ground to 1st floor - Resin-Stenni panels, fire classification B-s1-d0

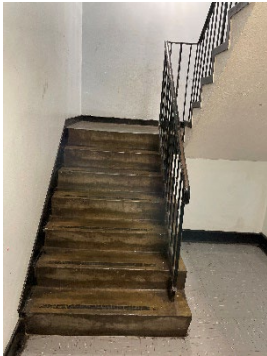
- 1) The site has a single staircase that provides a means of escape and is 970mm in width.

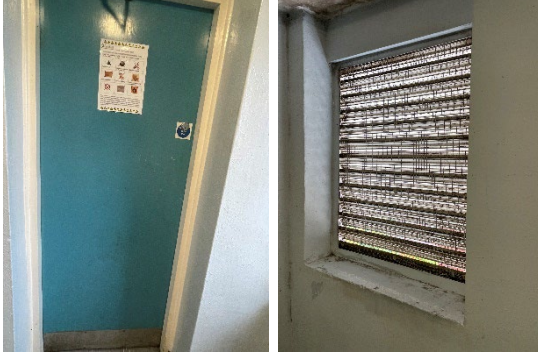
- 9) The chute rooms on each floor have a natural louvre vent / screen and FD30s door. Fire Door Keep Shut signs to the chute room doors on the 4th & 11th floor were installed at the time of the visit by the caretaker to replace defective / missing signs.

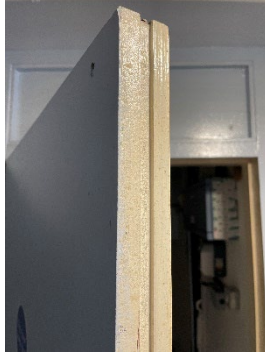
A. 13th floor cupboard door requires combined intumescent / cold smoke seal.

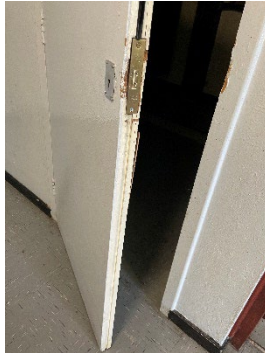
B. 1st floor cupboard requires combined intumescent / cold smoke seal on leading edge.

07/16b	1 st floor service cupboard door requires intumescent / cold smoke seal.

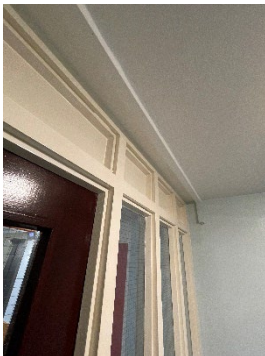
- 24) Small amount of plastic trunking has been used for cabling above communal door on ground floor by the chute room door.**

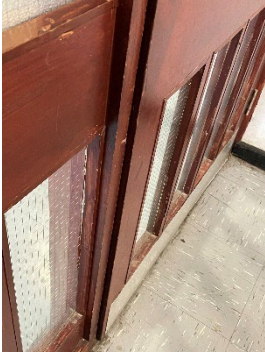
25) Communal door on 13th floor by flat 82, not reliably self-closing into frame.

<p>07/25</p>	<p>13th floor communal door by flat 82 not reliably self-closing into frame, requires adjustment.</p>

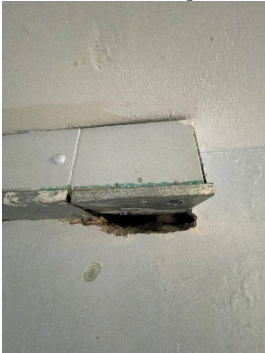
26) 11th floor by flat 72 firestopping is required to a small hole on service cupboard wall, light can be seen passing through.

<p>P3</p>	<p>Within 3 months of action plan date. Rapid Response Fire. JM:9861058 JM:10992120</p>	<p>29/06/2023</p>
<p>07/26</p>	<p>11th floor by flat 72 firestopping required to hole beneath trunking on service cupboard wall.</p>

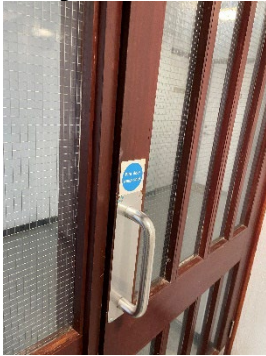
31) 1st floor communal door by flat 7 not reliably self-closing fully into frame.

P2	Within 3 months of action plan date. Rapid Response Fire. JM:9861591	08/11/2022
07/31	1 st floor communal door by flat 7 not reliable self-closing into frame, requires adjustment.

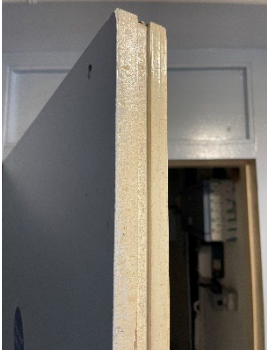
Question/ Ref No	Required Action	Supporting photograph	Priority	Timescale and Person Responsible	Date Completed
07/16a	13th floor – Service cupboard door requires intumescent / cold smoke seal

P2	Within 3 months of action plan date. Rapid Response Fire. JM:9860764	08/11/2022

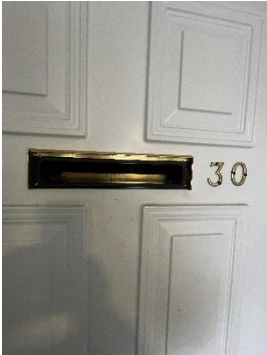
30) 4th floor Flat 30 – Outer letter box plate is missing.

07/30	Flat 30 reinstate outer letterbox plate.
