# Fire Risk Assessment

## St Giles Court

**Reservoir Road,  
Rowley Regis  
B65 9PE**

**Date Completed: 09/02/2023**

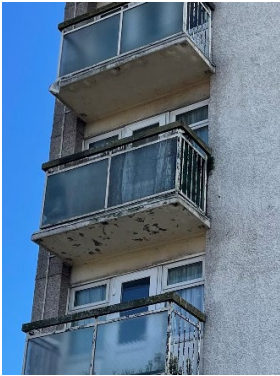
6. Flat 16, second floor, plastic screening to balcony.

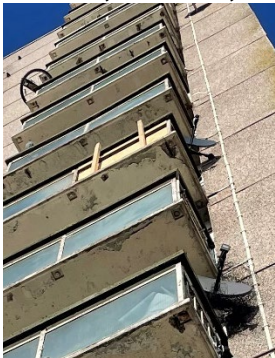
7. Flat 21, Third Floor, bamboo screening to balcony.
-

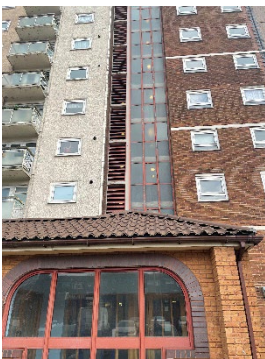
In addition, it appears a temporary repair has been undertaken to the balcony of flat 36 with the installation of timber guarding to cover a defective glazed panel. The temporary repair in these circumstances is considered acceptable prior to a permanent repair.

8. Flat 36, Floor 5, timber guarding to balcony.

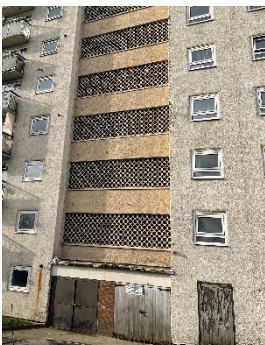
9. Ventilation panels to the front elevation consist of powder coated aluminium louvre vents.

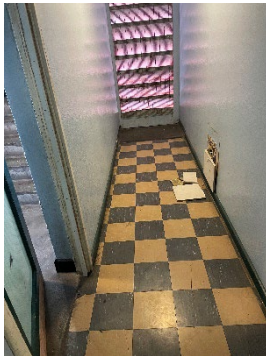
21) Access panels to stop taps are fixed to masonry and bedded on intumescent material.

**Panel located within corridor of floor 13 requires replacing.**

<p>07/21</p>	<p>13<sup>th</sup> floor – Panel to stop tap has broken and requires replacing.</p>

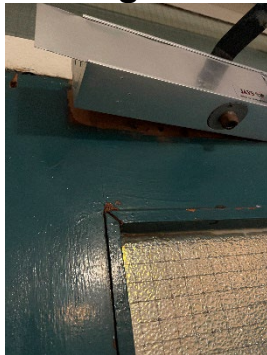
**24) 13<sup>th</sup> floor. Fire Door, separating lobby from corridor, by electrical cupboard, does not shut as self-closer requires refixing.**

<p>P2</p>	<p>Within 1 – 3 months of action plan. Electrical Repairs</p>	
<p>07/24</p>	<p>13<sup>th</sup> floor – Fire door across corridor, by electrical cupboard,. Re fix self-closer.</p>

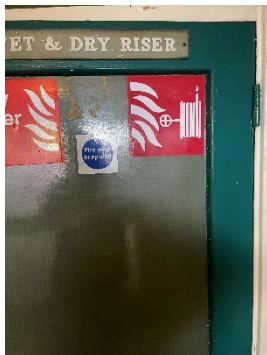
**25) 13<sup>th</sup> floor. Dry riser cupboard door difficult to open as catching on floor.**

**26) Firefighting signage, on all dry riser doors, indicating the presence of a hose reel should be removed as the hose reel is now obsolete.**

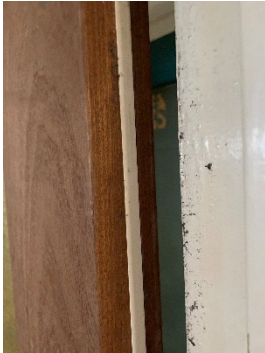
**32) 12<sup>th</sup> Floor. Fire door separating corridor and lift lobby has no cold smoke strips top and side.**

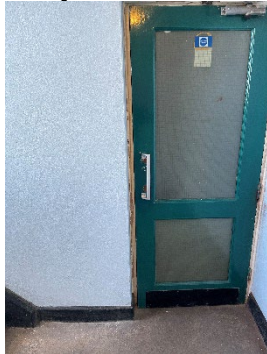
34) 12<sup>th</sup> Floor. Small section of trunking missing from lift lobby.

P2	<p>Within 1 – 3 months of action plan. Housing Manager JM:10627289</p>	20/04/2023
07/34	12 <sup>th</sup> floor – Lift lobby. Small section of metal trunking missing. Replace missing section.

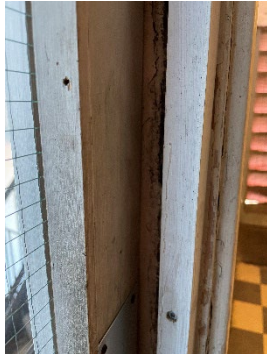
38) Floor 10. Staircase door not adequately shutting fully into frame.

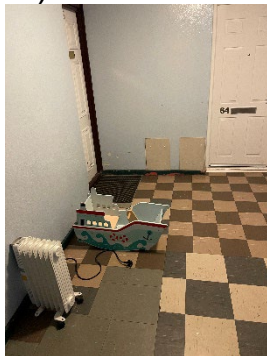
39) Floor 10. Lift lobby. Rubbish on floor. *1<sup>st</sup> March 2023 resolved.*

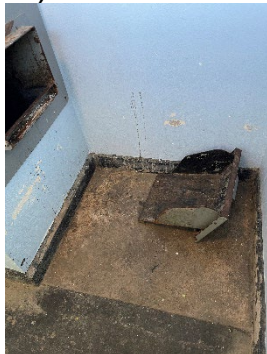
40) Floor 10. Chute Room. Hopper on floor. *1<sup>st</sup> March 2023 resolved.*

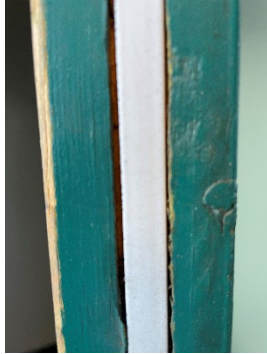
- 41) Floor 9. Cold smoke seal required to leading edge of staircase door.

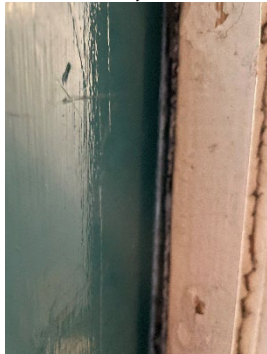
- 42) Floor 9. Door Frame to staircase. Door stop, to leading edge of door, to be re-nailed to enclose gaps.

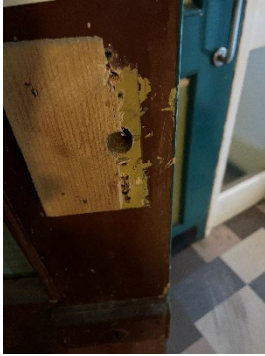
**48) Floor 8. Dry Riser Cupboard. No Lock.**

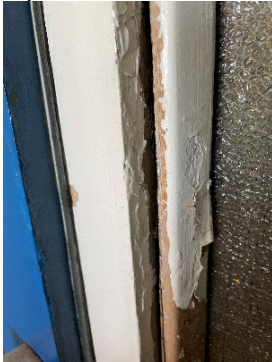
**49) Floor 8. Chute Room. Fire door not adequately shutting.**

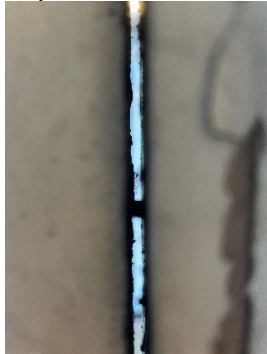
54) Floor 7. Corridor door into lift lobby not fully closing into frame.

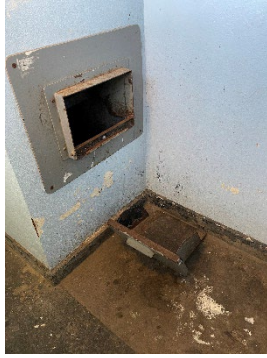
74) Floor 2. Chute room. Bag of rubbish on floor. *1<sup>st</sup> March 2023 resolved.*

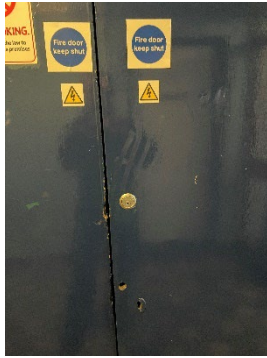
**80) Ground Floor. Chute room. Door not positively closing fully into frame.**

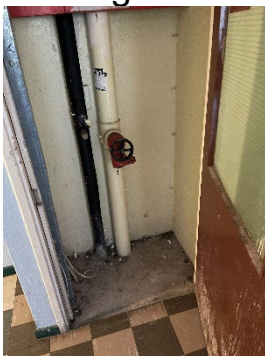
- 2) The dry riser outlets are located in cupboards adjacent the chute rooms at the lift end of the communal corridor on each floor. Each cupboard is secured with a budget lock. It was evident that telecommunication cabling within the riser cupboards does hang loose and is generally untidy. The cabling does not restrict the use of the riser outlets and will be made good as part of the significant building refurbishment works that are planned.

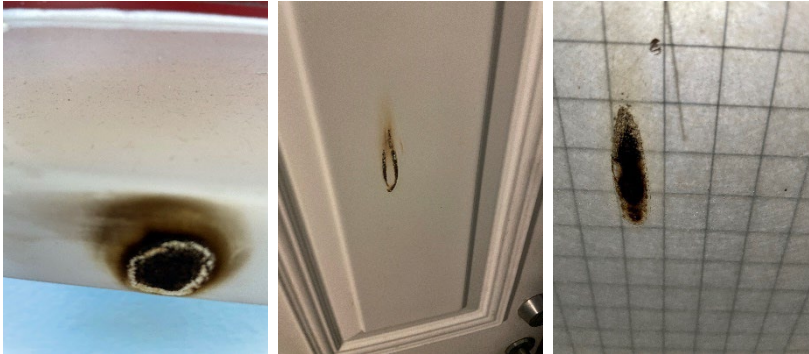
- 4) Evidence of arson was noted to the: ground floor internal window to corridor, flat entrance door 12 and side panel entrance to chute room on floor 2.

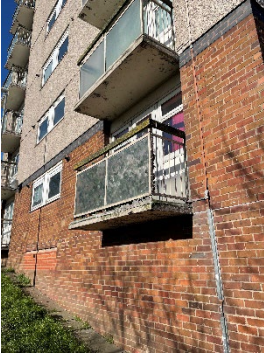
Question/ Ref No	Required Action	Supporting photograph	Priority	Timescale and Person Responsible	Date Completed
06/05	Flat 6 – remove decorative screening installed to balcony.

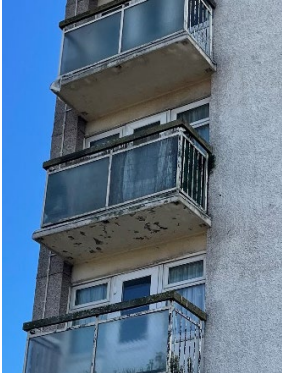
06/06	Flat 16 – remove plastic screening to balcony.	 	P2	Within 1 – 3 months of action plan. Housing Manager.	
06/07	Flat 21 – remove screening to balcony.

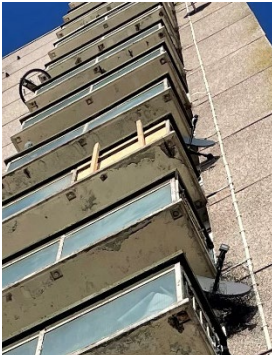
P2	Within 1 – 3 months of action plan. Housing Manager.	
06/08	Flat 36 – remove timber guarding to balcony and re instate with appropriate material.

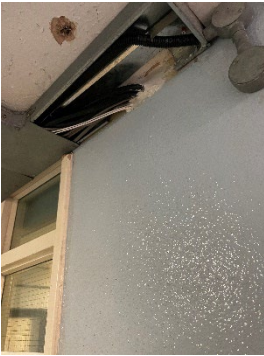
23) **13<sup>th</sup> floor. Section of trunking missing by stairs.**

<p>P2</p>	<p>Within 1 – 3 months of action plan. Rapid Fire Team JM:11355380</p>	<p>26/07/2023</p>
<p>07/23</p>	<p>13<sup>TH</sup> floor – Section of metal trunking missing by stairs. Metal trunking to be re-instated.</p>

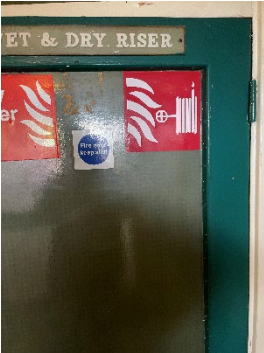
07/25	13 <sup>TH</sup> floor – Dry riser door difficult to open as binding on floor. Bottom of door to be trimmed.	No photo	P2	Within 1 – 3 months of action plan. Rapid Fire Response. JM:10856139	22/05/2023
07/26	Remove hose reel signage from all dry riser doors.

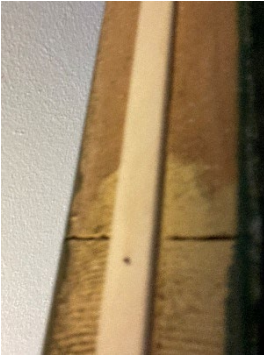
P2	Within 1 – 3 months of action plan. Caretakers	11/04/2023
07/27	13 <sup>th</sup> floor – Fire door to chute room entrance. Install cold smoke seal to door.

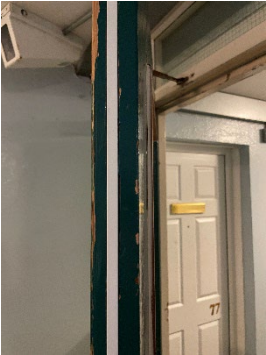
07/28	12 <sup>th</sup> floor – Fire door separating lobby from corridor, by staircase, requires cold smoke seal on leading edge.

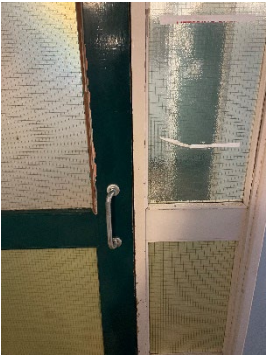
**29) 12<sup>th</sup> Floor. Glazing to side of fire door separating lobby from corridor, by staircase is slightly cracked.**

P2	<p>Within 1 – 3 months of action plan. Rapid Fire Response. JM:10856287</p>	22/05/2023
07/29	12 <sup>th</sup> Floor- Glazing to side of fire door, separating lobby from corridor, by staircase, is cracked. Glazing to be replaced.

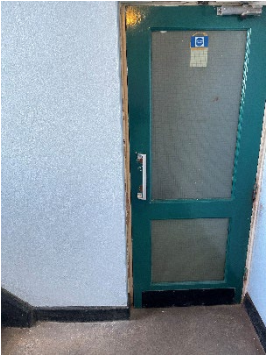
07/35	11 <sup>th</sup> floor. Staircase door not positively closing. Self-closer to be adjusted.

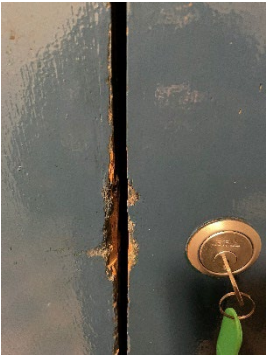
P2	Within 1 – 3 months of action plan. Rapid Fire. JM:10856779	23/05/2023
07/36	11 <sup>th</sup> Floor . Electrical cupboard doors has excessive gaps. Provide timber strip to front of doors alternatively cold smoke seals.

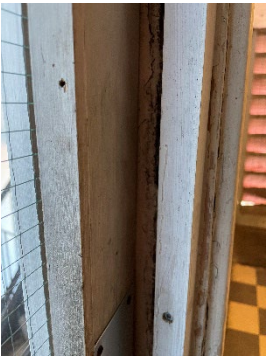
P2	Within 1 – 3 months of action plan. Rapid Fire. JM:10856827	22/05/2023
07/38	10 <sup>th</sup> Floor. Staircase door not positively closing. Self closer to be adjusted.

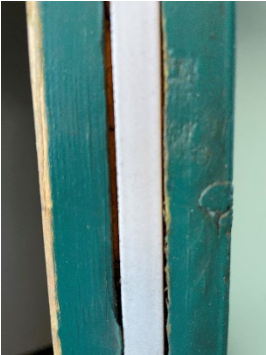
07/41	9 <sup>th</sup> Floor. Staircase door. Install cold smoke seal to leading edge.

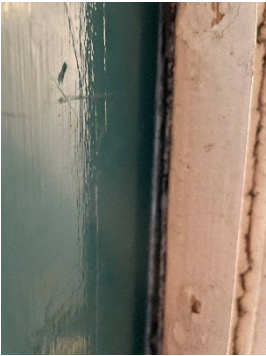
P2	Within 1 – 3 months of action plan. Rapid Fire JM:10856879	22/05/2023
07/42	9 <sup>th</sup> Floor. Door frame to staircase. Door stop to leading edge of door to be re-fixed. To ensure no gaps.

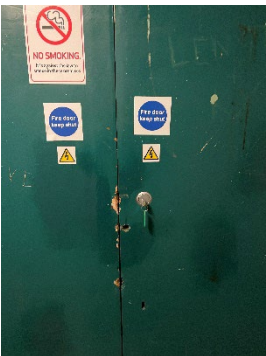
44) Floor 9. Electrical cupboard. Unable to access as lock is defective.

P2	Within 1 – 3 months of action plan. Rapid Fire. JM:10856907	22/05/2023
07/44	9 <sup>th</sup> Floor. Electric cupboard. Unable to operate lock. Requires attention.

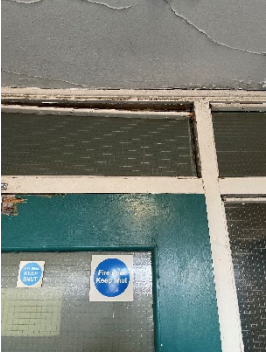
46) Floor 9. Chute Room. Beading loose to fan light above fire door.

07/45	9 <sup>th</sup> Floor. Chute room. Glazed entrance panel is loose. Re fix at floor level.	No photo	P2	Within 1 – 3 months of action plan. Rapid Fire. JM:10856952	22/05/2023
07/46	9 <sup>th</sup> Floor. Chute room. Beading loose to fanlight above fire door. Re fix beading.

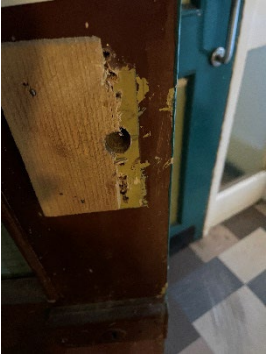
P2	Within 1 – 3 months of action plan. Rapid Fire. JM:10856968	22/05/2023
07/48	8 <sup>th</sup> Floor. Dry riser cupboard. Install budget lock to door.

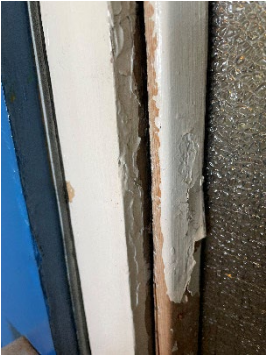
07/49	8 <sup>th</sup> Floor. Chute room. Fire door not positively closing. Re adjustment of self closer required.

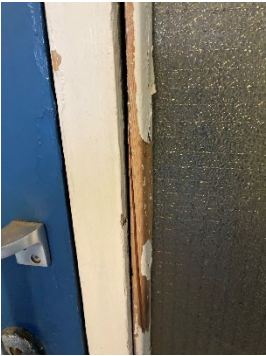
P2	Within 1 – 3 months of action plan. Rapid Fire JM:10857479	22/05/2023
07/50	8 <sup>th</sup> Floor. Chute room. Beading to fire door side panel is loose. Beading requires refixing.

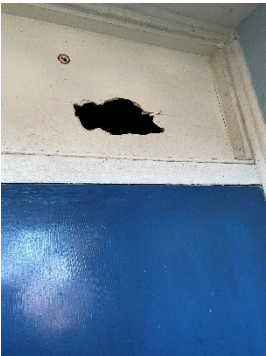
P2	Within 1 – 3 months of action plan. Rapid Fire JM:10857591	22/05/2023
07/51	8 <sup>th</sup> Floor. Chute room. Hole in fan light above store door. Fan light to be over-boarded with superlux.

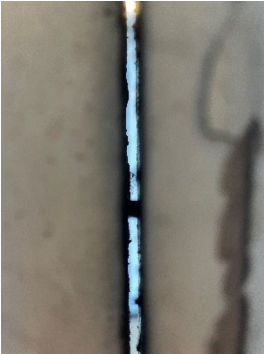
07/53	7 <sup>th</sup> Floor. Staircase door frame. Gap between stop and frame. Stop to be re fixed.

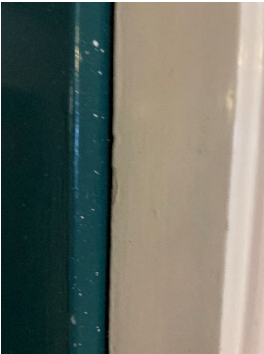
P2	Within 1 – 3 months of action plan. Rapid Fire. JM:10858839	22/05/2023
07/54	7 <sup>th</sup> Floor. Corridor door into lift lobby. Re adjustment of self closer required.

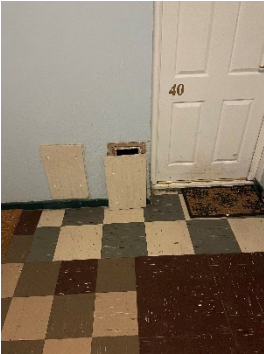
P2	Within 1 – 3 months of action plan. Rapid Fire JM:10858944	22/05/2023
07/58	6 <sup>th</sup> Floor. Cover to stop tap, flat 40, has become detached. Re fix cover.

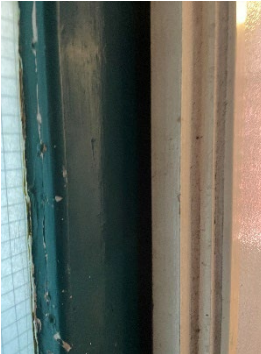
07/59	5 <sup>th</sup> Floor. Staircase door is not fully closing. Self closer to be adjusted.

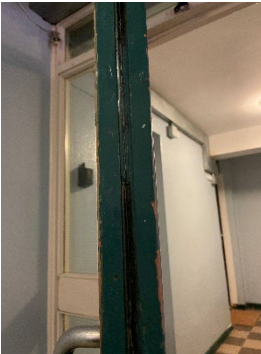
**60) Floor 5. Corridor door into lobby, by staircase, has a damaged cold smoke seal.**

P2	<p>Within 1 – 3 months of action plan. Rapid Fire.</p> <p>JM:10859019</p>	22/05/2023
07/60	5 <sup>th</sup> Floor. Corridor door into lobby by staircase. Replace cold smoke seal.

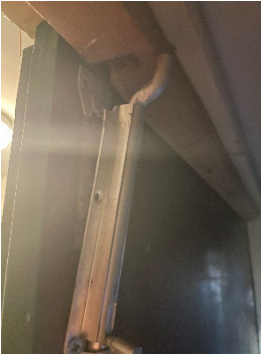
**61) Floor 5. Broken bolt lock to top of door to electrical cupboard.**

P2	<p>Within 1 – 3 months of action plan. Rapid Fire.</p> <p>JM:10859060</p>	22/05/2023
07/61	5 <sup>th</sup> Floor. Electrical cupboard.. Replace broken bolt

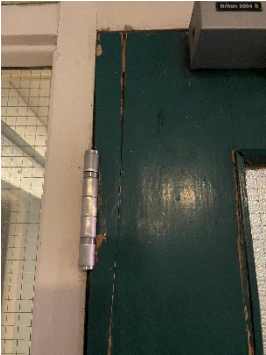
**62) Floor 5. Corridor Fire door by dry riser requires repair as crack evident.**

07/62	5 <sup>th</sup> Floor. Corridor fire door , by dry riser, requires suitable repair to maintain fire resistance.

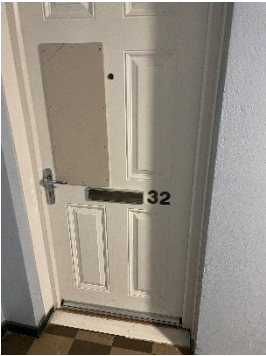
**63) Floor 5. Door 32 has had a suitable temporary repair . Flat not accessible at time of FRA to conduct further assessment (Jm 8225114)**

P2	Within 1 – 3 months of action plan. Rapid Fire. JM:10859219	22/05/2023
07/63	5 <sup>th</sup> Floor. Door 32 is damaged. Investigation is required to ascertain extent of damage and associated required action.

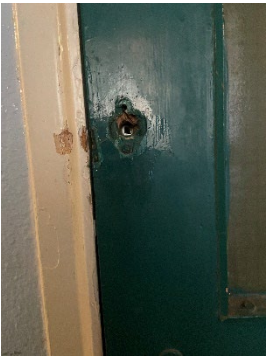
P2	Within 1 – 3 months of action plan. Repairs JM:10859300 Passed to MP replacement door and frame	
07/64	4 <sup>TH</sup> Floor. Dry riser door. Lock requires attention as difficult to open.

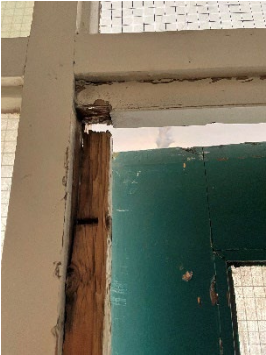
**66) Floor 4. Chute room. Stop to fire door frame requires repair/replacement.**

07/66	4 <sup>th</sup> Floor. Chute room. Entrance door frame. Top of doorstop missing. Replace door stop.

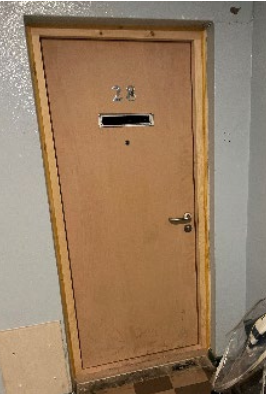
P2	Within 1 – 3 months of action plan. Rapid Fire JM:10859402	22/05/2023
07/67	4 <sup>th</sup> Floor. Flat 28. Adjust self-closer to enable door to fully close into frame and replace missing outer letter box plate.

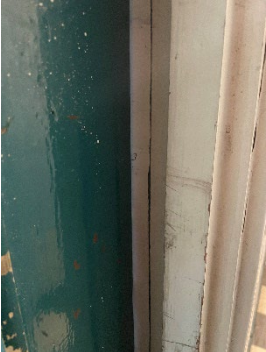
P2	Within 1 – 3 months of action plan. Rapid Fire. JM:10859433	22/05/2023
07/68	3 <sup>rd</sup> Floor. Staircase door not positively closing. Adjustment of self-closer required.

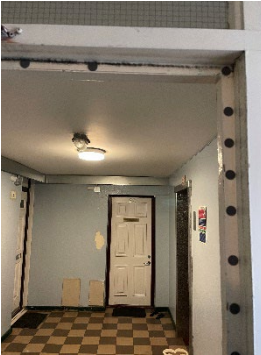
07/69	3 <sup>rd</sup> Floor. Corridor fire door into lift lobby. Remove all sticky pads from frame.

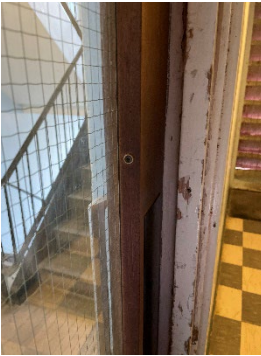
P2	Within 1 – 3 months of action plan. Caretakers	11/04/2023
07/70	2 <sup>nd</sup> Floor. Staircase door is not positively closing. Adjustment of self-closer is required.

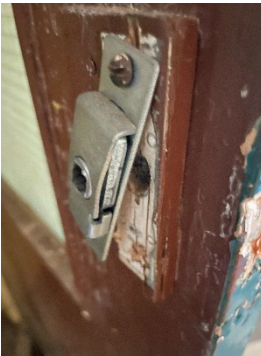
P2	Within 1 – 3 months of action plan. Rapid Fire. JM:10859543	22/05/2023
07/71	2 <sup>nd</sup> Floor. Dry riser door. Lock requires refixing.

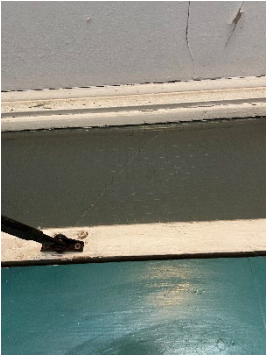
**72) Floor 2. Chute room. Fan light cracked above fire door.**

07/72	2 <sup>nd</sup> Floor. Chute room. Fan light cracked above entrance fire door. Glazing to be replaced.

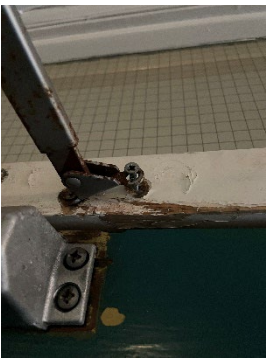
P2	Within 1 – 3 months of action plan. Glazing Repairs.  JM:10875797	02/06/2023
07/75	2 <sup>nd</sup> Floor. Fire door separating lift lobby and corridor has a loose self-closing device. Re fix self-closing device.

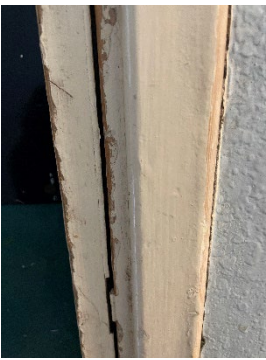
P2	Within 1 – 3 months of action plan. Rapid Fire. JM:10859639	22/05/2023
07/76	1 <sup>st</sup> Floor. Staircase door frame. Stop to be re-fixed to frame, to enclose gap, on leading edge of door.

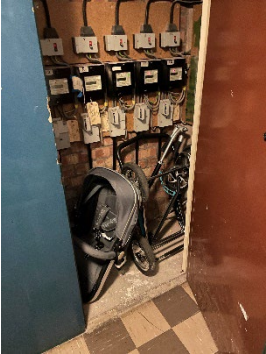
<p>07/77</p>	<p>1<sup>st</sup> Floor by flats 11, 12 and 13. Electrical cupboard. Remove Push chair and child's car seat.</p>

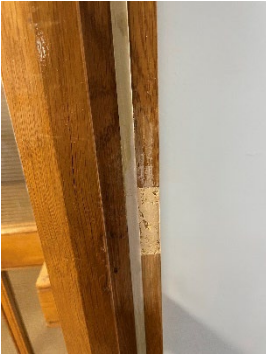
<p>P2</p>	<p>Within 1 – 3 months of action plan. Housing Manager.</p>	<p>18/04/2023</p>
<p>07/78</p>	<p>Ground Floor. Fire door frame, between entrance and small corridor leading to laundry room, Install cold smoke seal.</p>
