Fire Risk Assessment

Addenbrooke Court

**Southbank Rd, Oldbury,
Cradley Heath, B64 6LJ**

Date Completed: 09/07/24

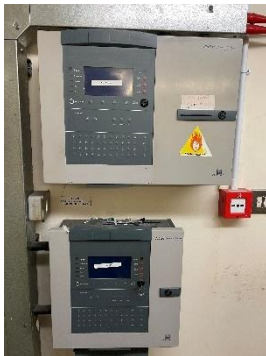
The fire alarm panels (and system) in the COMMs room has been decommissioned. [Refer to section 8.](#)

- 6) It was noted that these 2 decommissioned fire alarm panels have been labelled as not in use however, it is recommended that they are removed as part of any future renovation program.
- 7) Automatic smoke ventilation is employed and referred to in section [7.9](#).
- 8) A fire suppression system is provided to the refuse chute bin store. An approved contractor maintains the system. The frequency for the maintenance checks are twice per year (April and October) of each calendar year.

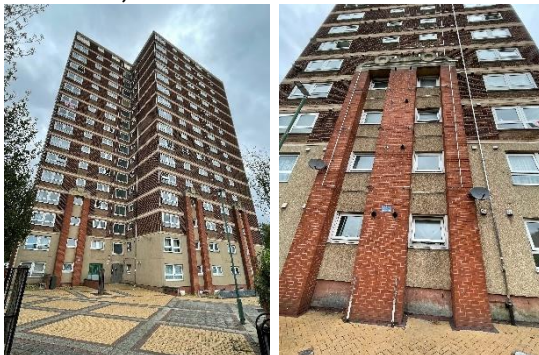
1. Ground to 1st floor - Resin-Stenni panels, fire classification B-s1-d0. Also, small areas to 2nd and 3rd floor.

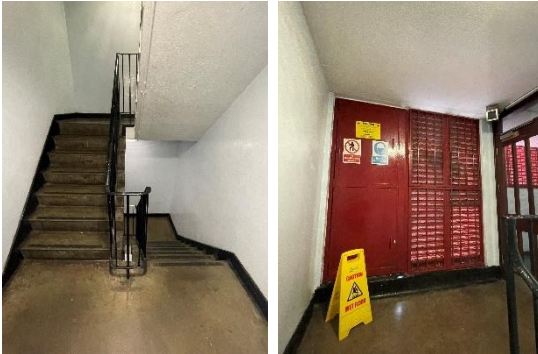
- 1) The site has a single staircase that provides a means of escape and is 970mm in width. There is a ventilated panel to the 15th floor.

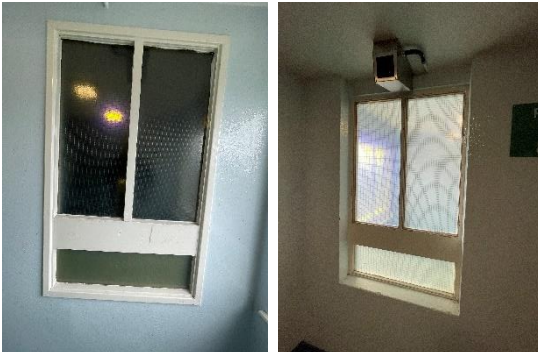
- 2) Each landing has a Georgian wired glazed hardwood unit to the corridor.

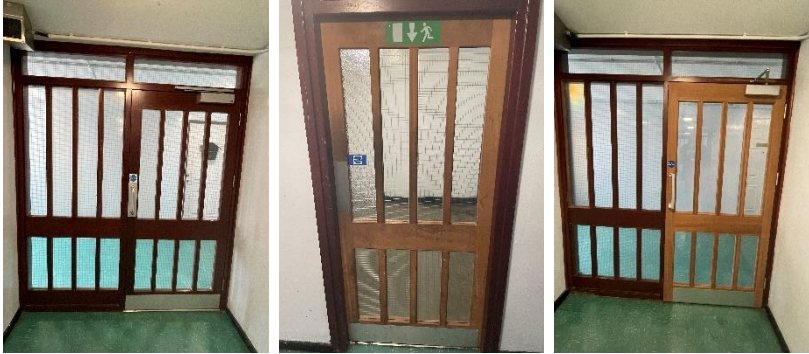
- 5) The means of escape are protected to prevent the spread of fire and smoke.
- 6) The communal landing / staircases are protected by use of notional FD30s fire doors with vision panels. It was noted that some communal doors have been replaced with nominal FD30s fire doors.

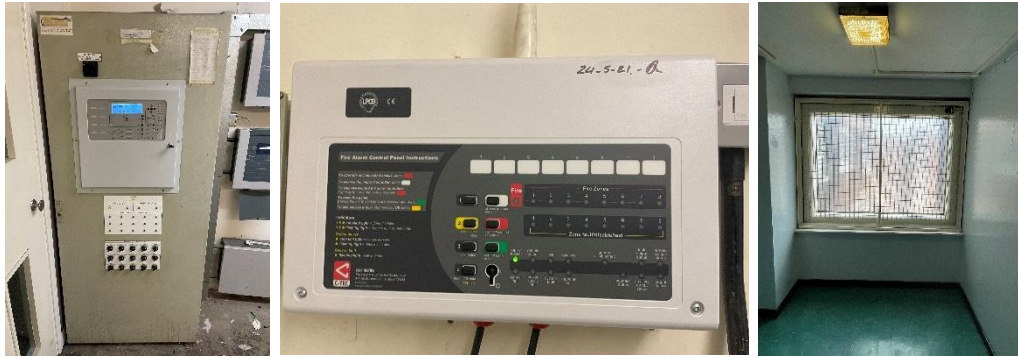
- 9) Automatic smoke ventilation is employed. This is tested, inspected and maintained by a competent procured contractor in accordance with BS7346. The frequency for the maintenance checks are twice per year (April and October) of each calendar year. The main control panel is located in the COMMs room (left of the main entrance lobby door) with repeater panels in the service cupboards on each floor. These service cupboards are secured with 138 suited mortice locks.
-

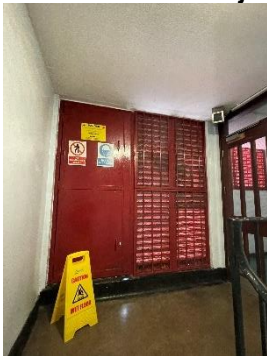
14) The protected stairwell is naturally vented by means of a full height louvre vent adjacent the roof access door.

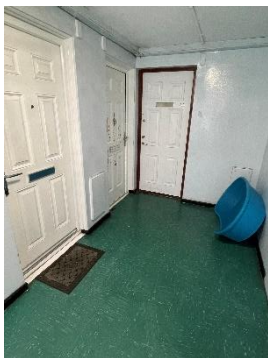
21) Plastic dog bed in communal corridor outside flats 34, 35, 36 is already being dealt with by the housing officer due to an aggressive tenant.

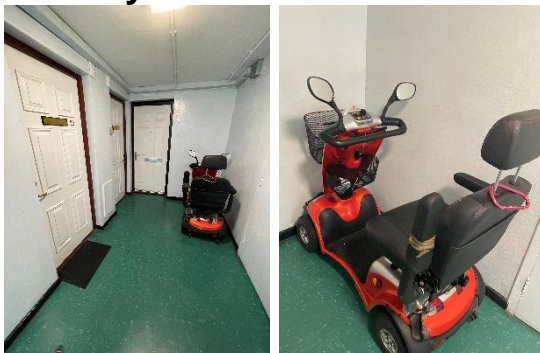
22) Mobility scooter in communal corridor outside flats 28, 29, 30.

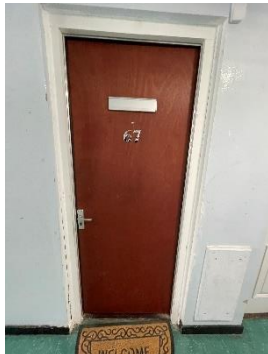
C. Flat 67 – Entrance door not reliably self-closing.

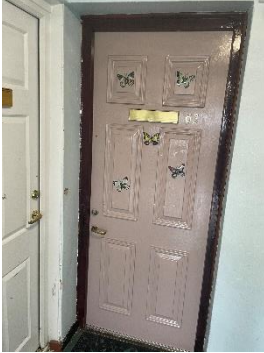
33) Flat 63 entrance door has been painted. This is deemed to be of low risk.

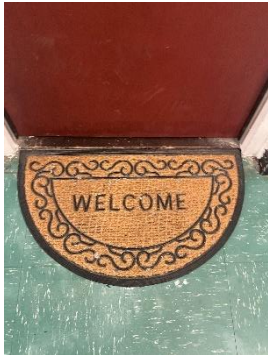
34) The fire rating of individual door mats to flat entrances is unknown but deemed to be of low risk.

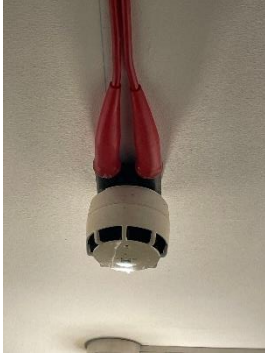
- 5) In addition to the LD1 / LD2 fitted system, some flats also had a smoke detector within the hall that was previously part of a former system linked to the now decommissioned fire alarm panels within the ground floor comm's room. Residents were aware that this detector was now redundant.

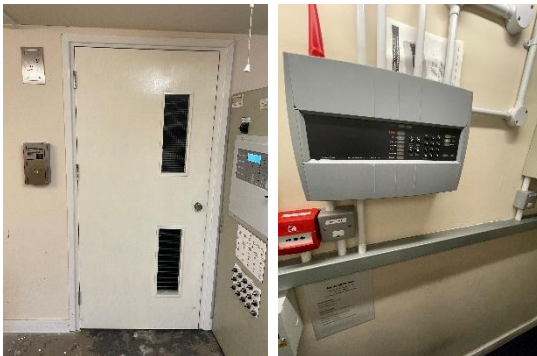
10) There is a fire alarm panel located within the CCTV server (comms) room adjacent to the main front entrance on the ground floor. This system only protects the server room. Access is obtained via the use of a suited type 54 key for the door off the communal corridor and then via entry-com link to the Concierge Team or firefighter override key. **Evidence of periodic testing couldn't be determined.**

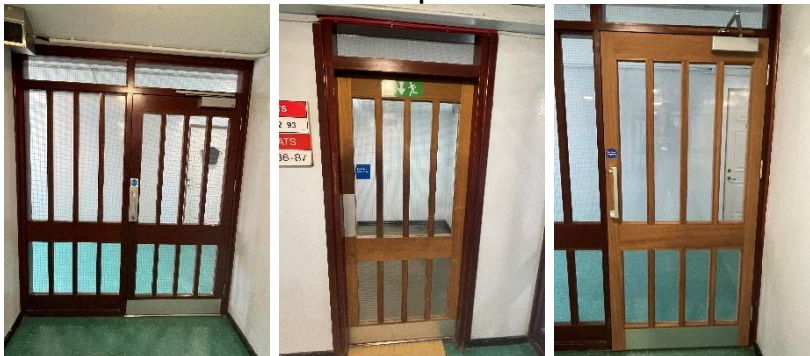
- 9) The communal landings / staircase and corridors are protected by use of notional self-closing 44mm 30-minute timber fire doors with vision panels. It is recognised that these doors do not meet today's benchmark of a certified FD30s fire door install however, because they were installed at the time of the building's construction and to the standard of that time they are deemed as acceptable so long as the doors are free of damage and function as they were intended to do so. It has been recognised that all of the landing / staircase and corridor notional doors in this block have been upgraded with combined intumescent strips & cold smoke seals to enhance their original design and minimise departures from today's standards. Were minor shortcomings have been identified actions have been created for corrective works. It was noted that some doors have been replaced with nominal FD30s timber doors.

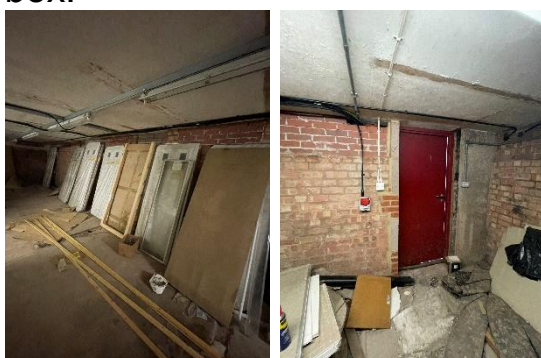
- 6) The basement appears to have become an area where by surplus SMBC materials and items are being stored. The basement is secured by a non-suited key that is stored in the firefighter’s white box.

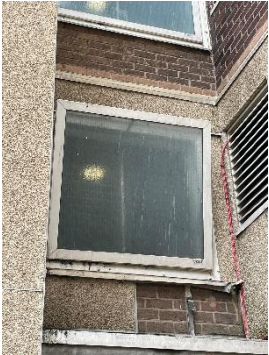
- 10) The AOV to the first floor lobby by flats 10, 11, 12 is defective and stuck in the open position due to the hinges failing. The assessor has been informed that replacement hinges are no longer available therefore, a solution to resolve the issue is likely to involve commissioning an engineering firm to re-manufacture the hinges.

7/10	Replace defective hinges to 1 st floor AOV that remains in the open position

P3	Within 3-6 months of action plan Asset Management.	
7/18	Mobility scooter in communal corridor outside flats 73,74,75 to be removed from communal corridor.

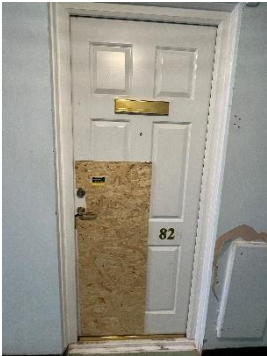
30) Emergency repair using sterling board to flat 82 entrance door. Confirmation required that a new FD30s door has been requested.

P2	Within 1-3 months of action plan. Housing Manager.	
7/30	Flat 82 install emergency FD30s fire door

P1	Within 7-10 days of action plan Repairs.

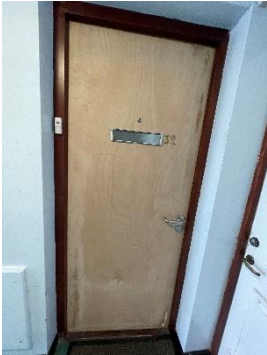
G. Flat 32 – Combined intumescent strip partially missing on lock side. Self-closing device arm catching on door leaf.

P2	Within 1-3 months of action plan. Fire Rapid Response JM14499015	
7/32g	Flat 32 – Replace missing section of combined intumescent / CSS strip. Self-closing arm catches on door leaf refit / adjust as necessary.		P2	Within 1-3 months of action plan. Fire Rapid Response JM:14499059	23/07/2024

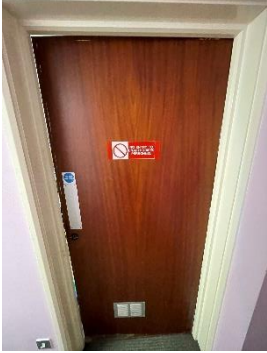
- 11) Cleaners' cupboard notional fire door within the community room area requires intumescent strip, cold smoke seal and replacement intumescent vent. Cupboard contains electrical switchgear.

<p>10/11</p>	<p>Cleaners' cupboard in community room area – install intumescent strip / cold smoke seal to door. Also, install intumescent grill to door.</p>

<p>P2</p>	<p>Within 1-3 months of action plan. Fire Rapid Response JM:14496012</p>	<p>23/07/2024</p>
<p>10/12</p>	<p>Fire stop above community room door from entrance lobby.</p>

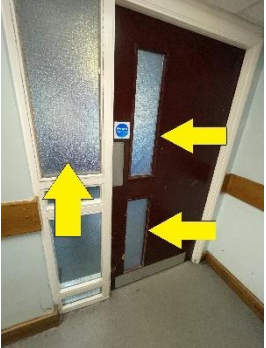
15) Communal door from lift lobby to stairwell, 3 x Fyberglaze GRP panels are loose and require refixing. Upper panel in combination frame is poorly fitted and loose. Upper panel in door - beading / panel not secure. Lower panel moves / not secure.

P2	Within 1-3 months of action plan. Fire Rapid Response JM:14496168	23/07/2024
10/15	3 x Fibreglaze GRP panels are loose and to be correctly re-fixed.

P2	Within 1-3 months of action plan. Fire Rapid Response JM:14498310	23/07/2024

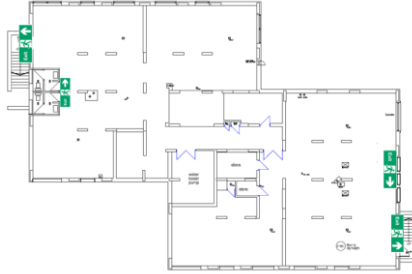
Furthermore, it would be beneficial if directional fire escape signage was installed to the basement area because of the lack of emergency lighting and direct sight of an exit is not possible from all areas.

<p>P2</p>	<p>Within 1-3 months of action plan. Fire Rapid Response JM:14498749</p>	<p>23/07/2024</p>
<p>12/7</p>	<p>Install directional exit signage to basement as per the plan.</p>

<p>P2</p>	<p>Within 1-3 months of action plan. Fire Rapid Response</p>	<p>Signs on order</p>
