# Fire Risk Assessment

## Addenbrooke Court

**Southbank Rd, Oldbury,  
Cradley Heath, B64 6LJ**

**Date Completed: 17/10/22**

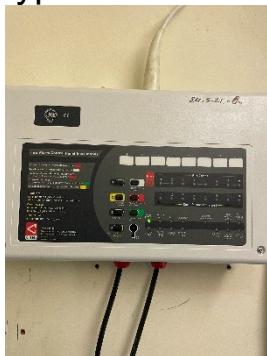
- 9) The smoke vent reset control panels are located within the electrical service cupboards on each floor, secured with a suited type 138 mortice lock.

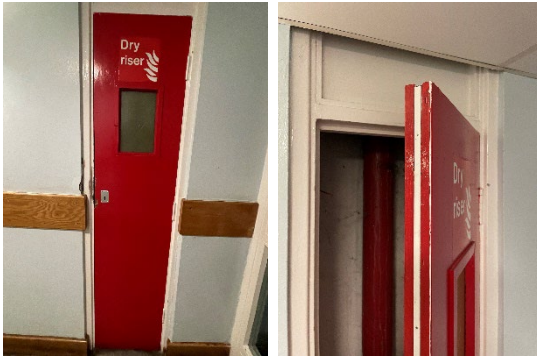
- 17) Service cupboards are FD30s rated and contain resident's electricity metres, automatic smoke ventilation reset panels and are secured with type 38 suited mortice locks. **1st floor service cupboard door is missing its cold smoke seal.**

Question/ Ref No	Required Action	Supporting photograph	Priority	Timescale and Person Responsible	Date Completed
07/17	1 <sup>st</sup> floor service cupboard reinstate missing cold smoke seal.

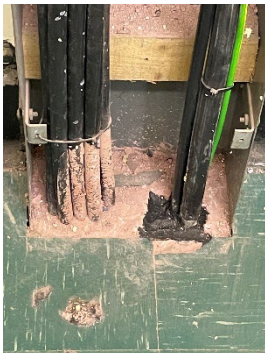
- 9) Cable penetrations between floors in service cupboards have been fire stopped with a filler of unknown specification. Remove filler and enhance fire stopping with appropriate material.

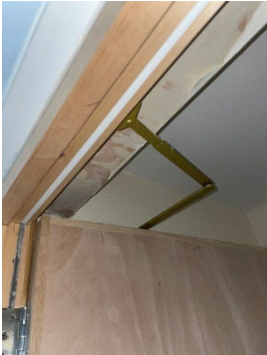
28) 4<sup>th</sup> Floor - Flat 26 entrance door requires cold smoke seal to top of frame.

<p>07/28</p>	<p>4<sup>th</sup> floor – Flat 26 install cold smoke seal to head of frame</p>

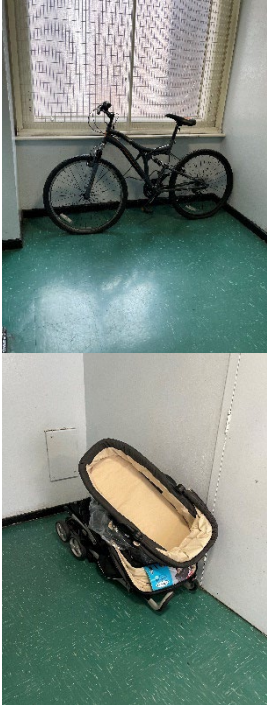
**34) 5<sup>th</sup> floor by flats 34, 35, 36 – Bike and pushchair in communal corridor.**

07/34	5 <sup>th</sup> floor – bicycle and pushchair to be removed from communal corridor by flats 34,35,36

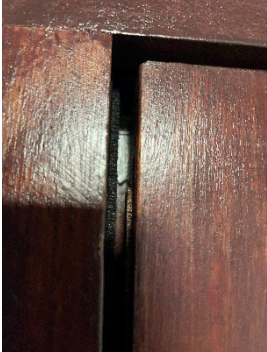
**35) 9<sup>th</sup> floor – communal door near to flat 55 has a loose handle and excessive gap on leading edge.**

The top photograph shows a black bicycle parked in a communal corridor with a green floor and a window with patterned curtains in the background. The bottom photograph shows a yellow and black pushchair parked in a similar corridor.	P2	Within 1 – 3 months. Housing Manager	07/02/2023
07/35	9 <sup>th</sup> floor – tighten loose handle to communal door by flat 55 and adjust door to correct excessive gap on leading edge.

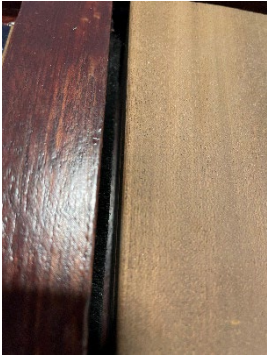
**36) 10<sup>th</sup> floor – Communal door by flat 64 excessive gap on leading edge.**

<p>07/36</p>	<p>10<sup>th</sup> floor – communal door by flat 64 requires adjustment to correct excessive gap on leading edge.</p>

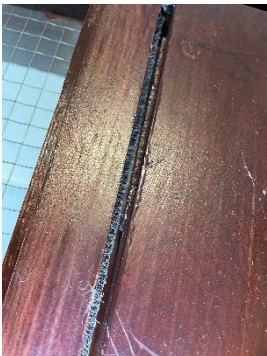
**37) 11<sup>th</sup> floor – Communal door by flat 70 excessive gap on leading edge.** It was also noted that the beading to one of the vision panels has been poorly installed with poor workmanship to mitred joints however glazing is sufficiently secured.

<p>P2</p>	<p>Within 1 – 3 months. Fire Rapid Response JM:9806894</p>	<p>01/11/2022</p>
<p>07/37</p>	<p>11<sup>th</sup> floor - communal door by flat 70 requires adjustment to correct excessive gap on leading edge.</p>

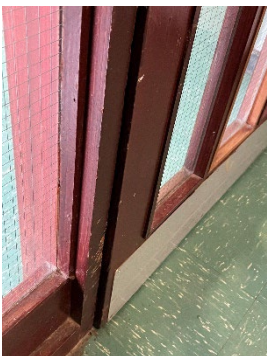
**38) 12<sup>th</sup> floor – Communal door near to flat 76 doesn't reliably close fully into frame leading lower edge.**

<p>P2</p>	<p>Within 1 – 3 months. Fire Rapid Response JM:9812904</p>	<p>03/11/2022</p>
<p>07/38</p>	<p>12<sup>th</sup> floor - Communal door by flat 76 requires adjustment, not reliably self-closing into frame.</p>

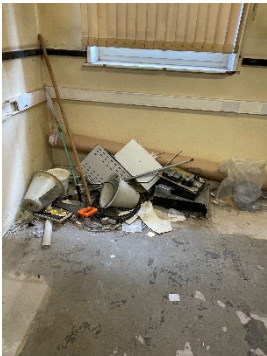
**41) Ground floor server / concierge room is untidy with items consisting of cabling, cardboard, redundant equipment having been discarded on floor.**

P2	Within 1 – 3 months. Fire Rapid Response JM:9814438	03/11/2022
07/41	Ground floor server / concierge room, remove discarded rubbish that's built up on floor.
