Fire Risk Assessment

Addenbrooke Court

**Southbank Rd, Oldbury,
Cradley Heath, B64 6LJ**

Date Completed: 09/07/24

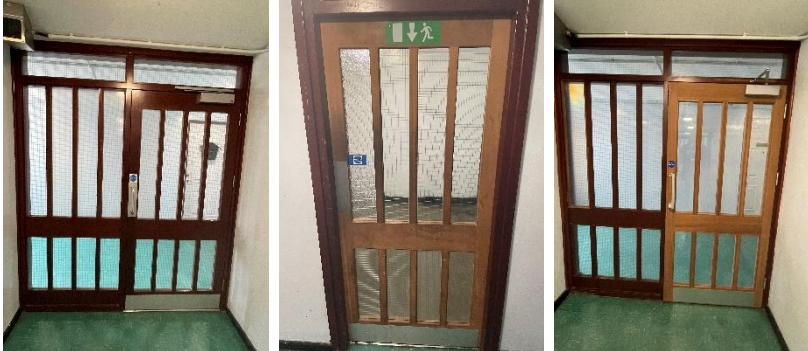
- 5) The means of escape are protected to prevent the spread of fire and smoke.
- 6) The communal landing / staircases are protected by use of notional FD30s fire doors with vision panels. It was noted that some communal doors have been replaced with nominal FD30s fire doors.

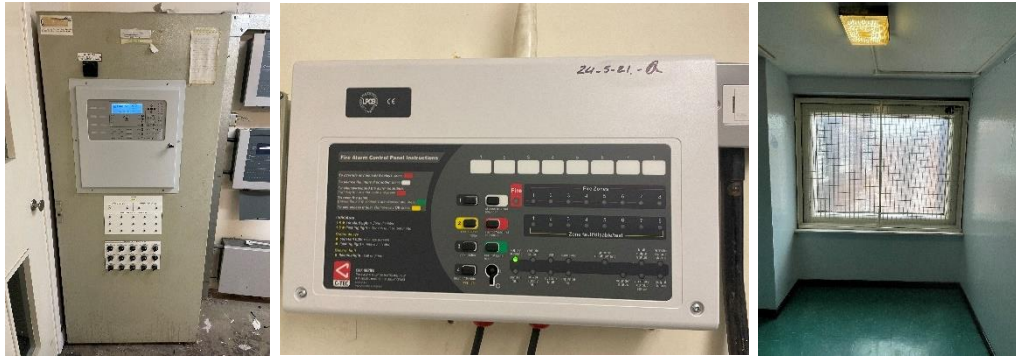
- 9) Automatic smoke ventilation is employed. This is tested, inspected and maintained by a competent procured contractor in accordance with BS7346. The frequency for the maintenance checks are twice per year (April and October) of each calendar year. The main control panel is located in the COMMs room (left of the main entrance lobby door) with repeater panels in the service cupboards on each floor. These service cupboards are secured with 138 suited mortice locks.
-

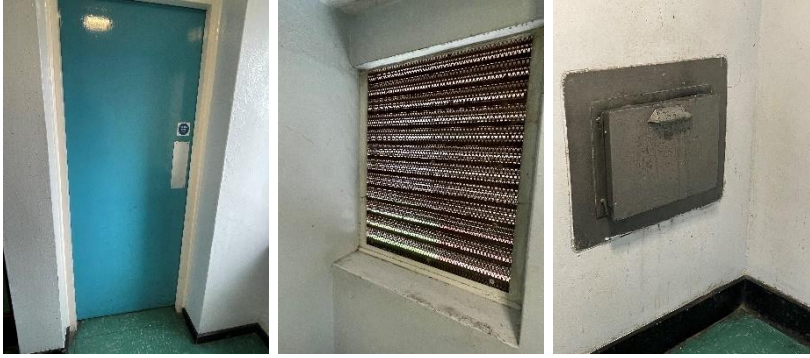
- 12) The chute rooms on each floor have a louvre vent and notional upgraded FD30s timber door.

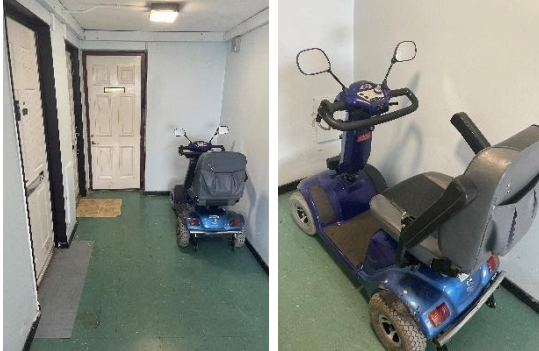
18) Mobility scooter in communal corridor outside flats 73, 74, 75.

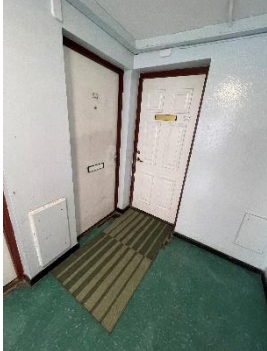
19) Rug outside flats 53 & 54 in communal corridor is unsuitable / slippery under foot.

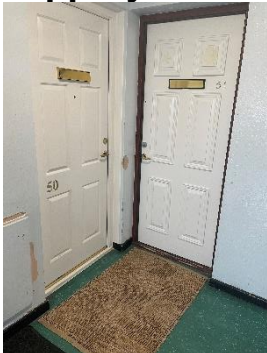
20) Rug outside flats 50 & 51 in communal corridor is unsuitable / slippery under foot.

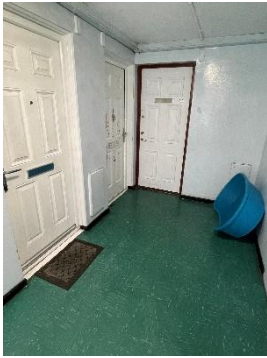
21) Plastic dog bed in communal corridor outside flats 34, 35, 36 is already being dealt with by the housing officer due to an aggressive tenant.

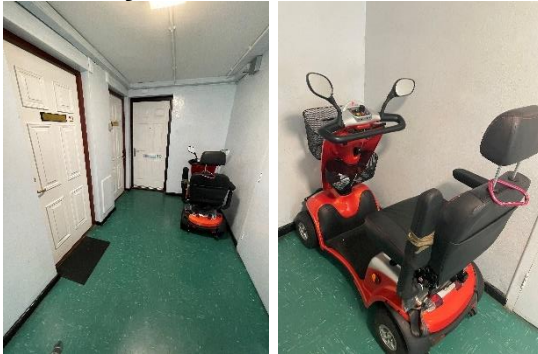
22) Mobility scooter in communal corridor outside flats 28, 29, 30.

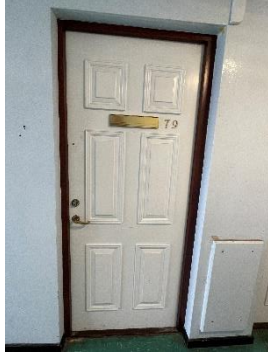
A. Flat 79 – Entrance door not reliably self-closing.

7/32a	Flat 79 – Adjust self-close to ensure entrance door reliably self closes	 	P2	Within 1-3 months of action plan. Fire Rapid Response JM:14498911	23/07/2024
7/32c	Flat 67 - Adjust self-close to ensure entrance door reliably self closes	 	P2	Within 1-3 months of action plan. Fire Rapid Response JM14499015	26/07/2024
7/32g	Flat 32 – Replace missing section of combined intumescent / CSS strip. Self-closing arm catches on door leaf refit / adjust as necessary.	 	P2	Within 1-3 months of action plan. Fire Rapid Response JM:14499059	23/07/2024

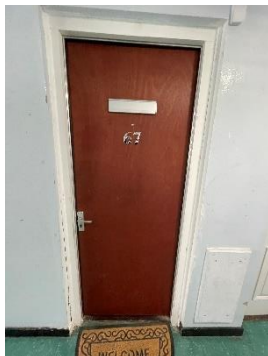
C. Flat 67 – Entrance door not reliably self-closing.

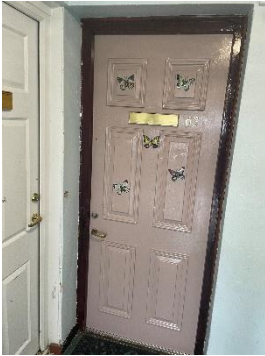
33) Flat 63 entrance door has been painted. This is deemed to be of low risk.

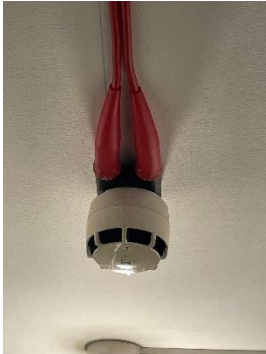
- 5) In addition to the LD1 / LD2 fitted system, some flats also had a smoke detector within the hall that was previously part of a former system linked to the now decommissioned fire alarm panels within the ground floor comm's room. Residents were aware that this detector was now redundant.

- 6) It was noted that these 2 decommissioned fire alarm panels have been labelled as not in use however, it is recommended that they are removed as part of any future renovation program.
- 7) Automatic smoke ventilation is employed and referred to in section [7.9](#).
- 8) A fire suppression system is provided to the refuse chute bin store. An approved contractor maintains the system. The frequency for the maintenance checks are twice per year (April and October) of each calendar year.

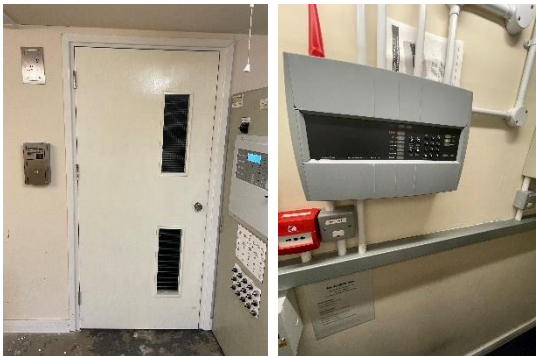
- 10) There is a fire alarm panel located within the CCTV server (comms) room adjacent to the main front entrance on the ground floor. This system only protects the server room. Access is obtained via the use of a suited type 54 key for the door off the communal corridor and then via entry-com link to the Concierge Team or firefighter override key. **Evidence of periodic testing couldn't be determined.**

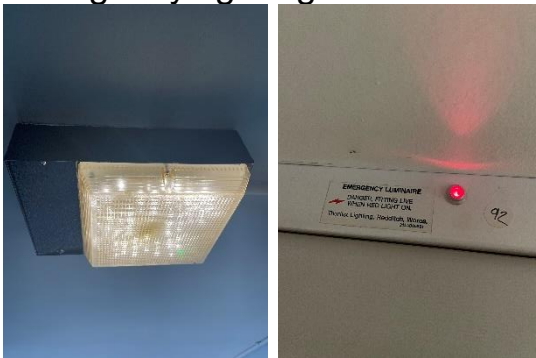
- 1) The premises have a sufficient emergency / escape lighting system in accordance with BS 5266 and has test points strategically located.
- 2) The self-contained units are provided to the communal landings, stairs, ground floor rooms and lift motor room. There is no emergency lighting within the basement.

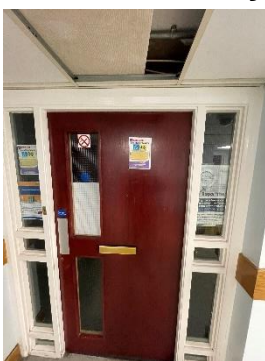
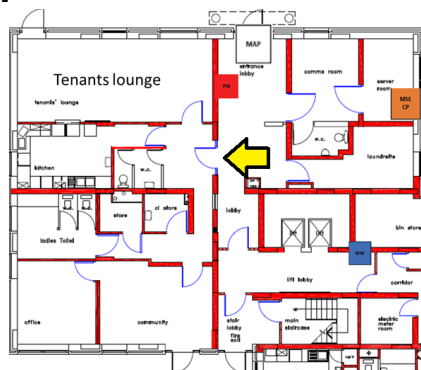
- 12) Enhance fire stopping above community room door from entrance lobby.**

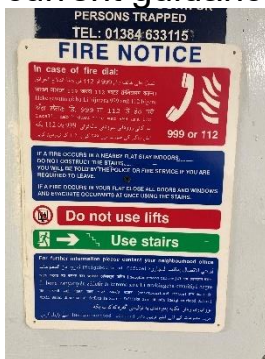
- 2) Fire Action Notices are displayed throughout the building. However, these are currently under review to align with S.M.B.C current guidance of “stay put unless”.

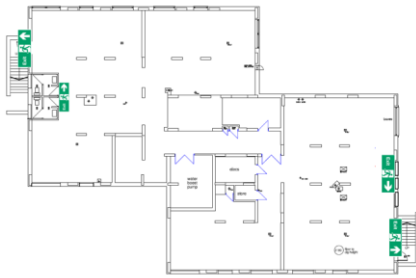
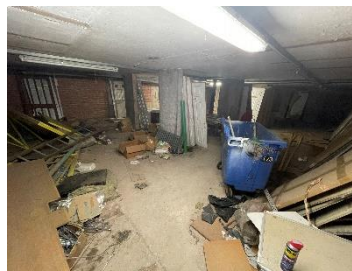
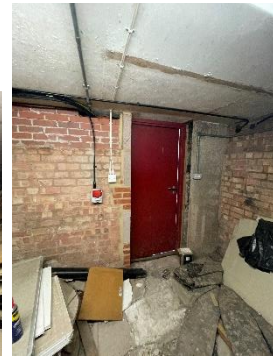
- 7) The fire escape routes generally do not use directional fire signage in accordance due to simplicity of layout, however there is a directional fire escape sign above some landing doors and to the server room door.

Furthermore, it would be beneficial if directional fire escape signage was installed to the basement area because of the lack of emergency lighting and direct sight of an exit is not possible from all areas.

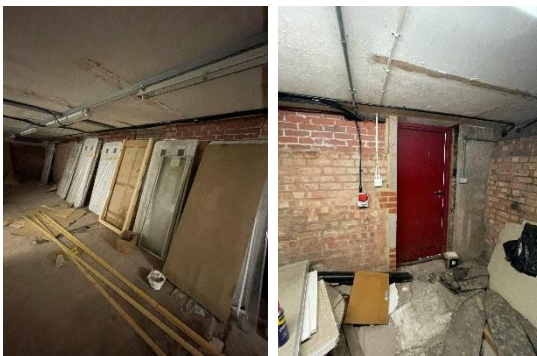
- 6) The basement appears to have become an area where by surplus SMBC materials and items are being stored. The basement is secured by a non-suited key that is stored in the firefighter’s white box.

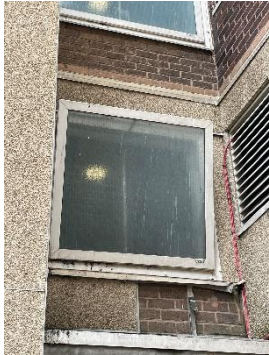
- 10) The AOV to the first floor lobby by flats 10, 11, 12 is defective and stuck in the open position due to the hinges failing. The assessor has been informed that replacement hinges are no longer available therefore, a solution to resolve the issue is likely to involve commissioning an engineering firm to re-manufacture the hinges.

- 11) It was noted that due to the AOV being stuck in the open position there is a small amount of rubbish that has blown in and has become trapped between the AOV and the mesh grill. This will need to be monitored to prevent a build-up of combustible waste.

7/10	Replace defective hinges to 1 st floor AOV that remains in the open position

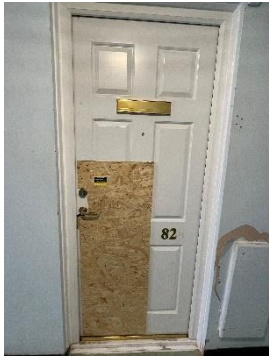
- 30) Emergency repair using sterling board to flat 82 entrance door. Confirmation required that a new FD30s door has been requested.**

P2	Within 1-3 months of action plan. Housing Manager.	09/11/2024
7/30	Flat 82 install emergency FD30s fire door

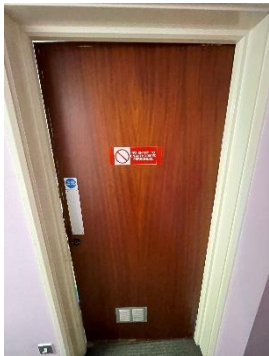
- 11) Cleaners' cupboard notional fire door within the community room area requires intumescent strip, cold smoke seal and replacement intumescent vent. Cupboard contains electrical switchgear.**

P2	Within 1-3 months of action plan. Fire Rapid Response JM:14495991	23/07/2024
10/11	Cleaners' cupboard in community room area – install intumescent strip / cold smoke seal to door. Also, install intumescent grill to door.

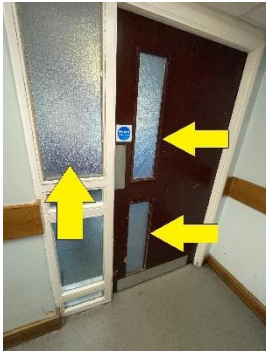
15) Communal door from lift lobby to stairwell, 3 x Fyberglaze GRP panels are loose and require refixing. Upper panel in combination frame is poorly fitted and loose. Upper panel in door - beading / panel not secure. Lower panel moves / not secure.

P2	Within 1-3 months of action plan. Fire Rapid Response JM:14496168	23/07/2024
10/15	3 x Fibreglaze GRP panels are loose and to be correctly re-fixed.
