# Fire Risk Assessment

## Moorlands Court

**Reservoir Road,  
Rowley Regis  
B65 9PB**

**Date Completed: 26/01/23**

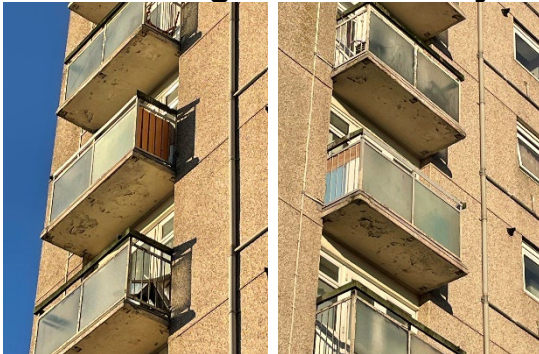
The addition of screening to some balconies could potentially support the surface spread of flame in those areas which is an unnecessary risk. Once this is removed the level of risk presented by materials present to the external envelope of this building would become trivial.

5. Flat 37, 5<sup>th</sup> floor has installed what appears to be timber ply as screening to the balcony.

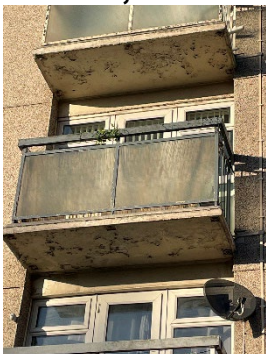
6. Flat 18, 2<sup>nd</sup> floor has installed willow screening to the balcony.

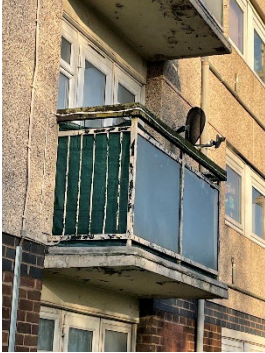
7. Flat 13, 1<sup>st</sup> floor has installed what appears to be mesh type material to the balcony.

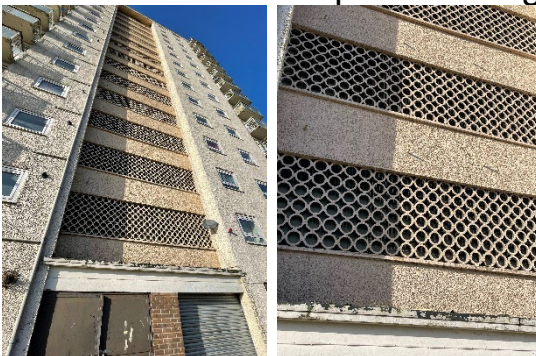
9. The ventilated block work to the chute rooms on the rear elevation have been externally covered with pest control netting. The netting will be permanently removed during significant refurbishments works that are anticipated to begin in the near future.

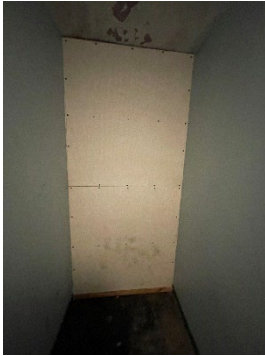
- 11) The louvred ventilation panel to 12<sup>th</sup> floor has been boarded over with Supalux board. It is recommended that this boarding should be removed to reinstate natural ventilation to the communal corridor.

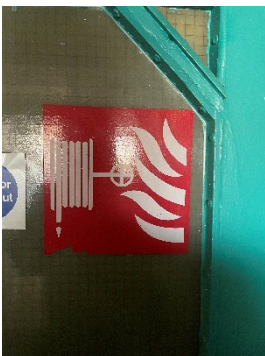
**16) Dry riser cupboard doors display signage which suggests that firefighting hose-reels are within. There are no hose-reels within any of the cupboards and therefore the signs should be removed.**

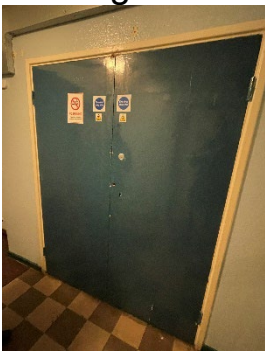
17) Electric service cupboards have FD30 rated doors, secured with a suited cylinder lock. Residents have been provided with a key for access to their electricity meters. It is recommended that all service cupboard doors are uprated to FD30s during the upcoming building refurbishment works.

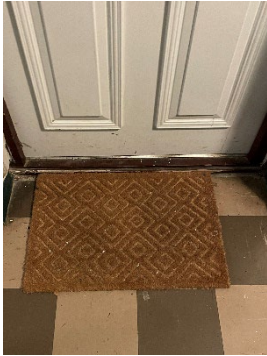
22) The fire rating of individual door mats outside flat entrances is unknown.

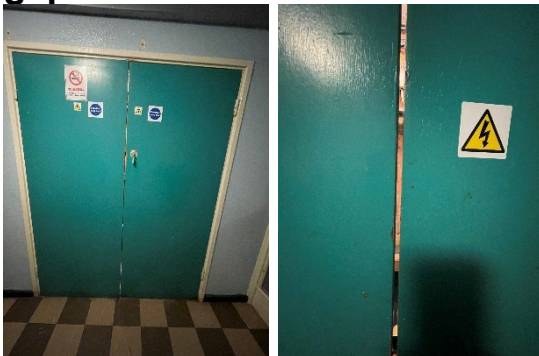
24) 13<sup>th</sup> floor electrical service cupboard doors have excessive gap between them due to no overlap or cold smoke seal.

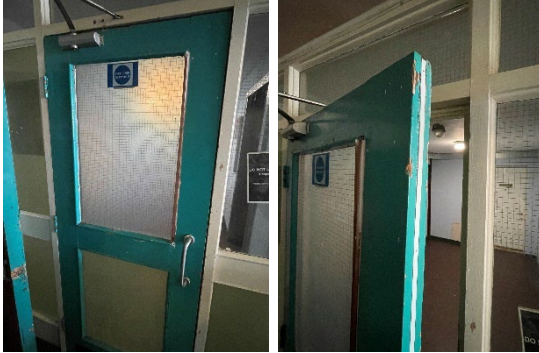
- 29) 12<sup>th</sup> floor communal door near flat 74 requires cold smoke seal and adjustment to correct excessive gap.

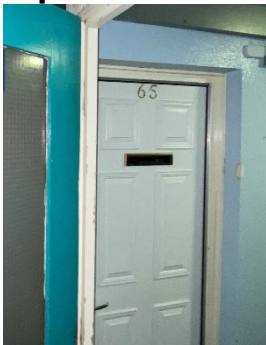
- 33) 10<sup>th</sup> floor - Flat 65 outer letter plate is missing and requires replacement.

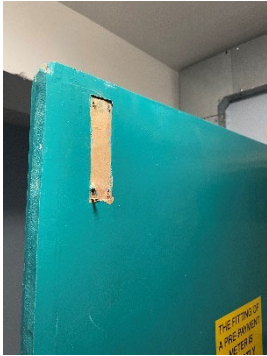
**35) 9<sup>th</sup> floor service cupboard is not securable, requires bolt to slave door.**

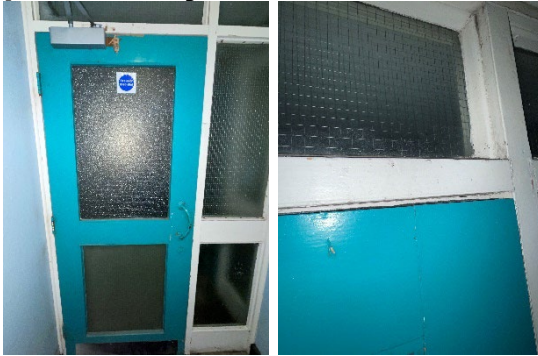
**38) 8<sup>th</sup> floor excessive gap around communal door to chute room particularly to head.**

P2	Within 1 – 3 months of action plan. Fire Rapid Response JM:10704871	04/05/2023
07/38	8 <sup>th</sup> floor communal door to chute room, excessive gap to head adjustment / repair required,

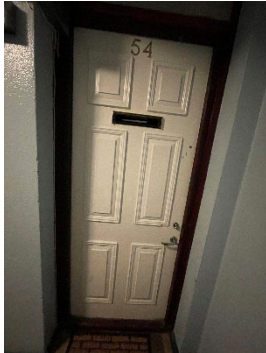
**40) 8<sup>th</sup> floor flat 54 is missing an outer letter plate.**

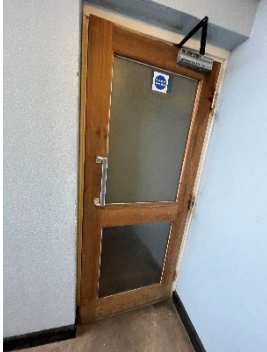
- 41) 8<sup>th</sup> floor communal door to staircase doesn't hold shut due to air pressure from ventilated corridor. Self-closing device requires adjustment.

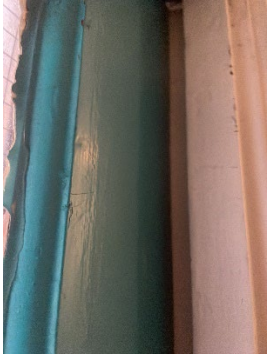
- 42) 7<sup>th</sup> floor communal door to staircase doesn't hold shut due to air pressure from ventilated corridor. Self-closing device requires adjustment.

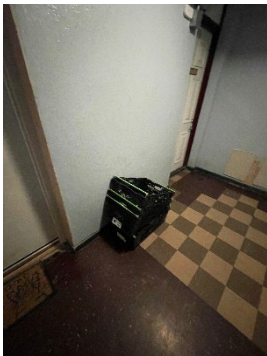
- 45) Supermarket home delivery crates outside flat 48. Supermarket were contacted during the FRA – crates removed.

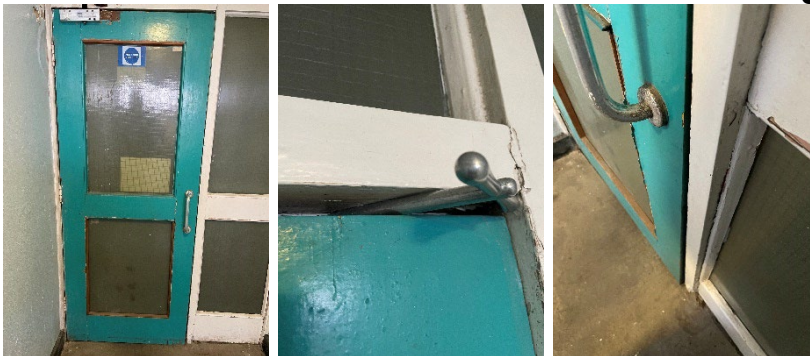
- 46) 7th floor communal door to chute room has excessive gap and lower frame handle side is not secure at ground.

07/46	7 <sup>th</sup> floor communal door to chute room, excessive gap to head adjustment / repair required. Lower frame requires fixing at floor to prevent movement.	 	P2	Within 1 – 3 months of action plan. Fire Rapid Response JM:10716719	04/05/2023
07/47	7 <sup>th</sup> floor communal door by flat 44 requires cold smoke seal.

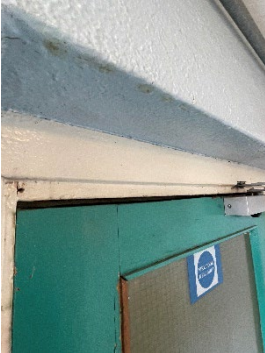
**56) 4<sup>th</sup> floor communal door to stairs excessive gap to head.**

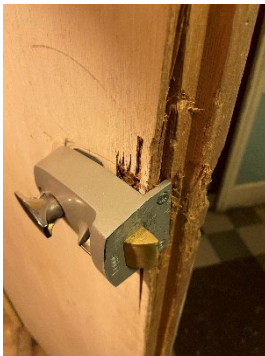
**57) 4<sup>th</sup> floor service cupboard doors are not secured because the lock is not securely fitted (slight damage to door). Hinge on r/h door not fixed.**

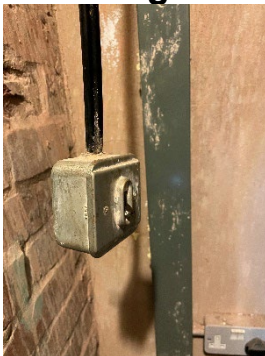
**58) 4<sup>th</sup> floor service cupboard light switch is not secured to wall and hangs loose.**

P2	Within 1 – 3 months of action plan. Fire Rapid Response JM:10767267	16/05/2023
07/58	4 <sup>th</sup> floor service cupboard light switch hangs loose requires securing to wall.

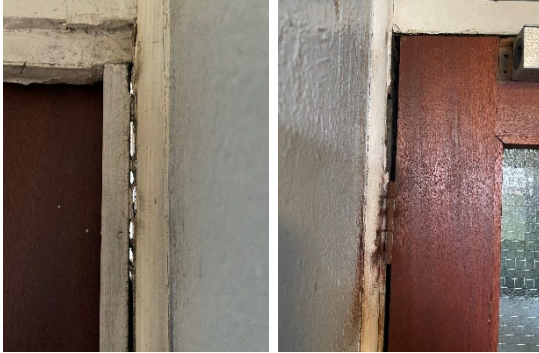
- 59) 4<sup>th</sup> floor communal door to chute room has gap between 25mm stop and frame also excessive gap to hinge side.

07/59	4 <sup>th</sup> floor communal door to chute room excessive gap to hinge side and gap between stop & frame. Adjustments / repair required

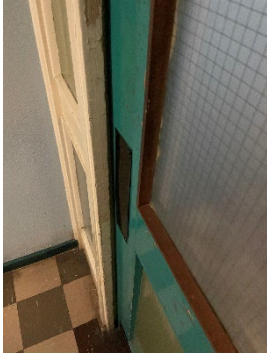
- 61) 3<sup>rd</sup> floor communal door by flat 23 fails to hold against stop.

07/61	3 <sup>rd</sup> floor by flat 23, communal door fails to hold against stop, adjustment self-closer

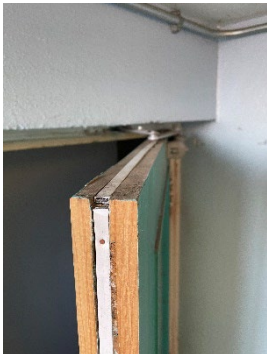
- 62) 2<sup>nd</sup> floor communal door to stairs doesn't have cold smoke seals.

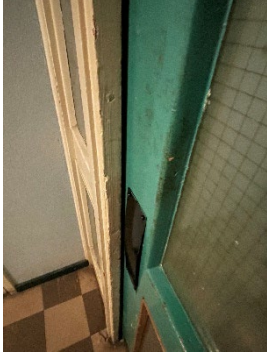
**63) 2<sup>nd</sup> floor communal door by flat 17 fails to close against stop.**

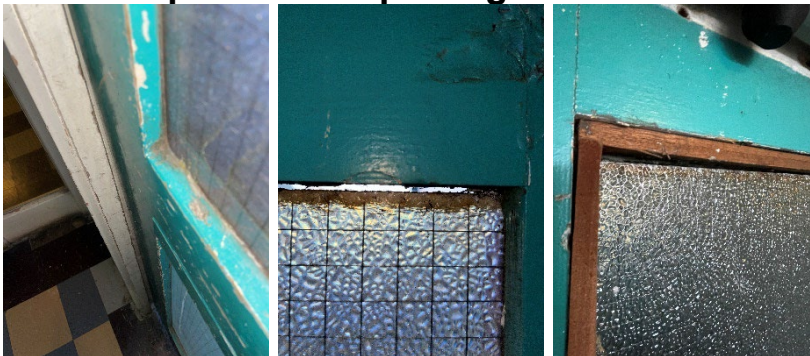
**64) 2<sup>nd</sup> floor communal door to chute room is significantly warped creating a gap of up to 20mm along the leading edge and beading to upper glazed panel is poorly fitted and wouldn't prevent the passage of smoke.**

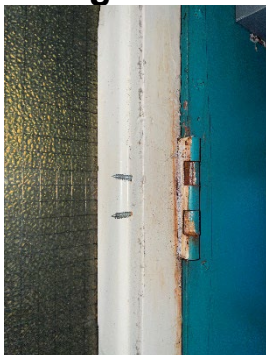
**65) 2<sup>nd</sup> floor communal door by flat 14 screws to hinge protruding through frame.**

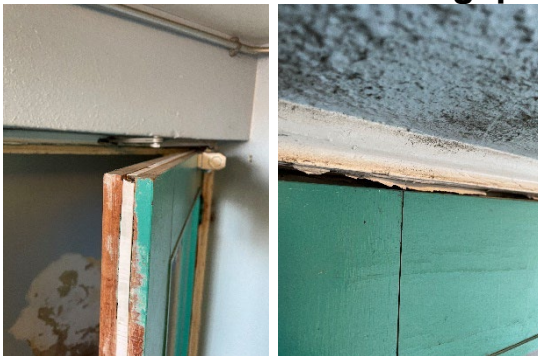
**67) 1<sup>st</sup> floor communal door to stairs has no cold smoke seals, binds and has excessive gaps to head.**

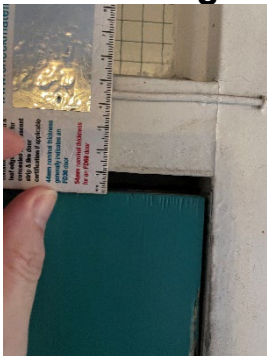
**68) 1<sup>st</sup> floor communal door by flat 8 has excessive gaps to head but seals against 25mm stop.**

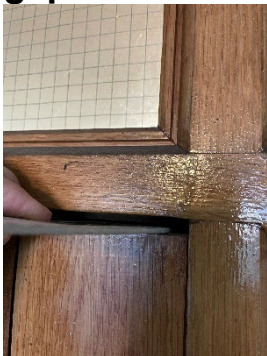
**74) Ground floor communal door to chute room has excessive gap to head.**

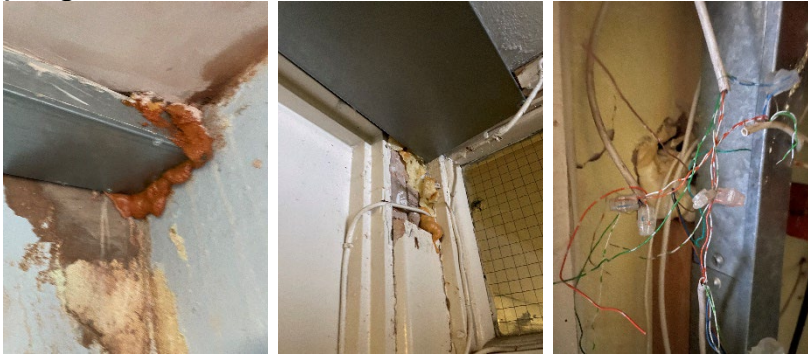
- 6) A variety of methods / materials have been used to achieve fire-stopping including Rockwool and intumescent pillows. It was evident that in some areas around cable penetrations (service & riser cupboards) there are small amounts of foam. The foam will be removed and fire stopping enhanced as part of the cyclical programme.

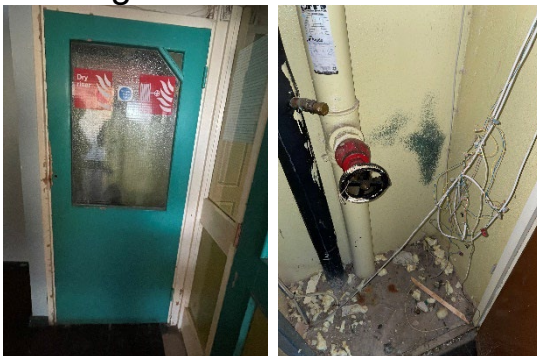
- 2) The dry riser outlets are located in cupboards adjacent the chute rooms at the lift end of the communal corridor on each floor. Each cupboard is secured with a budget lock. It was evident that telecommunication cabling within the riser cupboards does hang loose and is generally untidy. The cabling does not restrict the use of the riser outlets and will be made good as part of the significant building refurbishment works that are planned.

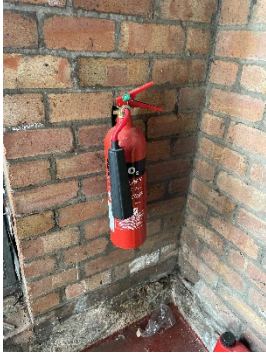
- 5) Portable fire extinguisher (CO2) is provided to the lift motor room. Maintenance contracts in place for maintenance of the extinguisher. The frequency for the maintenance checks are once (October) of each calendar year. The service record for this extinguisher suggests the pervious service was not carried out. *Passed to contractor 02/02/23 will be completed 10/02/23.*

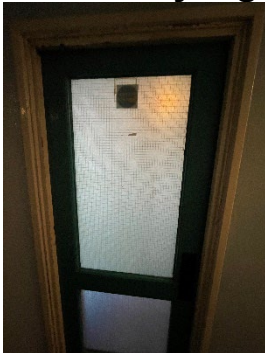
- 2) **12<sup>th</sup> floor communal door to stairs – Fire Door Keep Shut mandatory sign is missing from corridor side of the door.**

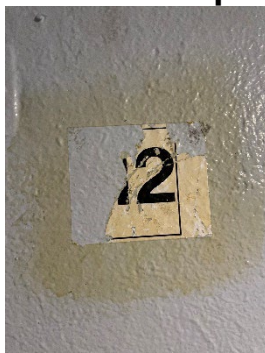
- 6) Wayfinding signage within the block is to be upgraded with photoluminescent signage in response to regulation 8 / fire safety regulations 2022.
- 7) Signage depicting floor level is fitted to the wall on each floor adjacent to lift. **Signage opposite the 12<sup>th</sup> floor lift car has been torn and requires replacement.**

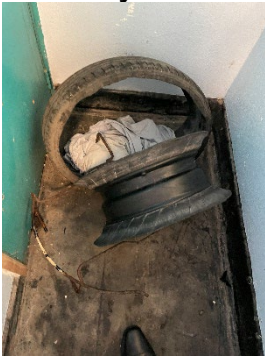
- 4) A discarded wheel and tyre was removed from the 6<sup>th</sup> floor chute room by the caretaking team at the time of the FRA.

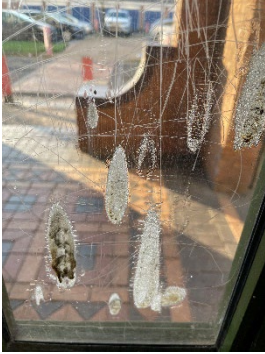
- 4) Evidence of arson was noticeable around the main entrance.

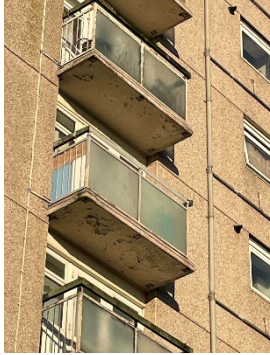
Question/ Ref No	Required Action	Supporting photograph	Priority	Timescale and Person Responsible	Date Completed
06/05	Flat 37 – remove timber plywood used as screening on balcony

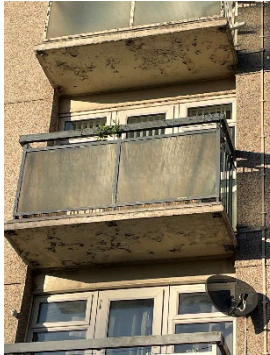
06/06	Flat 18 – remove willow screening installed to balcony.

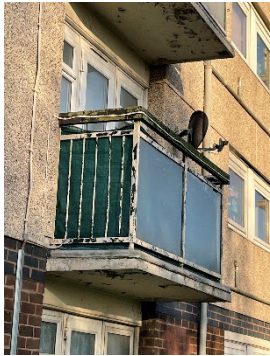
P2	Within 1 – 3 months of action plan. Housing Manager	19/04/2023
06/07	Flat 13 – remove combustible material installed to balcony as screening.

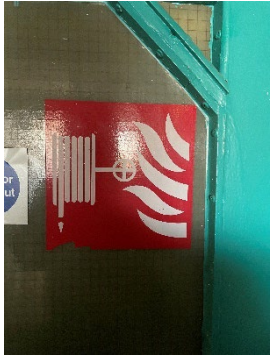
<p>07/16</p>	<p>Remove signage depicting "Hose Reels" from all dry riser cupboard doors.</p>

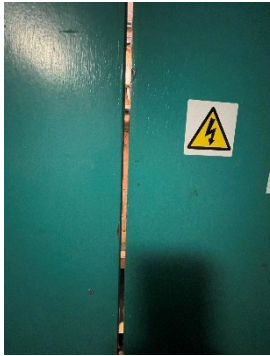
<p>P2</p>	<p>Within 1 – 3 months of action plan. Caretaking Manager</p>	<p>11/04/2023</p>
<p>07/24</p>	<p>13<sup>th</sup> floor – install cover/mould to make good excessive gap between electrical service cupboard doors.</p>

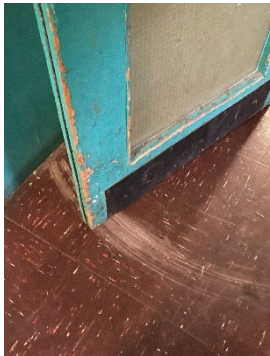
<p>P2</p>	<p>Within 1 – 3 months of action plan. Fire Rapid Response JM10633721</p>	<p>02/05/2023</p>
<p>07/25</p>	<p>13<sup>th</sup> floor – rehang door by flat 80 to cure binding on floor.</p>

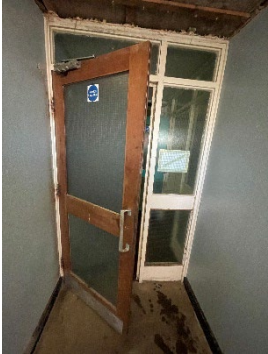
- 26) 13<sup>th</sup> floor communal door to chute room doesn't remain fully closed due to air pressure from natural ventilation. Self-closer requires adjustment or replacement.

07/26	13 <sup>th</sup> floor – communal door to chute, adjust self-closer to ensure door can hold fully closed into frame.

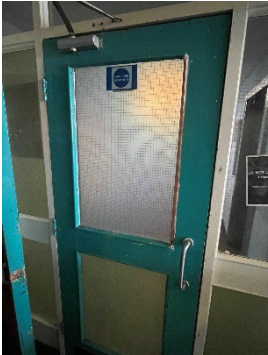
<p>07/29</p>	<p>12<sup>th</sup> floor near flat 74 communal door requires cold smoke seal &amp; adjustment to correct excessive gap.</p>

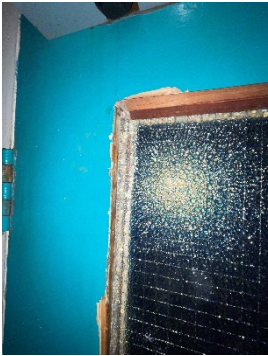
<p>P2</p>	<p>Within 1 – 3 months of action plan. Fire Rapid Response JM:10633908</p>	<p>02/05/2023</p>
<p>07/30</p>	<p>10<sup>th</sup> floor near flat 62, communal door requires section of beading around upper panel.</p>

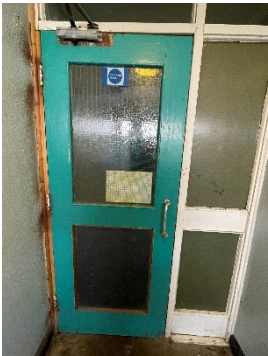
- 31) 10<sup>th</sup> floor communal door to chute room has damaged cold smoke seal to upper leading edge. There is also an excessive gap to the head which could be corrected with some adjustment & missing screw from the top hinge.

<p>P2</p>	<p>Within 1 – 3 months of action plan. Fire Rapid Response JM:10633936</p>	<p>02/05/2023</p>
<p>07/31</p>	<p>10<sup>th</sup> floor communal door to chute room – replace damaged smoke seal to upper leading edge / correct excessive gap to head / replace missing screw to top hinge.</p>

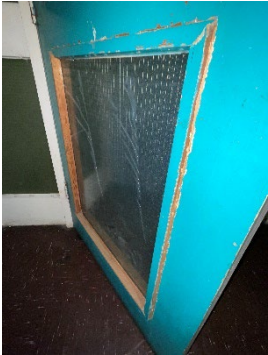
07/32	10 <sup>th</sup> floor by flat 65 – secure R/H/S beading to lower panel in communal door

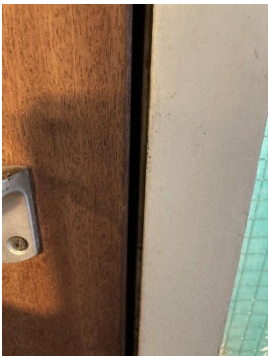
- 34) 9<sup>th</sup> floor – communal door by flat 59 is missing an intumescent strip to the head plus excessive gap to leading edge.

P2	<p>Within 1 – 3 months of action plan. Fire Rapid Response JM:10704084</p>	03/05/2023
07/34	9 <sup>th</sup> floor by flat 59 communal door requires intumescent strip / smoke seal to head and adjustment to correct excessive gap to leading edge.

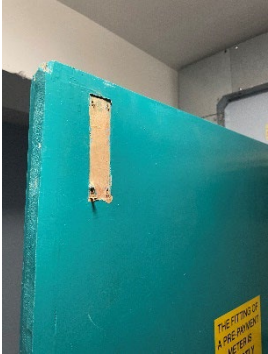
07/35	9 <sup>th</sup> floor service cupboard requires bolt to slave door.

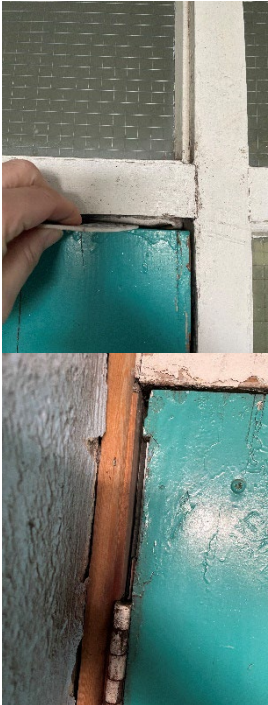
P2	Within 1 – 3 months of action plan. Fire Rapid Response JM:10704360	03/05/2023
07/36	9 <sup>th</sup> floor communal door to chute room, excessive gaps require adjustment / repair.

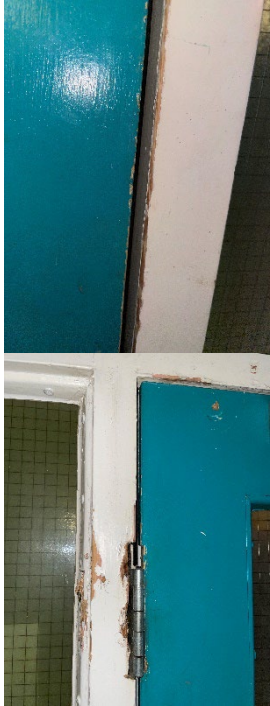
**37) 8<sup>th</sup> floor communal door by flat 50 damage to frame around top hinge creating excessive gap, also excessive gap around head and leading edge.**

07/37	8 <sup>th</sup> floor by flat 50 communal door excessive gaps to head & leading edge, damage to frame at top hinge – adjustment / repair required.

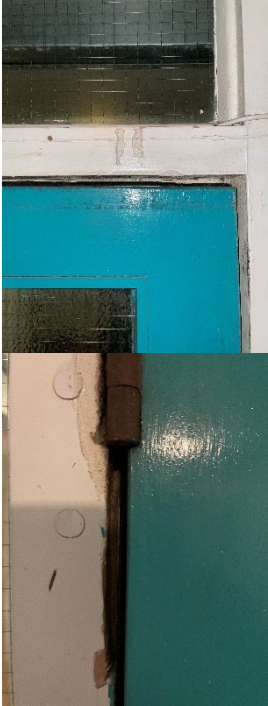
07/39	8 <sup>th</sup> floor by flat 53 communal door has excessive gaps around head and hinges, adjustment / repair required.

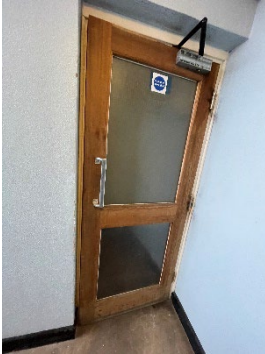
07/41	8 <sup>th</sup> floor communal door to stairwell, adjust self-closer to ensure door can hold fully closed into frame.

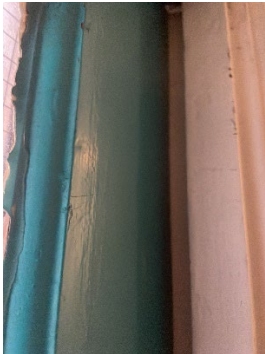
P2	Within 1 – 3 months of action plan. Caretakers	11/04/2023
07/42	7 <sup>th</sup> floor communal door to staircase adjust self-closer to ensure door can hold fully closed into frame.

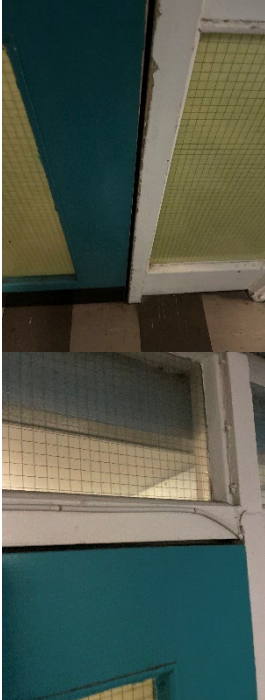
07/43	7 <sup>th</sup> floor by flat 47, communal door correct excessive gaps with adjustment / oversize smoke seal & gap between stop and frame requires re-fixing.

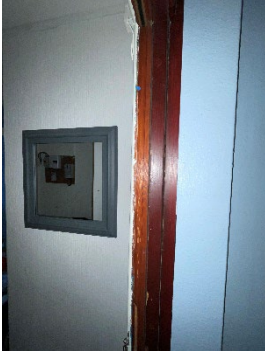
- 44) 7<sup>th</sup> floor flat 48 entrance door, section of combined intumescent strip / cold smoke seal is missing from frame.

P2	Within 1 – 3 months of action plan. Fire Rapid Response JM:10705204	04/05/2023
07/44	7 <sup>th</sup> floor flat 48 entrance door requires intumescent strip / smoke seal to frame.

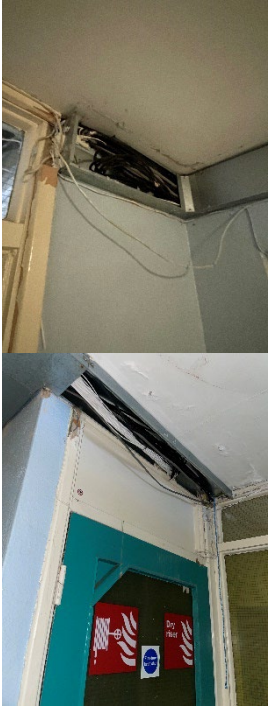
**48) 7<sup>th</sup> floor cable tray covers are missing above riser cupboard and adjacent flat 44.**

07/48	7 <sup>th</sup> floor cable tray covers missing above riser cupboard door and adjacent flat 44, both require replacing.

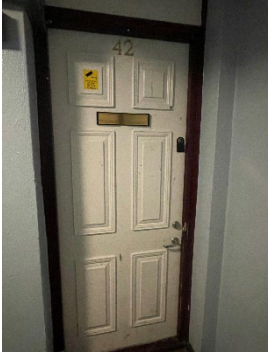
P2	Within 1 – 3 months of action plan. Electrical Repairs JM10468886	05/05/2023
07/49	6 <sup>th</sup> floor flat 42 entrance door requires adjustment, not reliably fully self-closing into frame

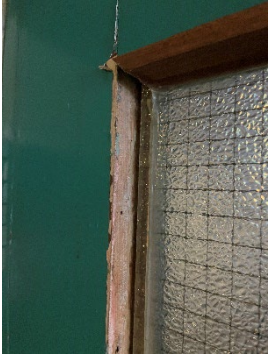
- 50) 6<sup>th</sup> floor communal door by flat 38 is missing a section of beading to the upper glazed panel.

07/50	6 <sup>th</sup> floor by flat 38, communal door, replace missing section of beading.

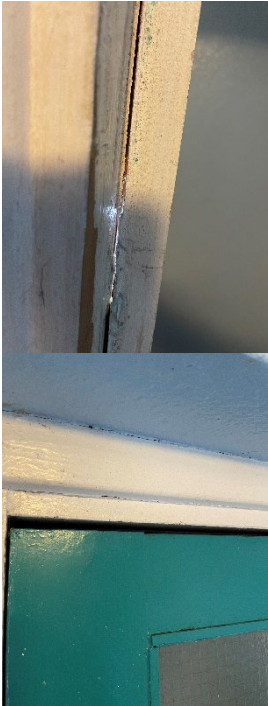
P2	Within 1 – 3 months of action plan. Fire Rapid Response JM:10717433	09/05/2023
07/51	6 <sup>th</sup> floor communal door to stairs correct gap between stop and frame and excessive gap to head, adjustment / repair required

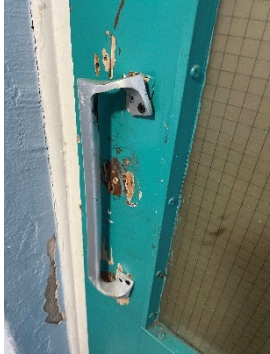
- 52) 5<sup>th</sup> floor communal door to stairs, door handle has been forcefully bent back into the door panel and requires replacement.

07/52	5 <sup>th</sup> floor communal door to stairs – replace damaged door handle.

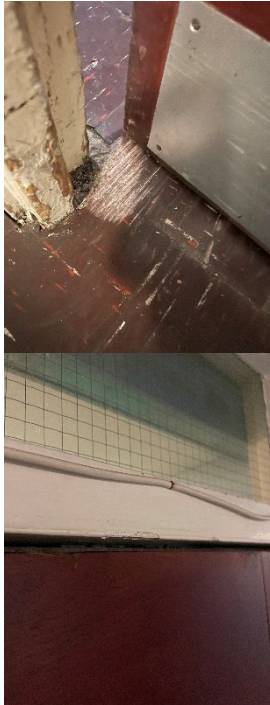
- 53) 5<sup>th</sup> floor communal door by flat 35 binds on floor, excessive gap to head and door doesn't fully close against stop. Frame is loose along floor edge.

P2	Within 1 – 3 months of action plan. Fire Rapid Response JM:10751921	10/05/2023
07/53	5 <sup>th</sup> floor by flat 35 communal door – door binds on floor, excessive gap to head, adjustment repair required. Fixed frame loose requires securing to floor (opening side).

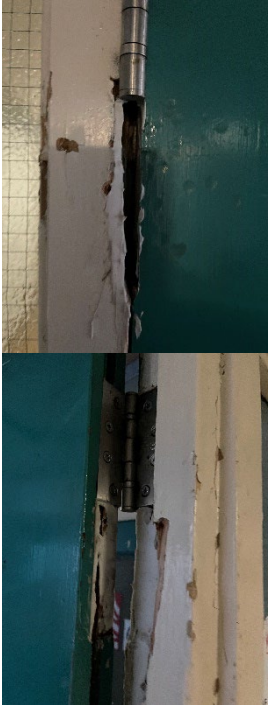
- 55) 5<sup>th</sup> floor communal door by flat 32 slight gap to door edge / frame / stop were hinge was previously located, some damage to 25mm stop.

07/55	5 <sup>th</sup> floor by flat 32, repairs adjustment required to communal door / frame to correct excessive gap around upper hinge

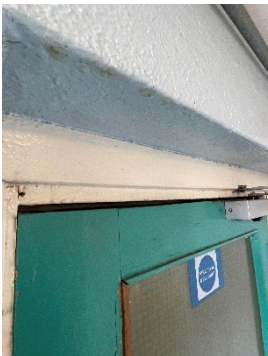
P2	Within 1 – 3 months of action plan. Fire Rapid Response JM:10752700	15/05/2023
07/56	4 <sup>th</sup> floor communal door to stairs correct excessive gap to head.

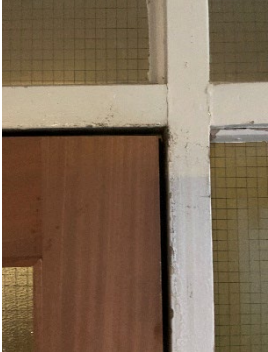
P2	Within 1 – 3 months of action plan. Fire Rapid Response JM:10767345	16/05/2023
07/60	4 <sup>th</sup> floor by flat 26 communal door excessive gap to head adjustments / repair required.

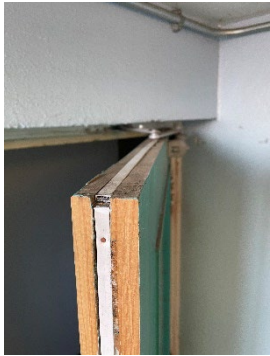
P2	Within 1 – 3 months of action plan. Caretakers	11/04/2023
07/62	2 <sup>nd</sup> floor communal door to stairs requires cold smoke seal

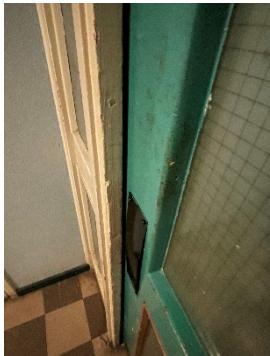
P2	Within 1 – 3 months of action plan. Fire Rapid Response JM:10767661	16/05/2023
07/63	2 <sup>nd</sup> floor by flat 17, communal door fails to close against stop adjust self-closer

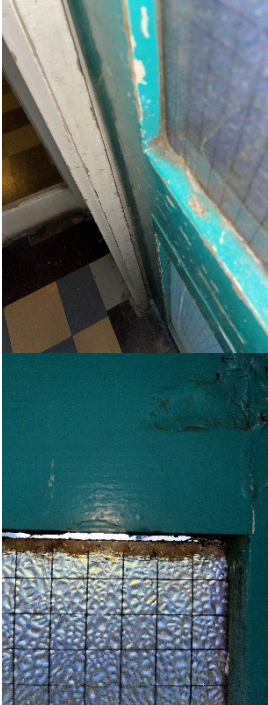
07/64	2 <sup>nd</sup> floor communal door to chute room warped and to be rehung / replaced.

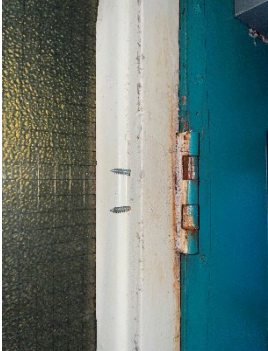
P2	Within 1 – 3 months of action plan. Fire Rapid Response JM:10767799  Door rehung	19/07/2023
07/65	2 <sup>nd</sup> floor communal door by flat 14 replace long protruding screws with suitable length.

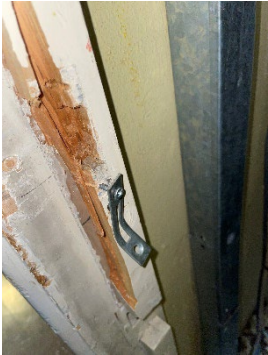
<p>07/66</p>	<p>2<sup>nd</sup> floor dry riser cupboard, repair frame to enable door to be locked.</p>

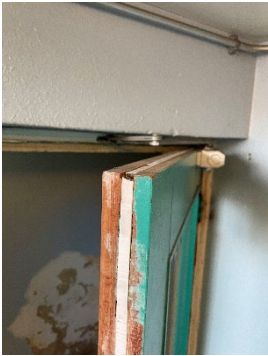
<p>P2</p>	<p>Within 1 – 3 months of action plan. Fire Rapid Response JM:10768163</p>	<p>16/05/2023</p>
<p>07/67</p>	<p>1<sup>st</sup> floor communal door to stairs requires cold smoke seals. Excessive gap to head may require adjustment after seals fitted.</p>

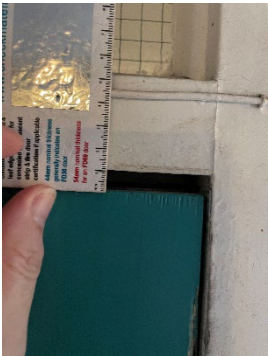
<p>P2</p>	<p>Within 1 – 3 months of action plan. Fire Rapid Response JM:10825459</p>	<p>18/05/2023</p>
<p>07/68</p>	<p>1<sup>st</sup> floor by flat 8, communal door has excessive gap to head adjustment required.</p>

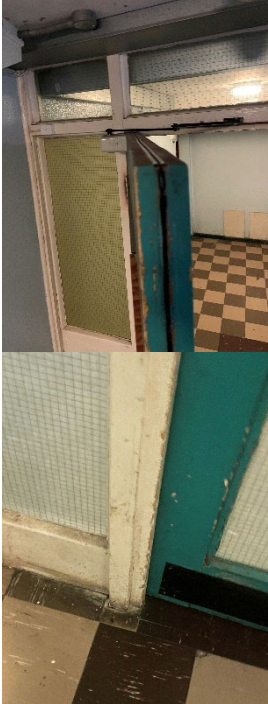
07/69	1 <sup>st</sup> floor communal door by flat 11, fit cold smoke to seal head, re-secure fixed frame on opening side to floor.

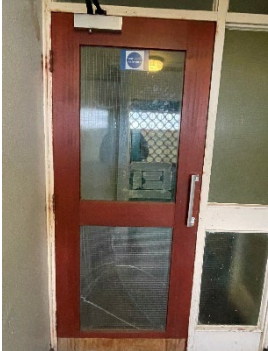
P2	Within 1 – 3 months of action plan. Fire Rapid Response JM:10768199	16/05/2023
07/70	1 <sup>st</sup> floor communal door to chute room, replace cracked glazing to lower panel.

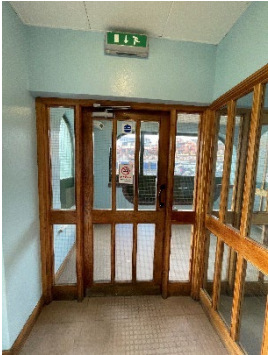
07/71	Ground floor communal door adjacent staircase, fit combined intumescent strip / cold smoke seal to head. Replace missing screws to hinges.

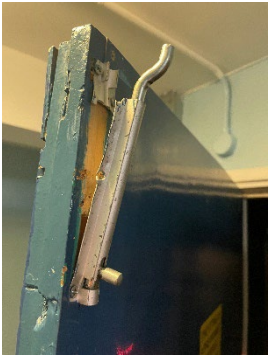
P2	Within 1 – 3 months of action plan. Fire Rapid Response JM:10768354	16/05/2023
07/72	Ground floor service cupboard, replace broken bolt to door.

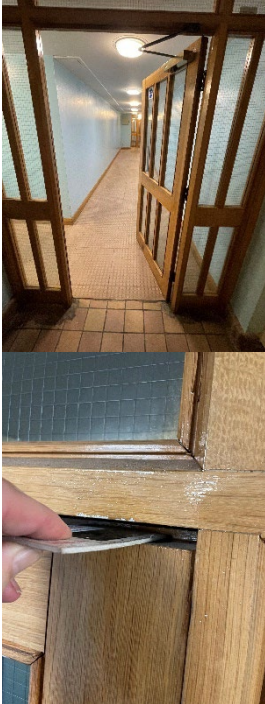
07/73	Ground floor communal door by flat 74 adjustment / repair required to correct excessive gap to head / binding on floor. Replace missing screw to top hinge.

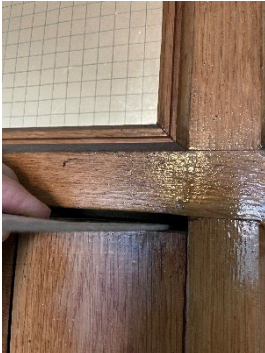
P2	Within 1 – 3 months of action plan. Fire Rapid Response JM:10769342	11/05/2023
07/74	Ground floor door to chute room, adjustment required to correct excessive gap to head.

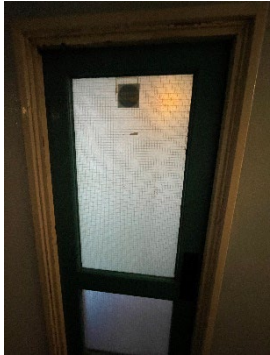
12/02	Install Fire Door Keep Shut mandatory sign to 12 <sup>th</sup> floor communal door to stairs / corridor side.

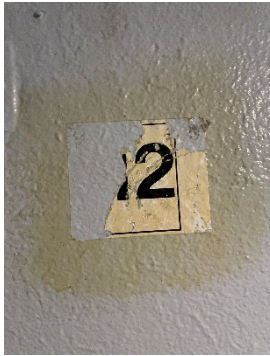
P2	Within 1 – 3 months of action plan. Caretaking Manager	11/04/23
12/07	Replace floor number adjacent lift car on 12 <sup>th</sup> floor.

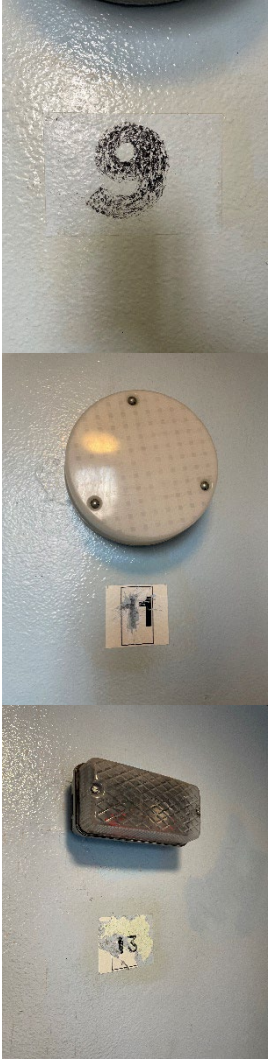
- 8) Floor indicator numbers are fitted to the wall of each floor on the communal staircase(s) **Signage to the 9<sup>th</sup> 11<sup>th</sup> & 13<sup>th</sup> floor stairwells have been vandalised and require replacement.**

12/08	Replace missing / damaged floor level signs to stairwell on floors 9, 11, 13
