Fire Risk Assessment

Bishops Close 8-12, 14-18

**Bishops Close, Smethwick,
B66 2RD**

Date Completed: 23/10/23

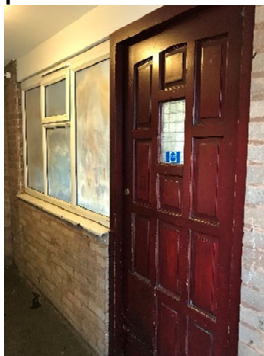
The ground floor flat is separated from the rest of the building by a timber door and frame with glazing within the same compartment partition wall.

- 2) Due to the partition wall in the ground floor lacking a fire door and fire resistant glazing and the window from the ground floor flat not having fire resistant glazing the premise lacks sufficient compartmentation to limit the travel and effect of smoke and flame in event of a fire (see section 7/7). Whilst other areas of the block does have existing fire stopping that is fit for purpose, there is a cyclical programme to ensure fire stopping as not been compromised by third parties and where applicable enhance the fire stopping.

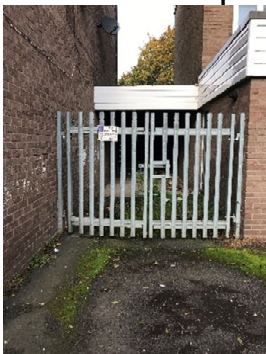
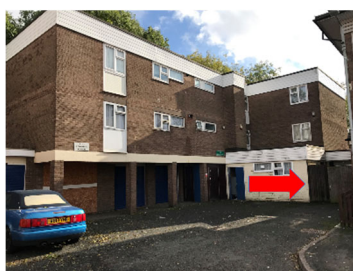
- 6) Ground floor flats have access to an external rear yard area acting as another means of escape from their flat, block 8-12 has its rear yard area gated (photo shown below) whereas block 14-18 has a timber fence present (photo shown below)

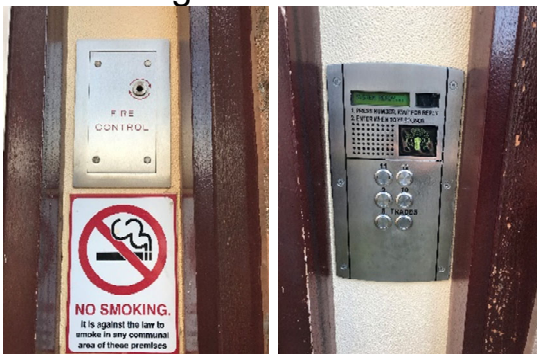
- 4) The means of escape are protected to prevent the spread of fire and smoke by the means of notional fire doors and fire rated walls from flats.
- 5) All communal doors are fitted with automatic closing devices that are checked on a regular basis by Caretaking Teams as part of their checks. Defective closing devices are replaced either by the Caretaking Team(s) or the in-house repairs team(s).
- 6) The final exit doors have door entry systems installed. These systems are designed to fail safe i.e. door unlocked in the event of a power failure. This prevents residents being locked in or out of the building.

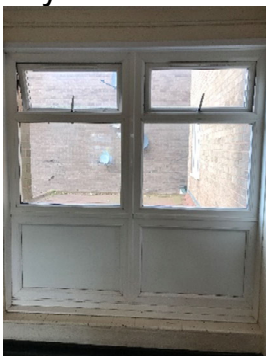
- 8) Automatic smoke ventilation is not employed within the blocks, communal windows can be opened manually without the use of a key.

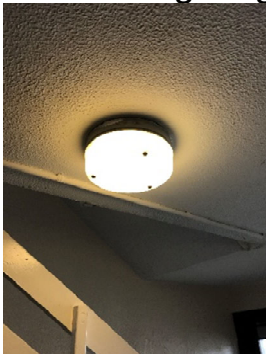
- 11) Emergency lighting is not provided, communal landings have standard lighting present within the blocks.

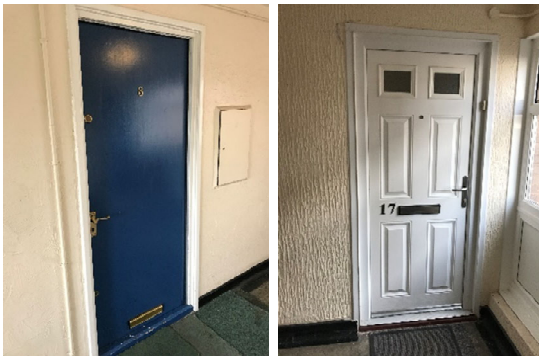
- 15) The surface coatings to the communal areas are Class 0 rated.
- 16) The building is a low risk premise and has sufficient passive controls that provide effective compartmentation in order to support a Stay Put-Unless Policy via notional timber doors to flats and compartment walls. Therefore, residents are advised to remain in their flat unless the fire directly affects them.
- 17) Individual flat doors are a mixture of notional timber and composite doors with associated frames.

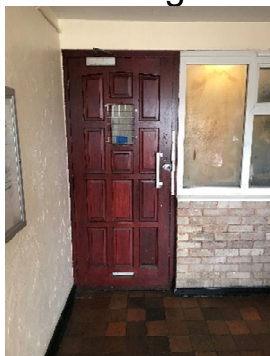
- 3) All communal doors are fitted with automatic closing devices that are checked on a regular basis by Caretaking Teams as part of their checks. Defective closing devices are replaced either by the Caretaking Team(s) or the in-house repairs team(s).
