Fire Risk Assessment

New Hope Road.

Smethwick

Date Completed: 15 March 2024

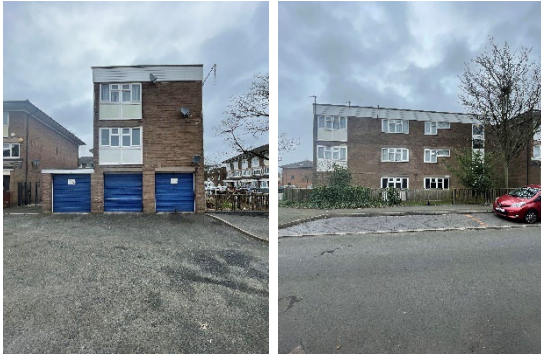
The low-rise block was built in 1969.
The block consists of 3 storeys (inclusive of the ground floor)
Each of the floors contains 1 number dwelling.

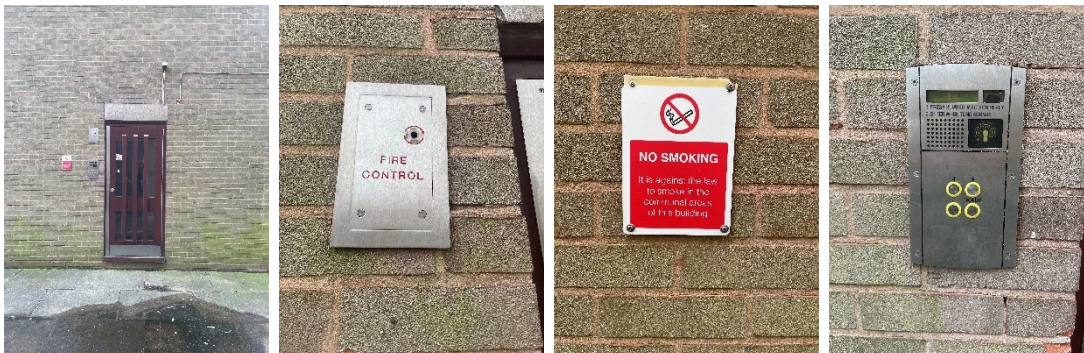
The block has a main entrance to the side elevation. The side entrance has a door entry system with a fob reader installed.

Each main entrance has a door entry system with a firefighter override switch.

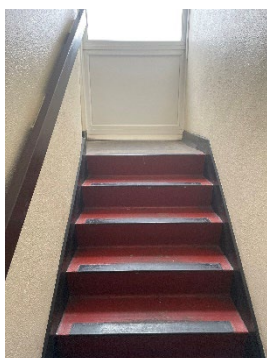
There is a single stairwell to each block, with a flat entrance door on each landing.

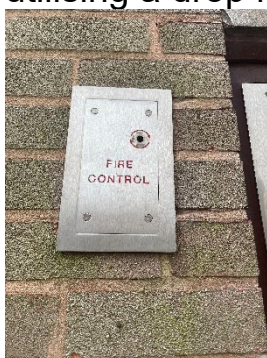
Access to each block is gained via the Firefighter override switch utilising a drop latch key.

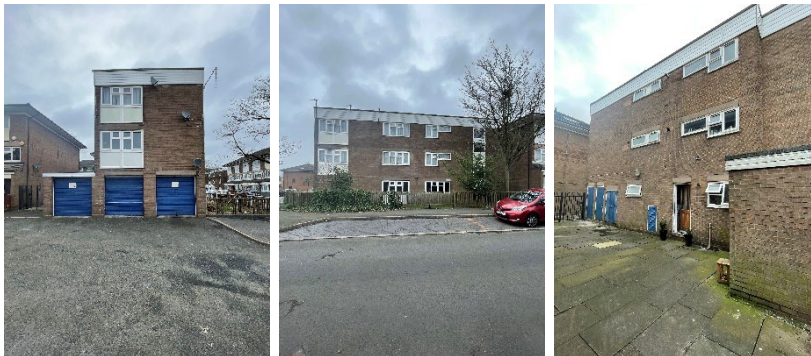
- 1) The exterior of the buildings is predominantly traditional brick construction.

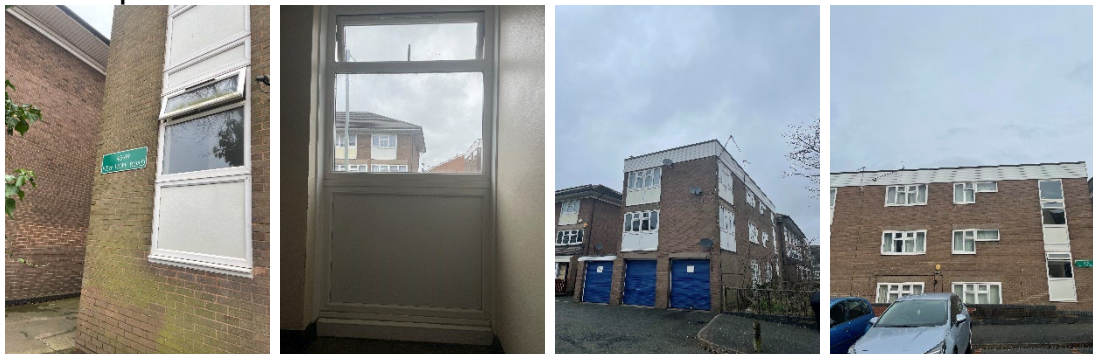
- 2) Individual communal windows to the stairs are UPVC double glazed units with UPVC panels. Flats have UPVC windows and UPVC panels.

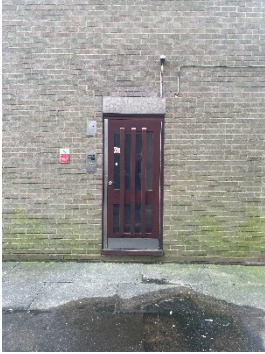
3) Front entrance doors are timber.

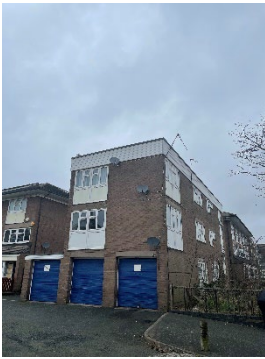
4) The block has a flat roof.

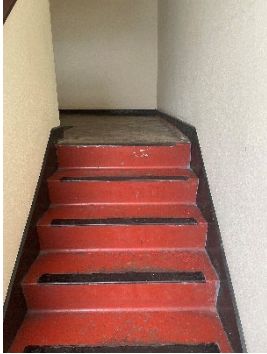
- 1) Each of the blocks has a single staircase, the width is 900 mm.

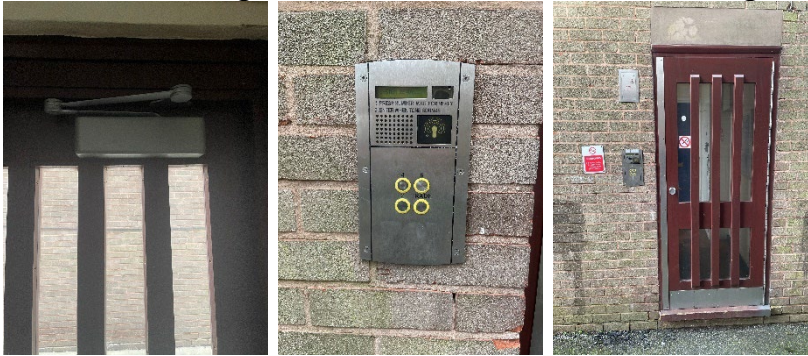
- 4) The final exit door is fitted with an automatic closing device and door entry system. This entry system is designed to fail safe i.e., door unlocked in the event of a power failure. This prevents residents being locked in or out of the building.

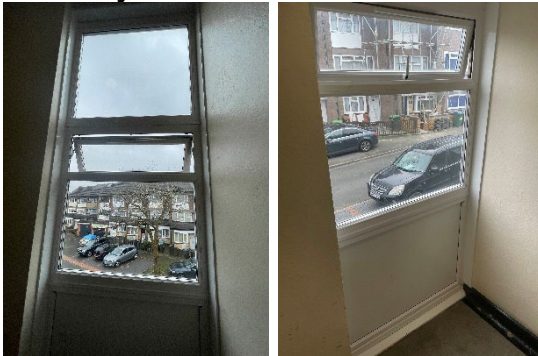
- 5) Automatic smoke ventilation is not employed.
- 6) Communal windows to the landings are openable without the use of a key.

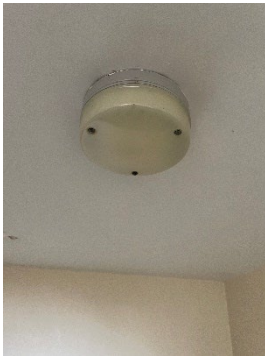
- 8) Conventional lighting is provided to the communal landings and stairs.

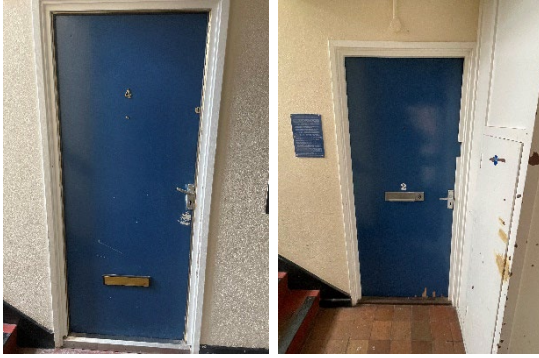
- 10) The surface coatings to the communal areas are class 0 rated.
- 11) The building has sufficient passive controls that provide effective compartmentation in order to support a Stay Put-Unless Policy. Therefore, residents are advised to remain in their flat unless the fire directly affects them or if they are advised to evacuate by the emergency services.
- 12) Individual Flat doors are predominately Notional FD30s rated doors. No access was gained during the Fire risk assessment to inspect the internal side of the door or residents smoke detection.
-

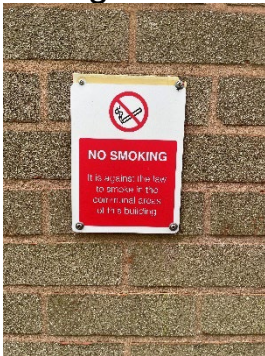
- 1) Fire Action Notices are not displayed throughout the building. The signs are not necessary due to the building not having a complex layout.
- 2) Smoking is prohibited within any communal parts of the building in line with Smoke Free England Legislation. Signs are displayed throughout the building.

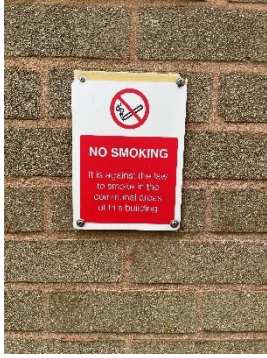
- 1) Smoking is prohibited within any communal parts of the building in line with Smoke Free England legislation.

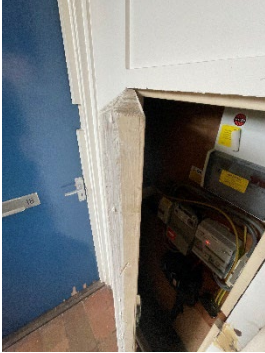
- 5) The electrical installation i.e., risers are contained within dedicated service cupboards and are located in the entrance lobby.

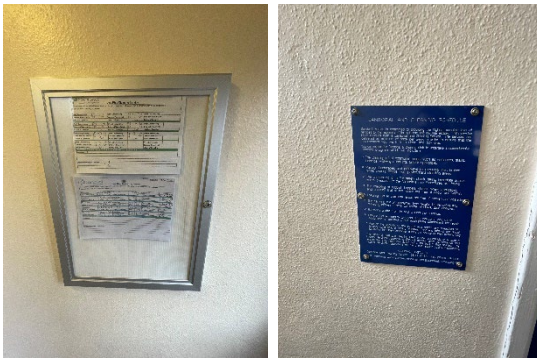
- 1) There is a regular cleaning service to the premises.
- 2) Regular checks by Caretakers minimise risk of waste accumulation.

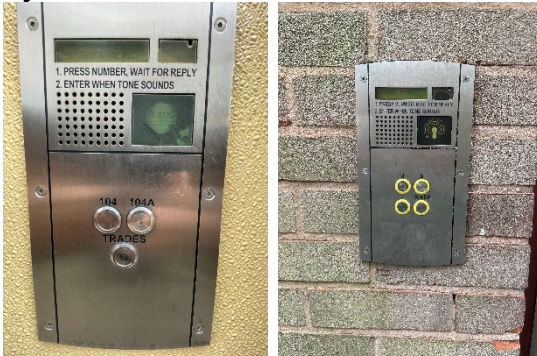
- 1) Restricted access to the premises by means of a door entry system.

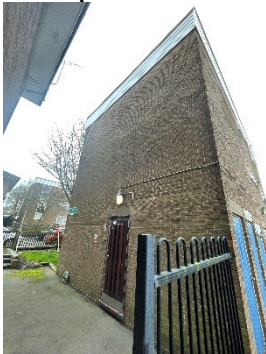
- 2) There is no current evidence of arson.
- 3) The perimeter of the premises is well illuminated.
