# Fire Risk Assessment

## Hewitson Gardens

**Flats 1 -26 Hewitson Gardens,  
Gladys Road,  
Bearwood,  
Smethwick,  
B67 5AR.**

**Date Completed: 15/04/2024.**

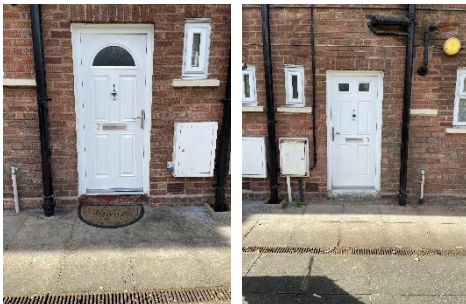
At the time of the assessment front doors to most flats appeared to be in good condition. It was noted that three premise front doors were UPVC. It is believed that these are leaseholder occupied.

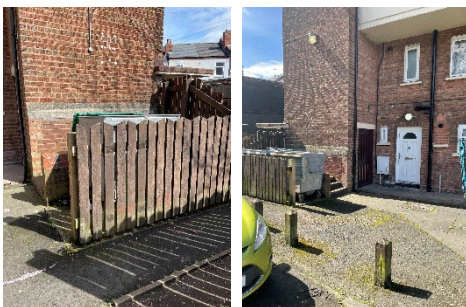
There are refuse areas provided at the rear of the premise in three areas; these are located at each staircase and centrally at the rear of the staircase.

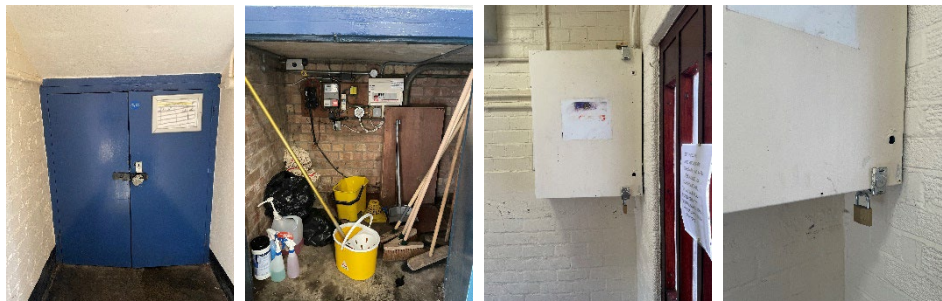
An electrical service cupboard/cleaner's cupboard and other service cupboards are located on the ground floor under/in the staircase(s). These are adjacent to Flat 1 & Flat 13.

P2	Glazing. 1-3 Months.	
07/03	Repair service cupboard doors in staircase, adjacent to Flat 1. Ensure that doors fully lock into position.

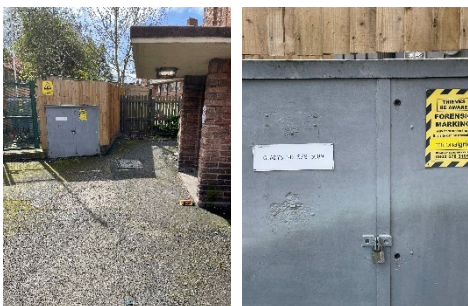
- 6) Observations were made of electrical boxes outside individual flats; some were noted as suffering from oxidation & will require replacements as part of any upgrades. Others needed to have work carried out to ensure they remained safe.
-

Faults noted with electrical boxes are: -

- Rusting in flats 3, 7 & 26.
- Replace door on Flat 6, 17 & 18.
- Flat 20 has a cracked door (Leaseholder).

Question/ Ref No	Required Action	Supporting photograph	Priority	Timescale and Person Responsible	Date Completed
06/06	Repair or replace defective electrical boxes to individual flats.

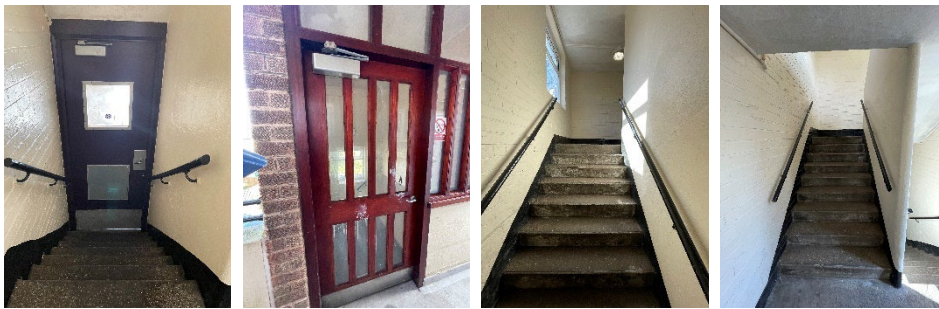
- 2) The central rear staircase only is protected by use of FD30 fire doors with vision panels. Intumescent vents were in this staircase. It was noted that a glazing panel had some damage which has resulted in a hole.

P2	Housing Management Team. 1-3 Months.	
07/02	Replace defective glazing in Means of Escape door to central staircase.
