Fire Risk Assessment

Priory Close 5-9, 10-15

**Priory Close, Smethwick,
B66 3SL**

Date Completed: 22/03/2024.

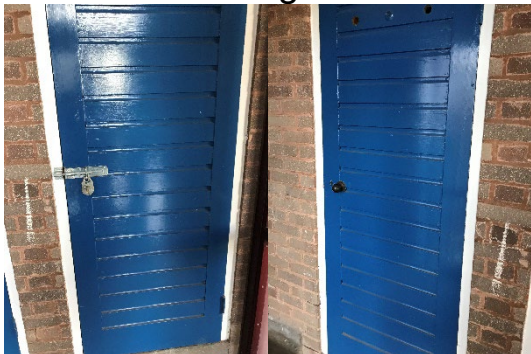
Residents have access to storage cupboards within the communal areas of the block on the ground floor as well as garages.

- 6) Residents have access to Storage cupboards that are located within the communal areas of the block and are not of a fire rated construction recommendation for the storage cupboards to be upgraded to fire rated doors with future improvement works to the blocks.

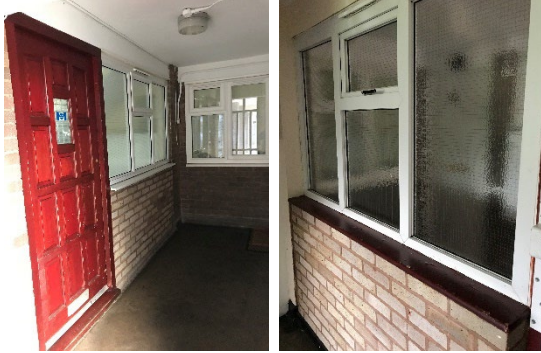
The ground floor flat is separated from the rest of the building by a timber door and frame with glazing within the same partition wall.

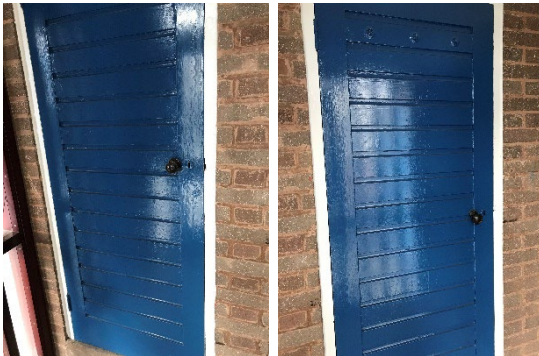
- 1) The site has a single staircase that provides a means of escape approx.1040mm.
- 2) All corridors are of adequate width (at least 1050mm) and will be maintained clear to that width as a minimum.
- 3) Resident communal cupboard doors within the staircase should be upgraded to certified FD30s fire rated doors with refurbishment works to the block.

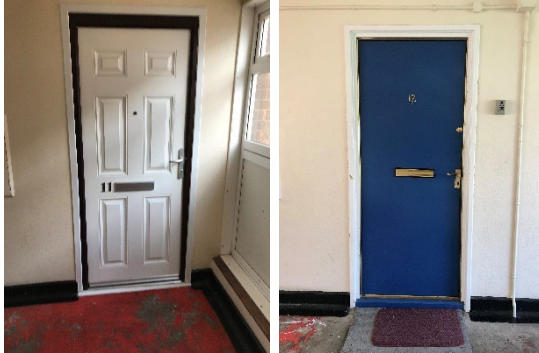
17) Individual flat doors are a mixture of nominal timber and composite doors with associated frames.

18) Access is gained to a sample of properties as part of the fire risk assessment to ensure the doors have not been tampered with by residents etc. During the FRA no access was gained to sample flat entrance doors despite best endeavours however it is believed that some doors within the blocks are non-fire rated door sets (Flat 6).

P2	1-3 months Fire Rapid Response	
10/11	Flat 6 appears to be a non fire rated door (UPVC) identification required / replace if needed

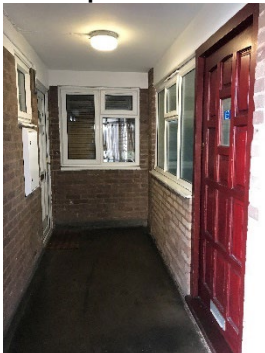
- 1) The building is designed to provide as a minimum 1-hour vertical fire resistance and 30 minute horizontal fire resistance around flats. All doors are 30-minute nominal fire doors, including those in 1-hour rated walls.
- 2) Due to the partition wall on the ground floor lacking a fire door and fire-resistant glazing and the window from the ground floor flat not having fire resistant glazing the premise lacks sufficient compartmentation to limit the travel and effect of smoke and flame in event of a fire (see section 7/7). Whilst other areas of the block do have existing fire stopping that is fit for purpose, there is a cyclical programme to ensure fire stopping has not been compromised by third parties and where applicable enhance the fire stopping.

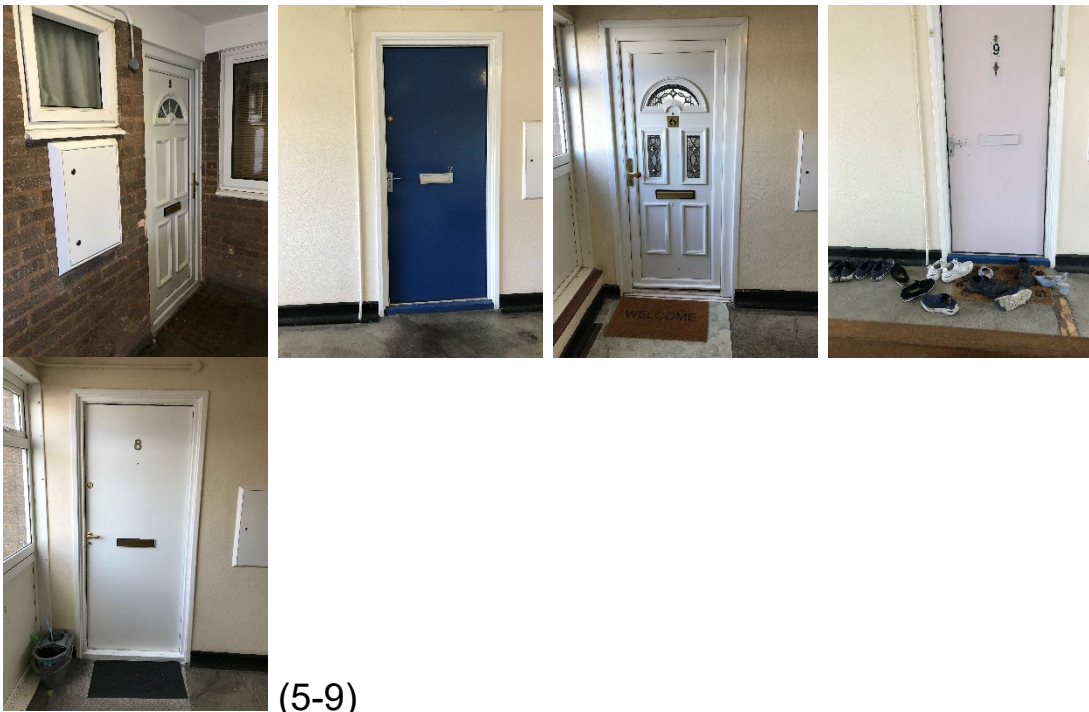
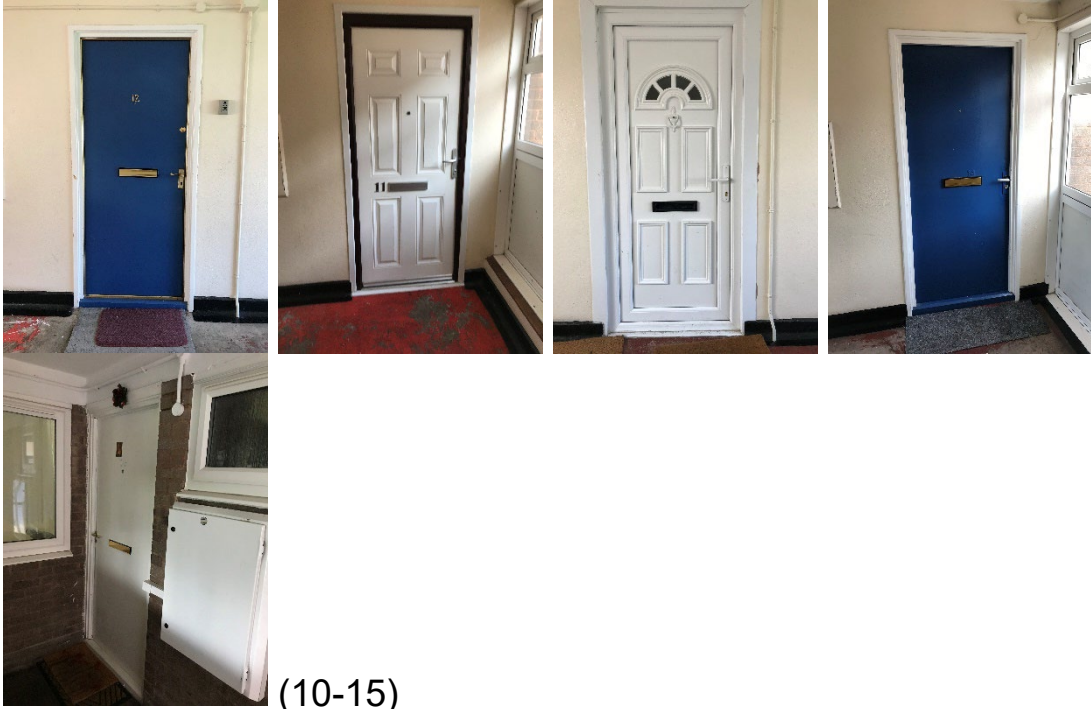
7) Individual flat doors are nominal composite and timber fire door construction within both blocks.

It is accepted that, in older blocks, fire doors, particularly flat entrance doors, do not meet current test standards for FD30S doors. However, these doors may still be acceptable if the doors remain in good condition, and they met the relevant standards at the time of construction of the block.

8) Missing number and letterplate to flat 15 entrance door

P2	1-3 months Housing Manager	
10/08	Replace missing number & letter plate from flat 15
