Fire Risk Assessment

Pitcairn House

**Maisonettes 1 - 8 Pitcairn House,
Norman Road,
Smethwick,
B67 5ND.**

Date Completed: 18/04/2024.

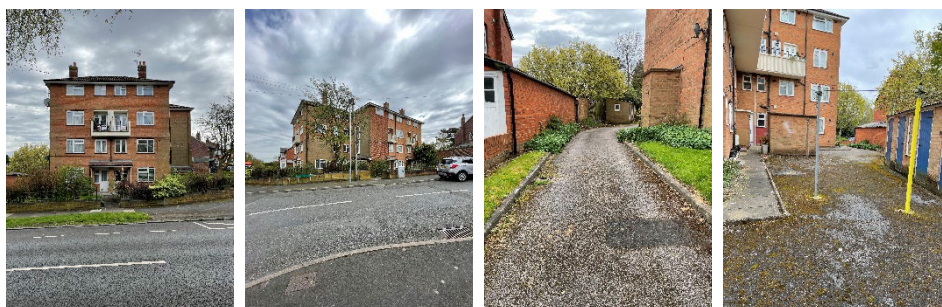
The block is of traditional Brick, concrete construction, double glazed UPVC window frames surmounted by a pitched roof. It is understood that access is gained to roof voids via individual maisonettes. Therefore, roof voids were not checked at the time of the assessment.

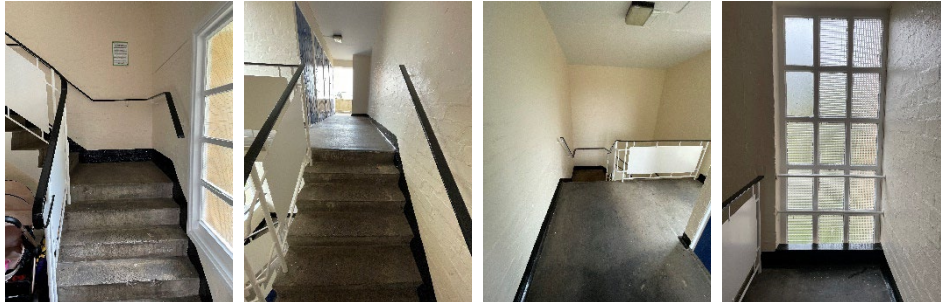
The block has one internal staircase accessed from the front and/or rear entrance. Ground floor maisonettes have no direct access to the internal staircase.

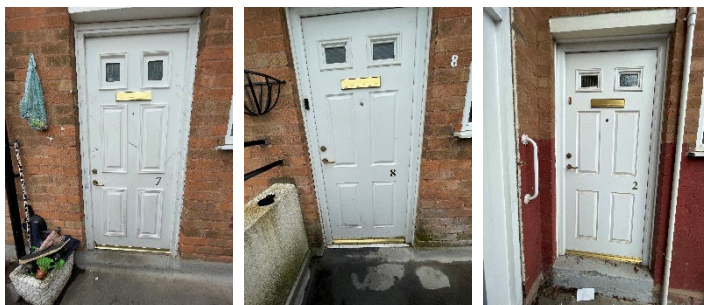
At the time of the assessment, it appeared that front doors to most maisonettes were in good condition.

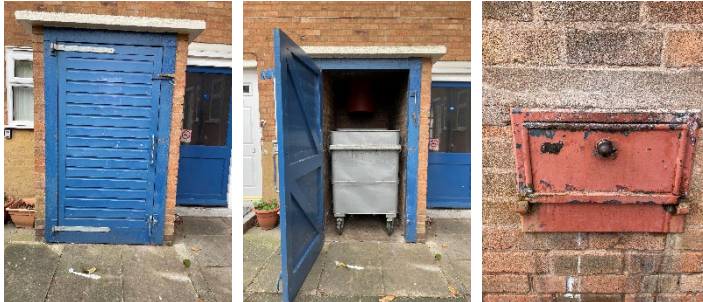
The bin room is located on the ground floor at the rear of the premise, there is an internal chute located on the second floor for disposal of rubbish.

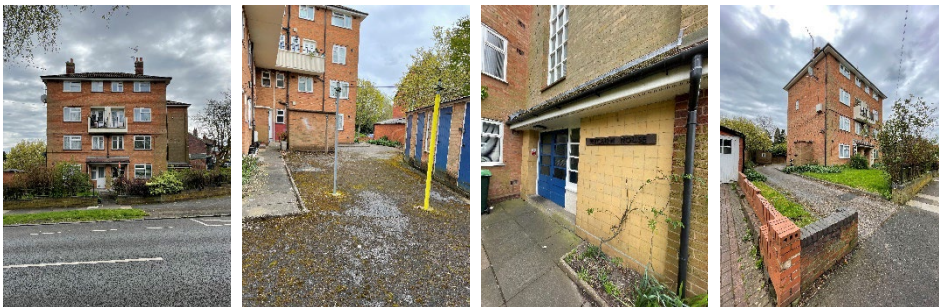
- 1) The external envelope of the premise is predominantly traditional brick, concrete, UPVC window frames in individual maisonettes and timber frames in the staircase area, surmounted by a pitched tiled roof.

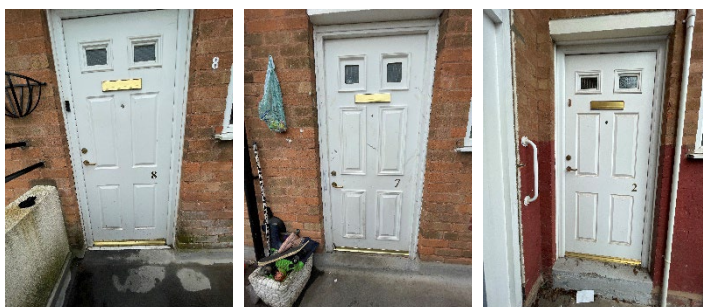
- 1) The building is designed to provide as a minimum 1-hour vertical fire resistance and 1-hour horizontal fire resistance around maisonettes. All flat entrance doors are 30-minute notional/nominal doors, including those in 1-hour rated walls.
- 2) At second floor level decked corridors & walkways are open air construction and therefore products of combustion, fire & smoke will ventilate naturally from the premise.
- 3) The means of escape is protected from maisonettes with the use of nominal FD30s doors with no communal doors to the blocks other than final exit doors.

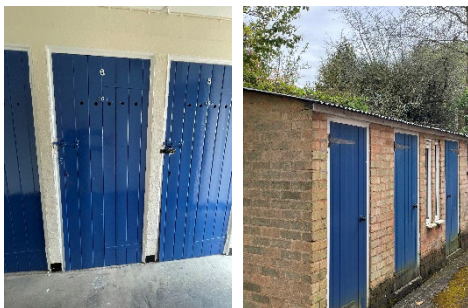
- 1) Residents instructed not to bring L.P.G cylinders into block. This information is contained within the tenants' handbook.
- 2) The tenancy conditions, Section 7 – Condition 5.6 stipulates “If you live in a flat or maisonette, you, people living with you and any visitors to your property must not keep or use paraffin oil, petrol, bottled gas appliances or any other explosive, FLAMMABLE or dangerous material in the property. This restriction also applies to any storage facility situated in or attached to the block, which has been provided for your use.”
- 3) No Flammable liquids stored on site by Caretakers / Cleaners.
- 4) Storage facilities are provided for residents in the staircase of the premise & external cupboards for ground floor residents. It was not that store cupboard doors inside the staircase need to be upgraded as part of any future refurbishment plans.
