Fire Risk Assessment

Sampson Close 1-6, 7-12, 13-18, 19-24

Sampson close, Tividale, B69 1NL

Date Completed: 05/09/2023

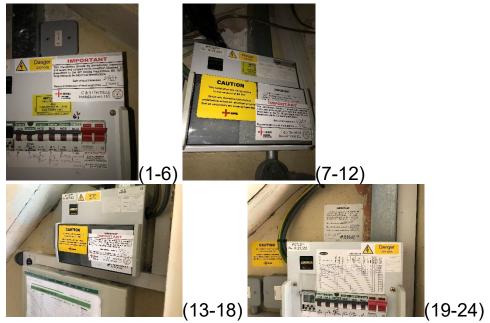
- 1) Smoking is prohibited within any communal parts of the building in line with Smoke Free England legislation.
- 2) Hot working is not normally carried out. If essential maintenance requires the use of hot work processes, then corporate policies and procedures are to be followed.
- 3) Portable electrical equipment used as part of the Caretaking / Cleaning regime is subject to annual PAT Testing. This information is held by the Estate Services Manager Bryan Low.
- 4) The fixed electrical installation shall be tested every 5 years. At the time of the assessment all electrical installation test were in date

- 5) The electrical installation i.e. risers are contained within dedicated service cupboards that are secure and protected.
- 6) Portable heaters are not allowed in any common parts of the premises.
