Fire Risk Assessment

Manifoldia Grange

**Coyne Road, West Bromwich,
B70 7JU**

Date Completed: 13th June 2024

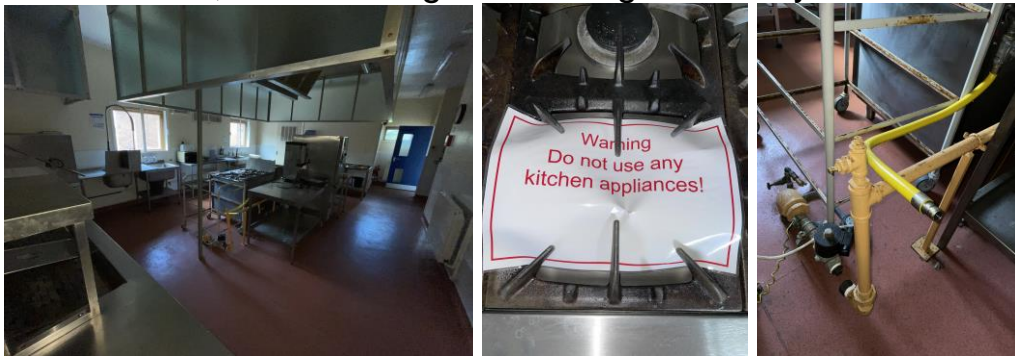
All kitchen appliances have been disconnected from the mains with only a microwave, kettle & fridge remaining for use by on site staff.

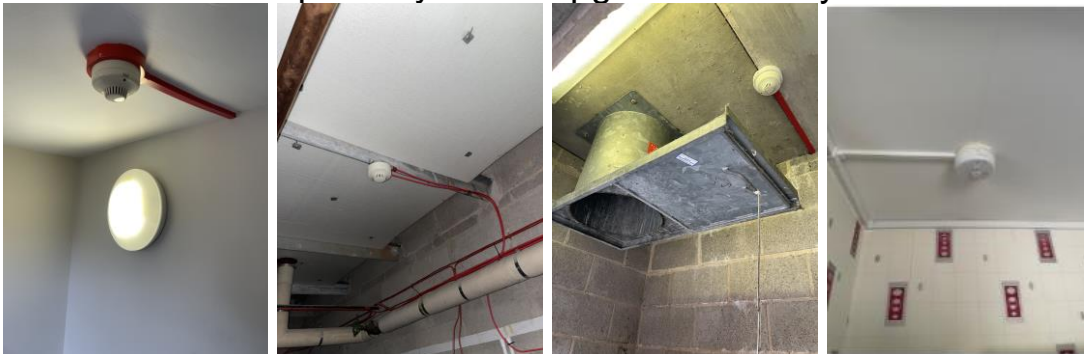
- 5) Hard wired smoke and heat detectors are located on each floor to include communal corridors (including voids above), offices, individual flats, bin room, kitchen, and boiler house (including roof void above). This is not extended to the roof voids above the communal toilets or above those individual flats with loft hatches (12,14, 15, 16,17, 18, 19, 20, 21, 33, 34, 35, 36, 37, 38, 39, 40, 41) however, consideration to extend detection to these voids should be considered as part any future upgrade to the system.

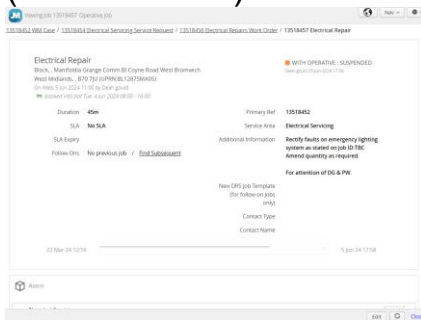
- 3) All installed equipment is checked and tested on a monthly basis by Sandwell MBC in house electrical team or approved contractor, in accordance with current standards. An order has been raised to rectify faults to installed equipment following a recent monthly test (JM13518457).

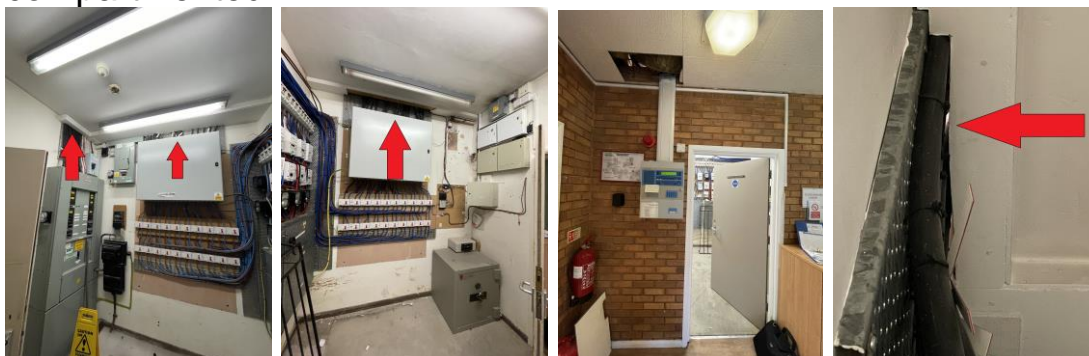
- 1) The building is designed to provide as a minimum 1-hour vertical fire resistance and 30 minutes horizontal fire resistance.
- 2) **Fire stopping is required to cable penetrations in the service cupboard within the central building. This is where the cables pass through the ceiling in three separate areas of the cupboard.** Light could be seen from a torch shone from the roof void over the entrance foyer. The roof void above is not compartmented.

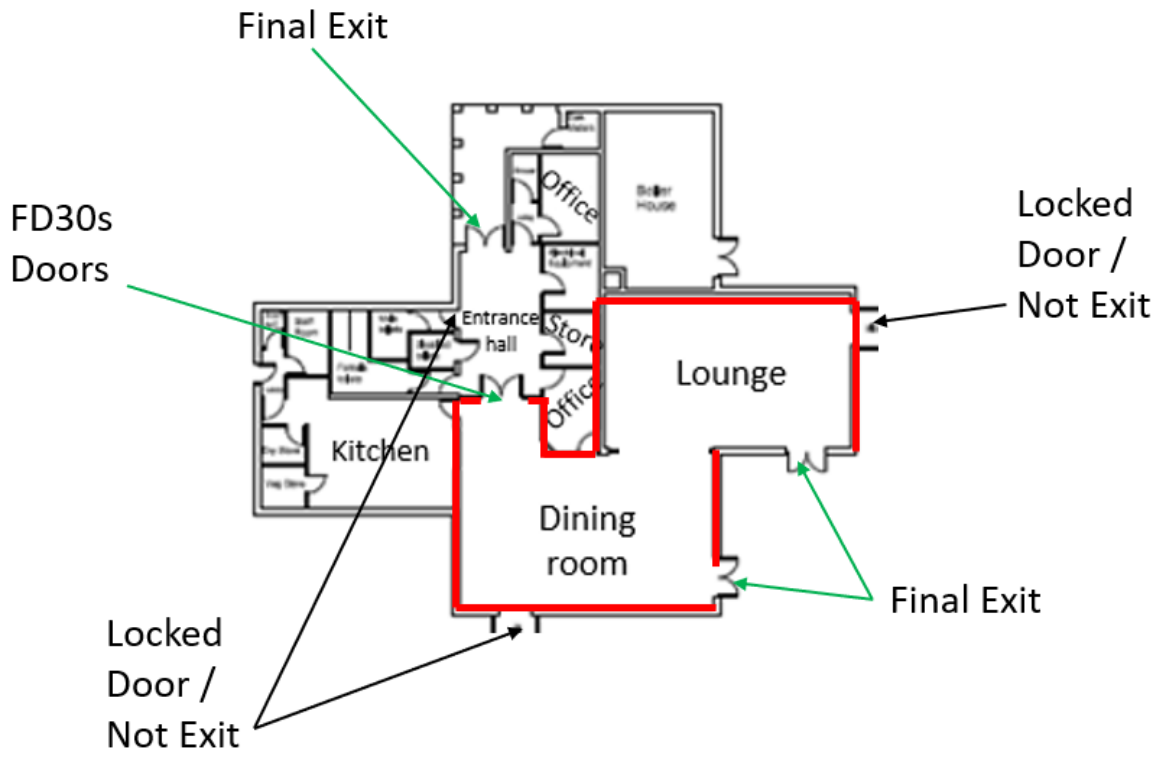
The dimensions of the combined former lounge & dining room are approximately 163m². The floor space factor for this type of room (common / meeting room) would recommend a safe area of 1m² per person, however the space occupied by the furnishings must be taken into consideration.

After discounting one of the larger final exits doors and taking into account the presence of furniture and floorspace factor, it is recommended that the maximum occupancy level for this meeting room (former lounge & dining room) is **128 persons**.

Based on floor space factors, travel distances and exit capacity in conjunction with an L1 automatic fire detection system, it is deemed that the total evacuation of this non-residential part of building can be achieved within 2.5 minutes which is acceptable for a normal risk building.

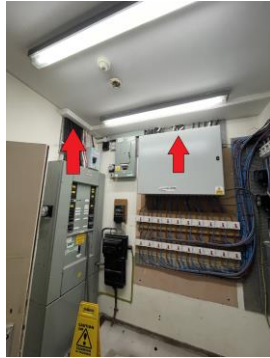
Question/ Ref No	Required Action	Supporting photograph	Risk Rating	Timescale and Person Responsible	Date Completed
10/2	Apply suitable firestopping material such as intumescent coated sponge to the ceiling cable penetrations in the switch room adjacent the main office.

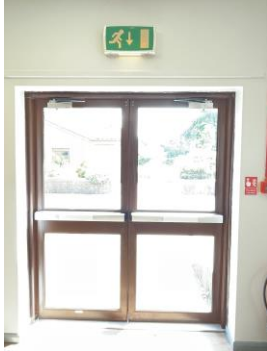
- 5) The two sets of exit doors in the former lounge / dining area with panic bars require Push Bar to Exit signage.

12/5	<p>Install push bar to exit adhesive signage on each final exit door in lounge / dining / meeting area. (4 x doors)</p> <p><i>Signage can be applied to upper glazed panels which are 680mm in width.</i></p>
