Fire Risk Assessment

**Flats 8 – 9B
Sedgley Road West,
Tipton,
DY4 8DB.**

Date Completed: 02/07/2024.

Officer: A Jones Fire Risk Assessor.

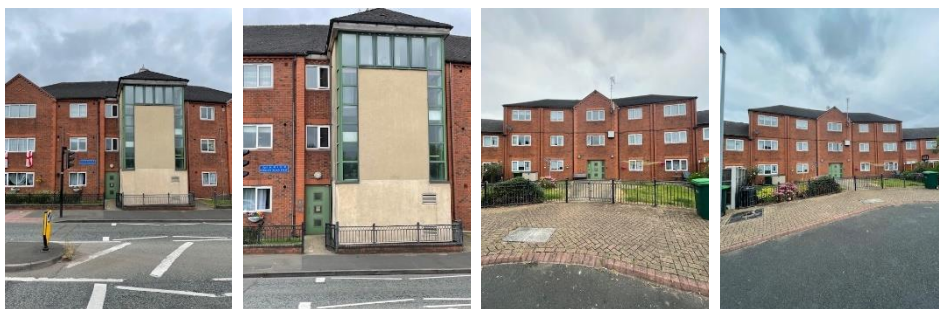
They are of traditional brick, concrete construction, double glazed UPVC window frames surmounted by a pitched roof.

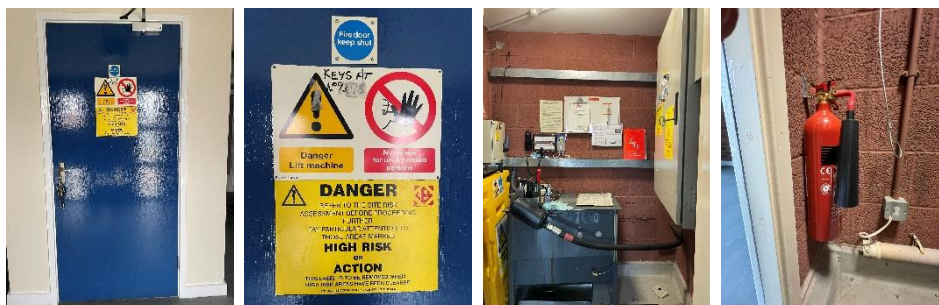
There is a lift that serves all floors of the building. The lift motor room is located in the ground floor communal area.

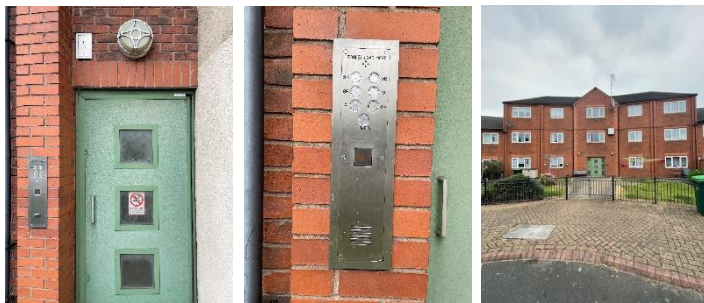
The block has two entrances; a main entrance to the front elevation and a further exit located on the rear elevation. Both front and rear entrances have door entry system with a fob reader installed to prevent unauthorised access.

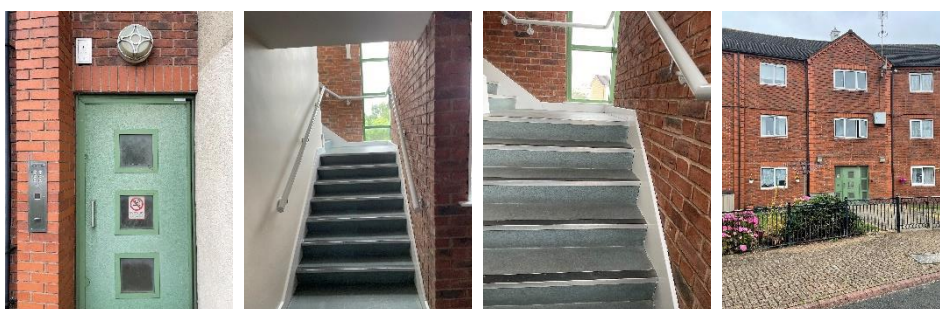
The building has a single staircase that serves dwellings on the first & second floors. Access can be gained from the front or rear elevation access door(s). The rear door can be accessed by residents through a side gate. This door is secured and controlled by an electronic fob.

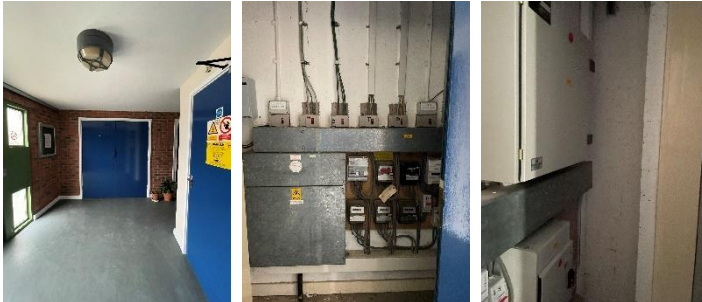
There are ground floor electrical cupboards that contains electrical equipment for the building. All service cupboard doors were in good condition at the time of the assessment.

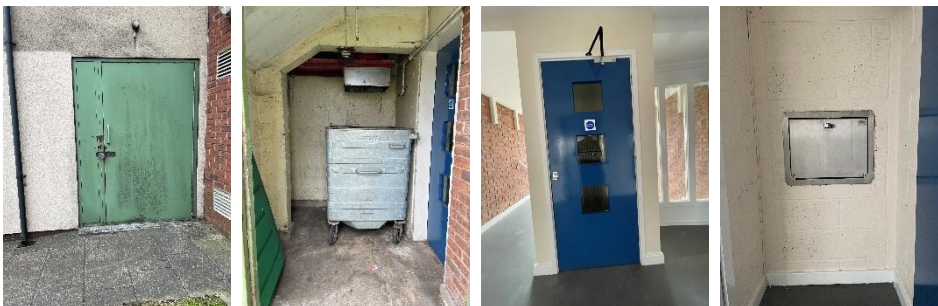
Residents utilise a refuse chute for the disposal of waste. The bin room can be accessed internally by residents on the ground floor and via a refuse chute on the first & second floors. The bin room is protected by detection and what appears to be a low-pressure water mist system.

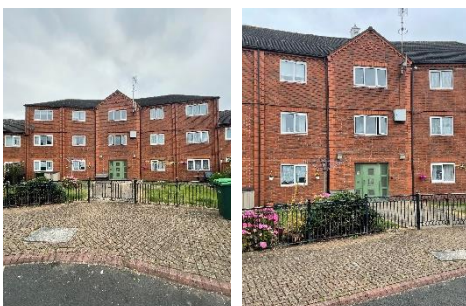
The rear garden is secured by a section of metal fencing with access gate.

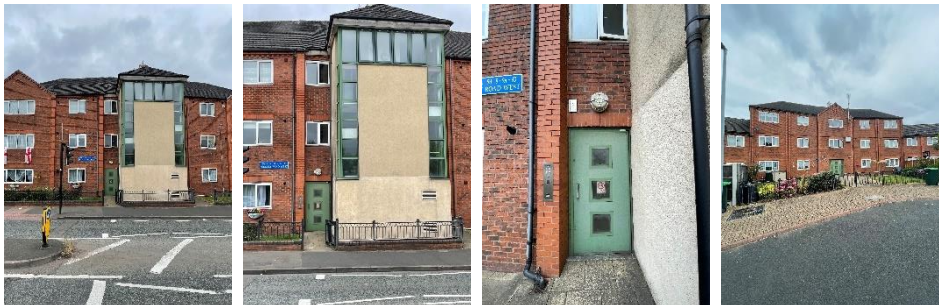
- 1) The external envelope of the premise is predominantly traditional brick, concrete construction, UPVC double glazed window frames surmounted by a pitched tiled roof.

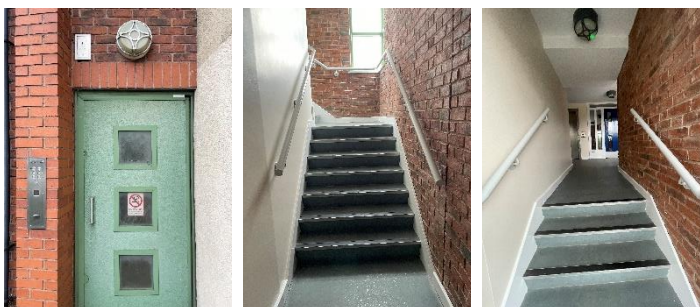
- 2) Access is gained to all flats from the ground floor using the main access door leading to the staircase area.

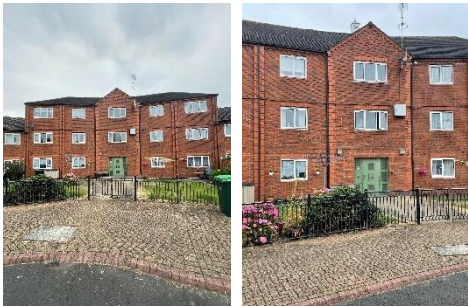
- 4) The small rear garden is protected by metal fencing.

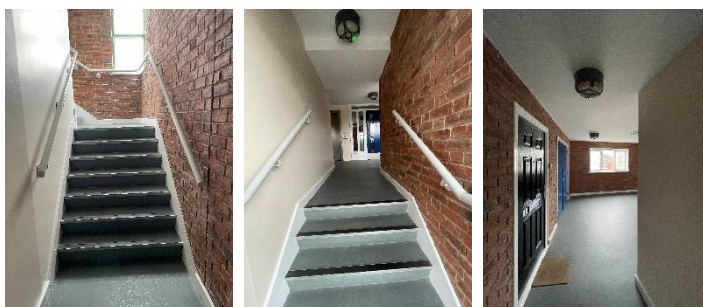
- 1) The building has a single staircase that provides the means of escape. All staircases are of adequate width (at least 1100mm) and should be maintained clear to that width as a minimum.

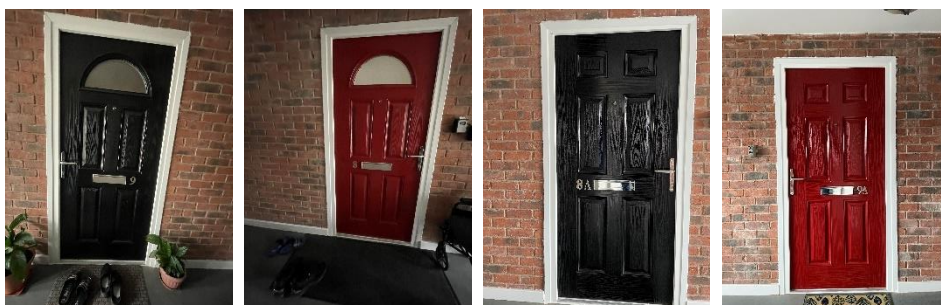
- 9) The means of escape are protected to prevent the spread of fire and smoke with a combination of nominal FD30s doors, mainly composite front entrance doors.

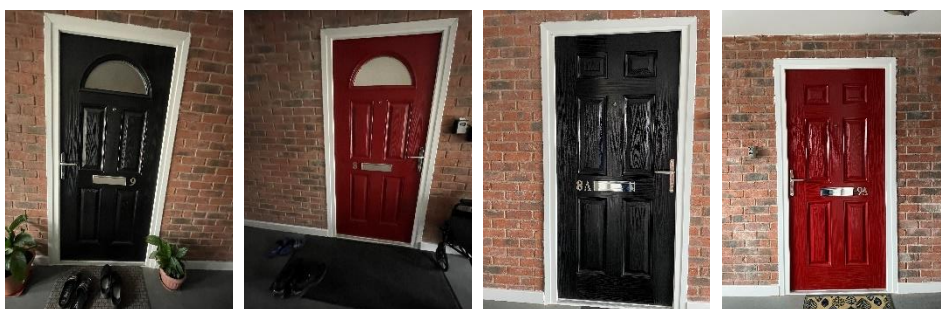
- 1) The building is designed to provide as a minimum 1-hour vertical fire resistance and 1-hour horizontal fire resistance around flats. All flat entrance doors are 30-minute notional/nominal doors, including those in 1-hour rated walls.
- 2) Generally, the means of escape is protected from flats with the use of nominal rated composite doors.

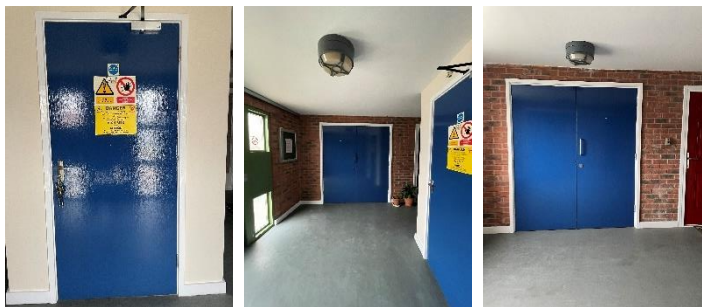
- 4) The premises have sufficient compartmentation to limit the travel and effect of smoke and flame in event of a fire in communal areas due to the design of the building.
- 5) The fire stopping / compartmentation of the premises is subject to an annual inspection by the Fire Safety Rapid Response Team.
- 6) The building has sufficient passive controls that provide effective compartmentation to support a Stay Put -Unless policy. Therefore, residents are advised to remain in their flat unless the fire directly affects them or if they are advised to evacuate by the emergency services.
- 7) There are service cupboard doors in means of escape corridors, these appeared to be in good condition and functioned correctly.

- 8) However, it was noted that some maintenance is required to re-align service cupboard doors on the second floor due to excess gaps greater than 4mm.
- 9) Residents utilise a refuse chute for the disposal of waste. The bin room, associated doors, and subsequent disposal chutes at upper floor levels are in good condition.
