Fire Risk Assessment

**Flats 1- 6, 7 – 12, 13 - 18 & 19 - 24
Hickman Road,
Tipton,
DY4 9QB.**

Date Completed: 25/07/2024.

Officer: A Jones Fire Risk Assessor

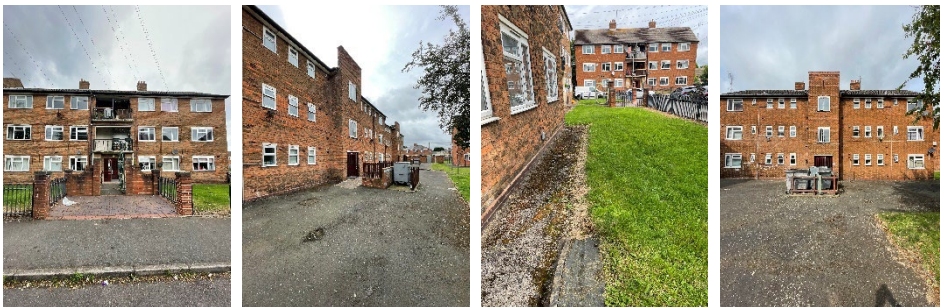
- 1) The external envelope of the premises is predominantly traditional brick, concrete construction, surmounted by a pitched tiled roof.

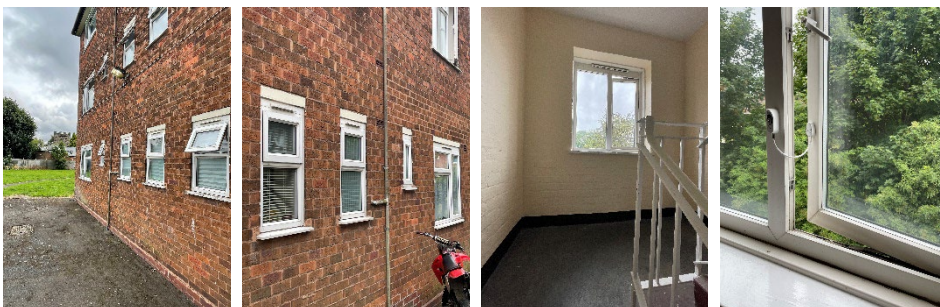
- 2) Individual flat windows are UPVC double glazed window frames. The windows in the communal areas are UPVC double glazed window frames.

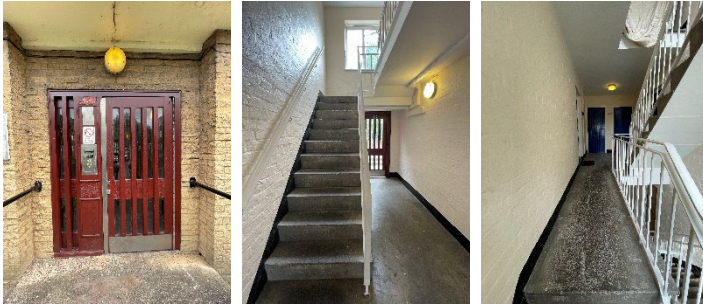
- 3) Access is gained to all flats from the ground floor using the main access door(s) leading to the staircase area, these doors are Timber.

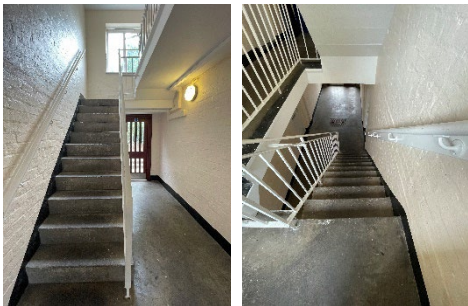
- 1) The building has a single staircase that provides the means of escape. All staircases are of adequate width (at least 880mm) and must be maintained clear to that width as a minimum.

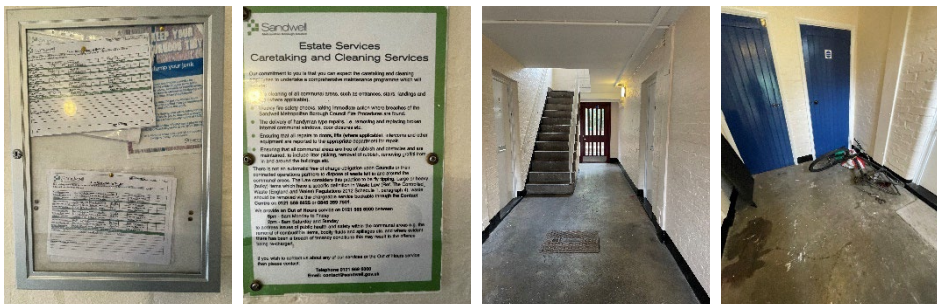
- 2) The final exit doors have door entry systems installed. These systems are designed to fail safe i.e., door unlocked in the event of a power failure. This prevents residents being locked in or out of the building.
- 3) Communal areas should be kept free of flammable items. The communal areas should be checked on a regular basis by Caretaking / Cleaning teams and all items of rubbish removed.

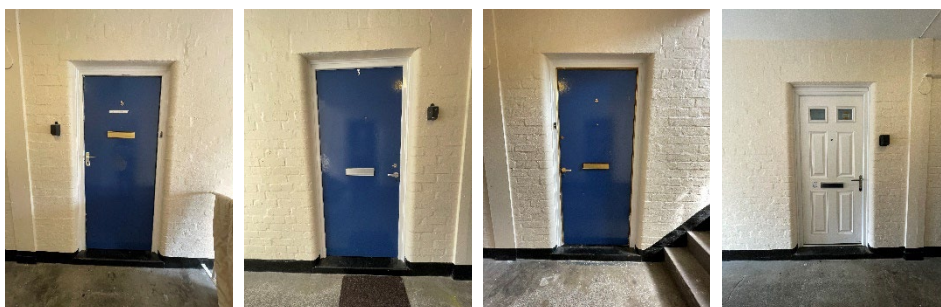
- 7) Surface coatings to the walls in the communal areas appear to be Class 0 rated.
- 8) The building has sufficient passive controls that provide effective compartmentation in order to support a Stay Put Policy Therefore residents are advised to remain in their flat unless the fire directly affects them.
- 9) The means of escape are protected to prevent the spread of fire and smoke with a combination of nominal timber and composite type entrance doors.

As part of any future upgrades or door replacement programme replace timber flat entrance doors for FD30s.
