# Fire Risk Assessment

**Flats 42 – 48  
Hackwood Road,  
Wednesbury,  
WS10 0DG.**

**Date Completed: 07/08/2024.**

**Officer: A Jones Fire Risk Assessor**

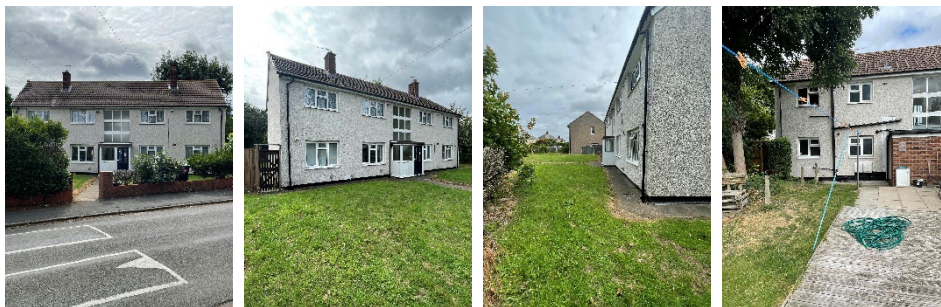
The building are of traditional brick, concrete construction, double glazed UPVC window frames surmounted by a pitched, tiled roof.

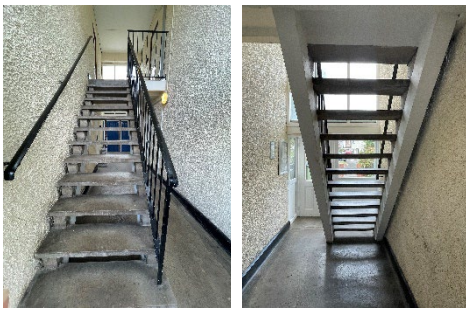
The building has a single staircase & small communal area that serves dwellings on all floors.

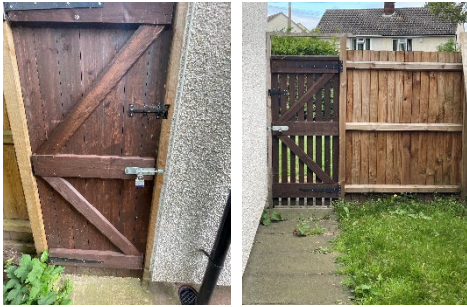
The rear garden is secured by fencing; there are access gates at each side of the building. These gates are padlocked at all times.

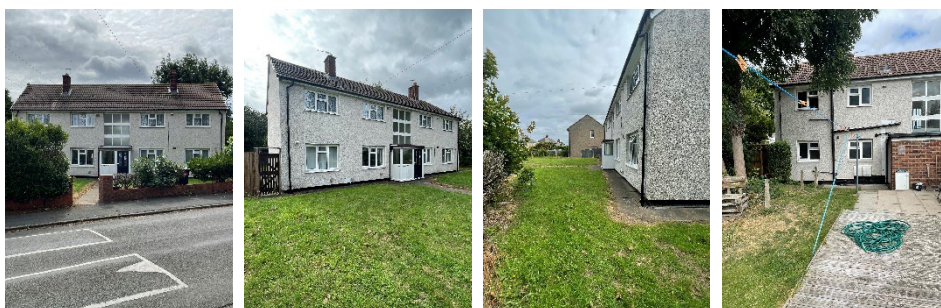
- 1) The external envelope of the premises is predominantly traditional brick, concrete construction, surmounted by a pitched tiled roof.

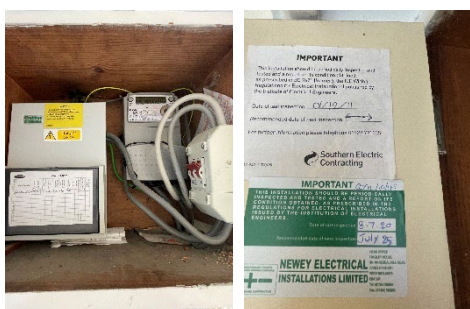
- 1) Smoking is prohibited within any communal parts of the building in line with Smoke Free England legislation.
- 2) Hot working is not normally conducted. If essential maintenance requires the use of hot work processes, then corporate policies and procedures are to be followed.
- 3) The fixed electrical installation should be tested every 5 years. At the time of the assessment, it was confirmed that the last electrical installation conditioning report (EICR) was carried out on 8<sup>th</sup> July 2020. The date of the next scheduled EICR inspection is July 2025.
