# Fire Risk Assessment

## Stonehouse Crescent

**Flats 9-15,25-31,26-32  
Stonehouse Crescent,  
Wednesbury,  
WS10 0DG.**

**Date Completed: 09/08/2024.**

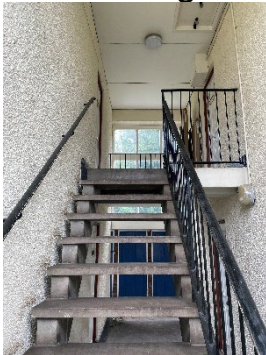
The building has a single staircase that serves dwellings on all floors.

The rear garden is secured by fencing; there are access gates at each side of the building. The gardens are overgrown, and it is recommended that they are cleared as the vegetation obstructs egress from the rear doors of the staircase.

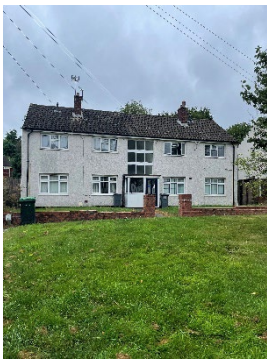
- 1) The external envelope of the premises is predominantly traditional brick construction with an insulated rendered finish.

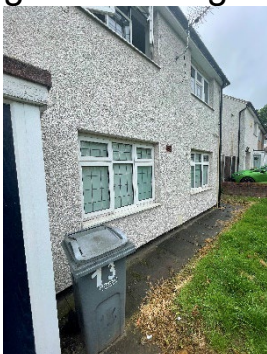
- 2) Individual flat windows are UPVC double glazed window frames. The windows in the communal areas are timber framed windows, single glazed Georgian wired glass.

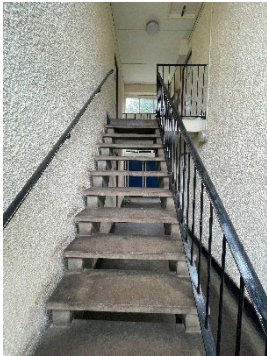
- 1) The building has a single staircase that provides the means of escape. The staircase is of adequate width (at least 950mm) and must be maintained clear to that width as a minimum.

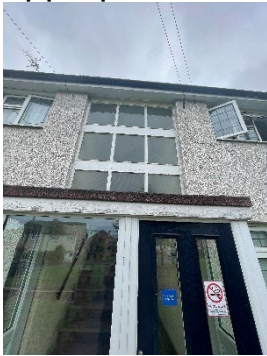
- 1) Communal fire doors display “Fire Door Keep Shut” where appropriate.

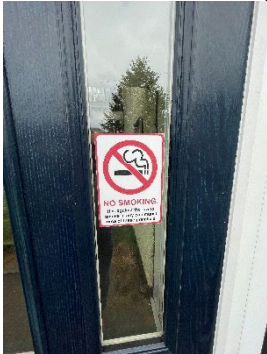
- 2) The fire escape routes are self-evident and therefore additional fire action notices are not required.
- 3) No smoking (Smoke Free England) signage is displayed at the front entrance to the premises.
