Fire Risk Assessment

Coronation Road

82-90, 94-102, 106-114

**Coronation Rd, Wednesbury,
WS10 0TJ**

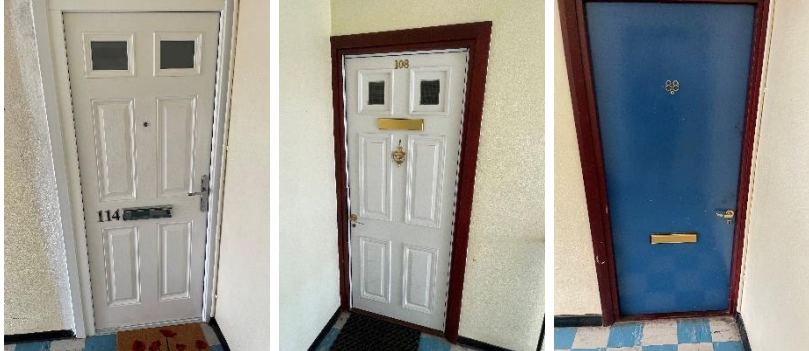
11) Individual flat doors are predominantly composite FD30s door sets manufactured by either Nationwide or Permadoor. The remaining two properties have nominal timber FD30s door sets.

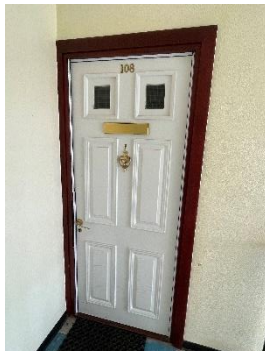
a) Flat 108 – door was correct.

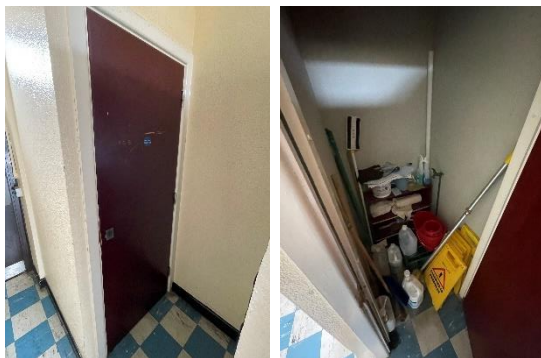
- 6) There are no service cupboards located in the block only a cleaner's cupboard in block 94-102. The door to this cupboard is an upgraded notional FD30s with intumescent strips and cold smoke seal.
-

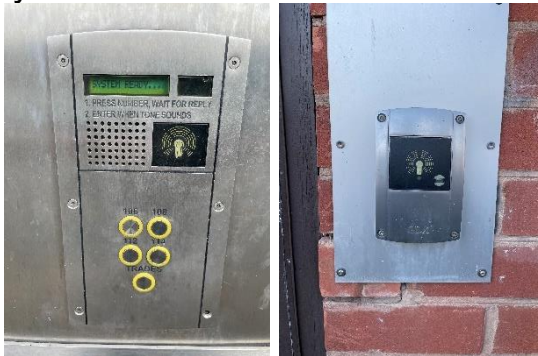
- 1) Regular checks are undertaken by Caretakers / Cleaning Team(s) 365 days per year which helps reduce the risk of arson.
- 2) Restricted access to the premises by means of a door entry system.

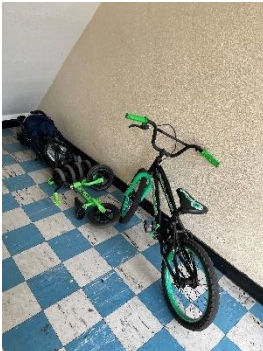
A photograph showing a green bicycle and a black pushchair parked in a narrow hallway. The floor is blue and white checkered tile.	P2	Within 1-3 Months Housing Manager
