# Fire Risk Assessment

## Trouse Lane

**26-48 Trowse Lane, Wednesbury,  
WS10 7HS**

**Date Completed: 30/08/2024.**

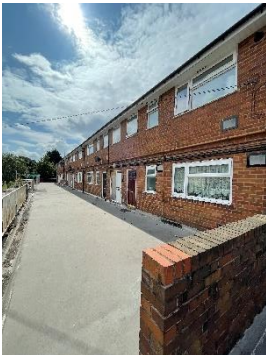
- 1) The external walls of the building are a brick masonry.

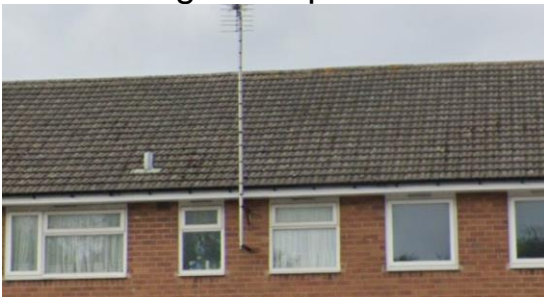
- 2) The building has a pitched and concrete tiled roof.

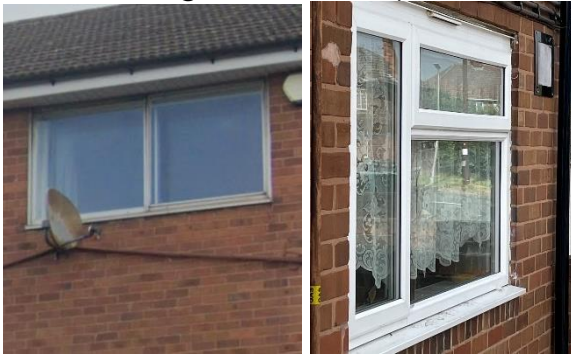
- 3) Flat windows are predominantly UPVC glazed units with some to flat 40 being aluminium (leaseholders flat).

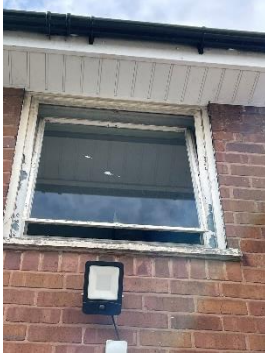
- 4) Communal windows are predominantly UPVC glazed units except the one to flats 38 & 40 communal lobby being aluminium.

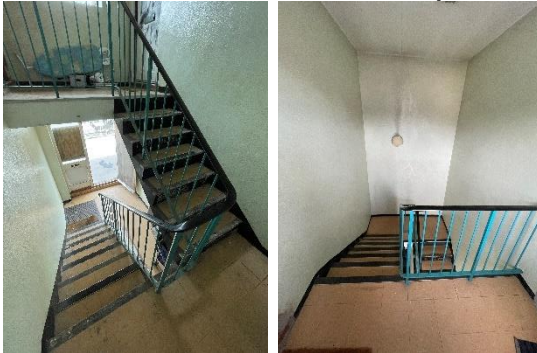
- 1) The building has 3 x stairwells to the second floor flats that provide a sufficient means of escape measuring 8000mm in width.

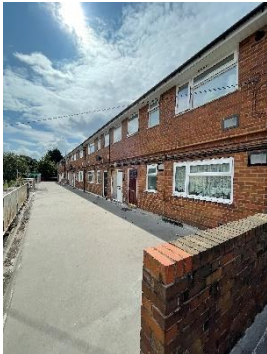
- 2) The deck access to 1<sup>st</sup> and second floor flats is of adequate width at 4.640m.

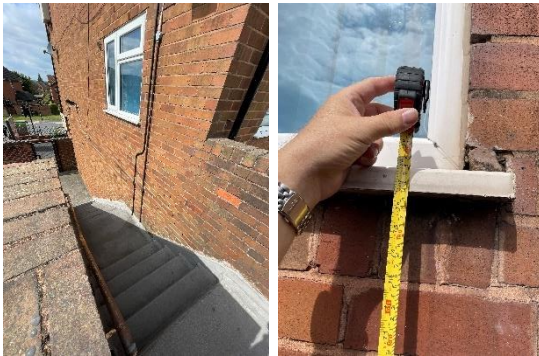
- 4) Flat windows above the external stairs do not require fire resistant glazing because they are at a distance greater than 1800mm from the stairs.

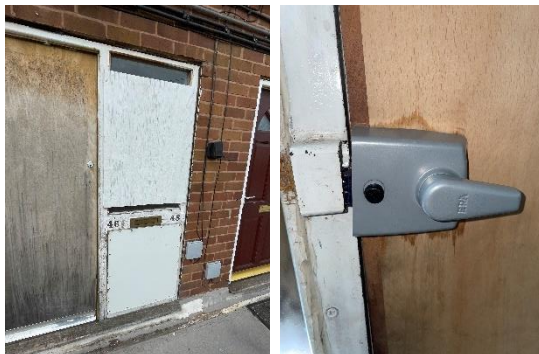
- 5) There are no dead end situations within the means of escape.
- 6) The means of escape are protected with 1-hour compartment walls and floors and fire rated doors to flat entrances (doors to flats 38 & 46 covered below). However, due to the open plan design if there was a fire in the communal area, fire and smoke could travel between floors within the communal area.
- 7) There are no communal doors within the blocks other than the final exit doors to the three stairwells. These three doors are kept locked by residents.
- 8) The final exit stairwell door for flats 46 & 48 has a thumb turn lock.

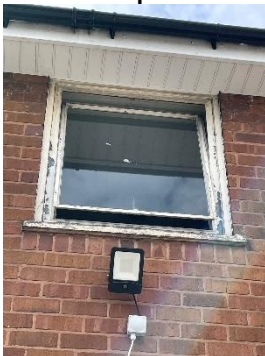
- 11) Natural ventilation is available within the communal areas via the use of openable windows.

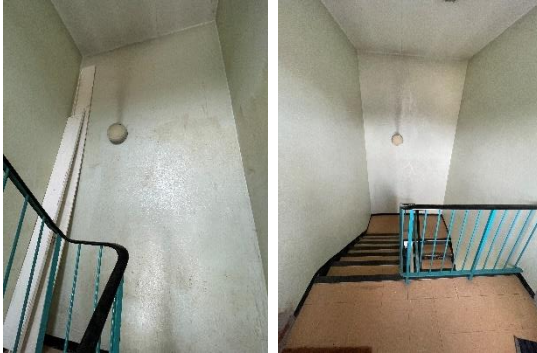
16) Conventional lighting is installed within the communal areas.

- 1) The premises should benefit from an emergency / escape lighting system. This has been noted within section 19 as an observation.
- 2) Conventional units are provided to the communal stairs.

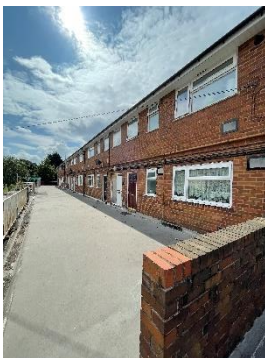
19) Individual flat doors to the first floor are a combination of composite, timber and what appears to be UPVC doors. The doors open onto a deck access that is 4.6m wide with open stairs at each end. Therefore, there is no requirement for these to be fire resistant doors.

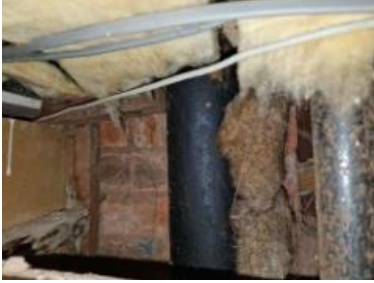
- 6) The separation between flats and shops is by concrete floor. The soil stack penetrations were inspected to confirm that appropriate firestopping is in place. The findings were satisfactory and are documented in the previous FRA (2022).

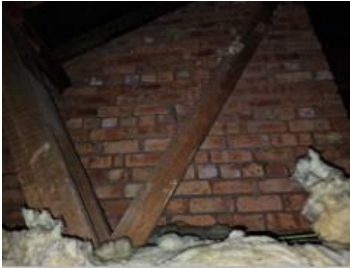
- 7) Compartment walls extend to the underside of the roof within the roof voids.

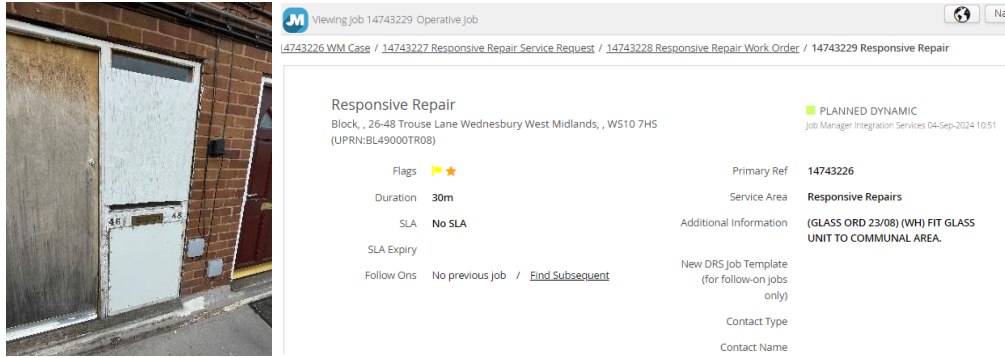
- 9) Block 46-48 stairwell final exit door combination frame has damaged glazing which has been boarded with timber. Replacement glass has been ordered JM14743229.

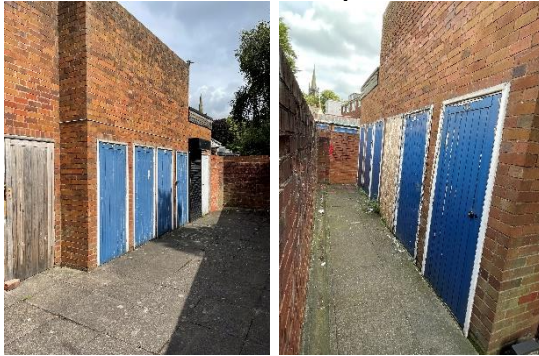
11) Resident's storage sheds are accessed externally at ground floor side elevations and secured with locked timber ledge and braced doors. There is no requirement for these doors to be fire rated.

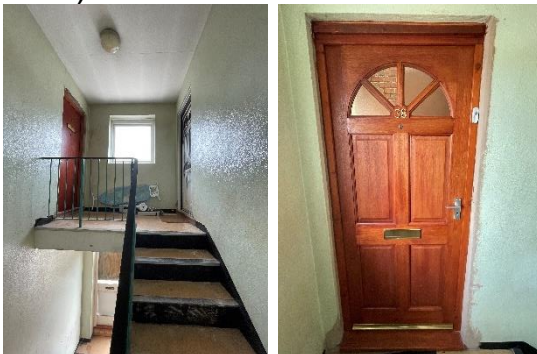
- b) Flat 38 – The door is a non-fire rated timber door with standard glazed panels and requires replacement with an FD30s fire door set. Door has been installed with a self-closer and intumescent strips.** *Approximate dimensions - door leaf 840mm x 1968mm and aperture (brickwork to brickwork) 910mm x 2133*

12) Individual flat doors to the second floor open into a protected stair and therefore are nominal FD30s timber or composite doors except for flat 38 which is a standard non-fire door (refer to section 7/20).

7/20a	Flat 44 – Adjust self-closer door not reliably closing fully.	 	P2	Within 1-3 months Fire Rapid Response	
7/20b	Flat 38 entrance door – Remove non fire door and install FD30s. <i>Approximate dimensions - door leaf 840mm x 1968mm and aperture (brickwork to brickwork) 910mm x 2133</i>	 	P2	Within 1-3 months Repairs

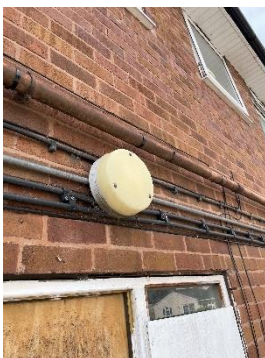
- 5) Portables heaters are not allowed in any common parts of the premises.
- 6) Gas appliances and pipework (where installed) are subject to annual testing and certification. This cyclical contract is managed by the in-house Gas Team. Mains gas pipework is external to the rear elevation.

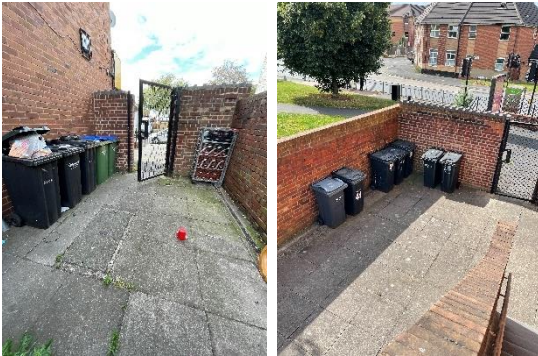
- 1) Refuse containers for block are emptied regularly and stored at ground floor level away from any windows or ventilation inlets / outlets.

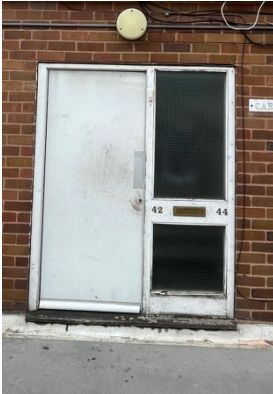
- 1) Restricted access to the 2<sup>nd</sup> floor stairwells by means of a secured door.

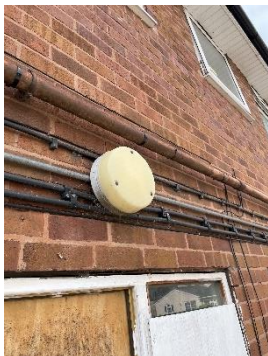
- 2) There are no CCTV provisions at the block.
- 3) The perimeter of the premises is well illuminated with borrowed lighting from streetlights.
- 4) An external light has been installed above the stairwell entrance doors.
