Fire Risk Assessment

Farley Street

**97 – 128, Farley Street
Tipton,
DY4 7LA.**

Date Completed: 19/09/2024.

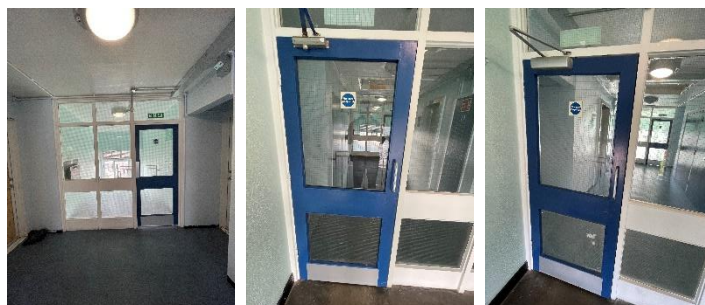
- 2) All corridors are of adequate width (at least 1050mm) and will be maintained clear to that width as a minimum.
- 3) None of the corridors that form part of the means of escape are dead ends.
- 4) The means of escape are protected to prevent the spread of fire and smoke.
- 5) The communal landing / staircases are protected by use of notional & nominal self-closing 44mm 30-minute timber fire doors with vision panels. All doors have been upgraded with intumescent strips / cold smoke seals.

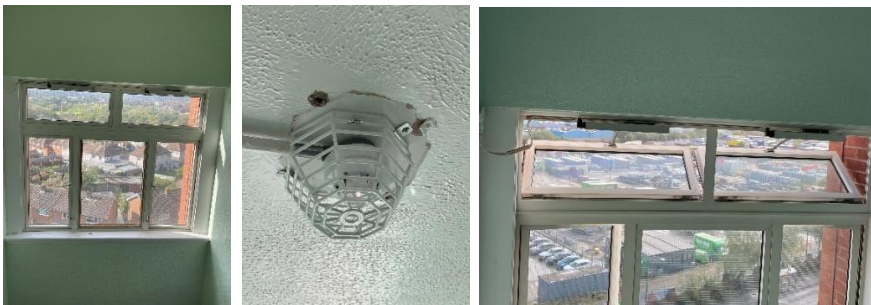
- 9) Automatic smoke ventilation is employed to the head of the rear staircase. This is tested, inspected, and maintained by a competent procured contractor in accordance with BS7346. The frequency for the maintenance checks are twice per year (April and October) of each calendar year.

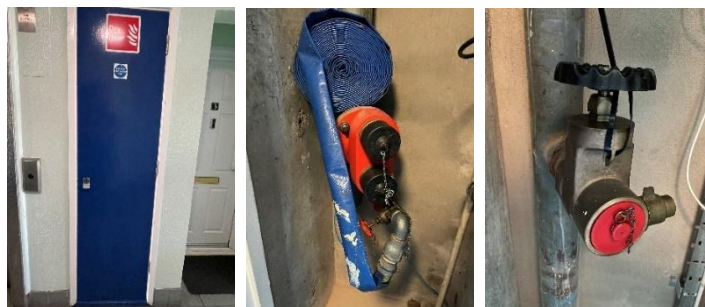
- 16) Dry riser inlet / outlets on lobbies are housed in cupboards with FD30s doors and secured by suited 54 key mortice locks. All outlet valves are secured in the closed position by cable tie.

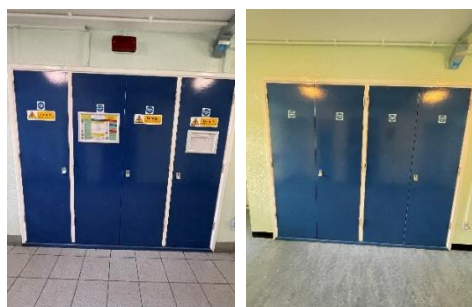
- 17) Service cupboards are 44mm nominal fire doors with intumescent strips and cold smoke seals, secured with type 138 suited mortice locks to allow residents access to their electricity meters.

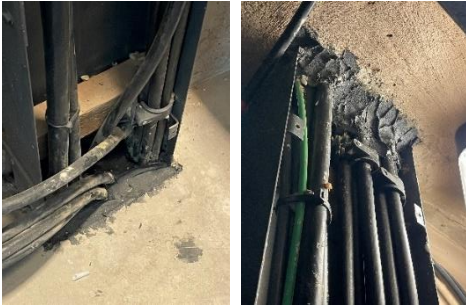
- 6) A variety of methods / materials have been used to achieve fire-stopping including Rockwool, fire rated sponge and intumescent pillows.

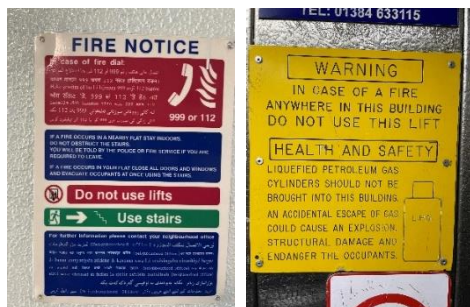
- 1) All Caretaking / Cleaning Employees have undertaken fire safety training. This includes use of bespoke 'Fire Safety in High / Low Rise Flatted Accommodation' Video.
- 2) All employees are encouraged to complete 'In the line of fire' training on an annual basis.
- 3) Caretaking Teams are not currently trained in the effective use of fire extinguishers. The only extinguishers located are within the lift motor room. Caretaking Teams are not expected to tackle fires in this area.
- 4) Staff undertaking fire risk assessments are qualified to or working towards Level 4 Diploma in Fire Safety.
- 5) Fire safety information has been provided as part of tenancy pack.
- 6) Building safety and evacuation notices are displayed in common areas and lift cars.

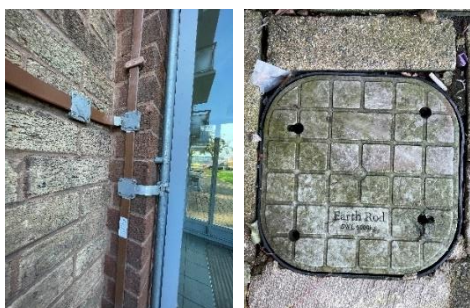
- 6) There is lightning protection installed to the block. Maintenance contracts are in place for lightning conductor testing in accordance with BS 6651.

- 7) The purpose of an external lightning protection system is to intercept, conduct and disperse a lightning strike safely to earth. Earth pads were noted in several locations at the base of the building.

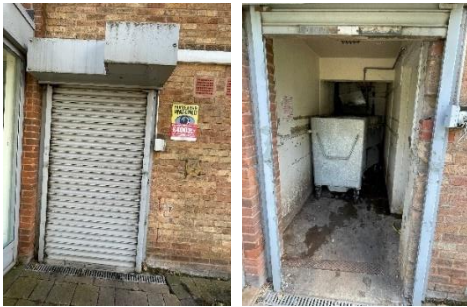
- 2) Refuse containers are located in the bin store which is to the right-hand side of the main entrance. Access is via a motorised roller shutter; key is stored in the firefighter's white box. All refuse containers are emptied regularly.
