Fire Risk Assessment

Nelson House

**1 – 34 Nelson House
Upper Church Lane,
Tipton,
DY4 9PW**

Date Completed: 01/10/2024.

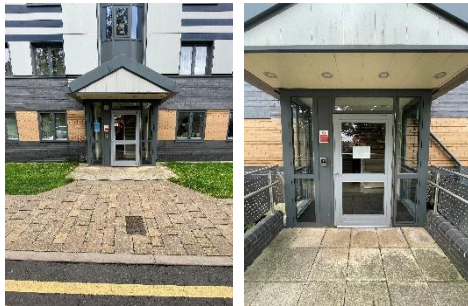
The block has a main entrance/exit to the front elevation and a further entrance/exit located on the rear elevation.

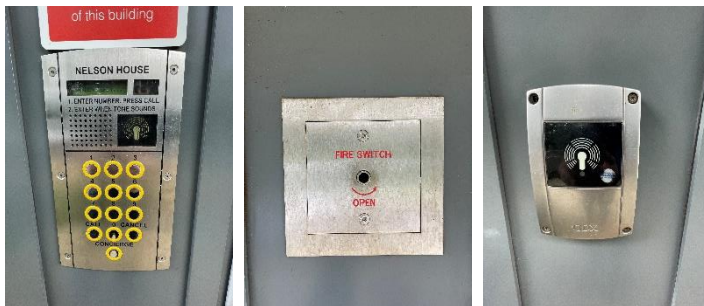
Both entrances have a door entry system with a fob reader installed. The front entrance only, has a firefighter door override switch by use of a drop latch key.

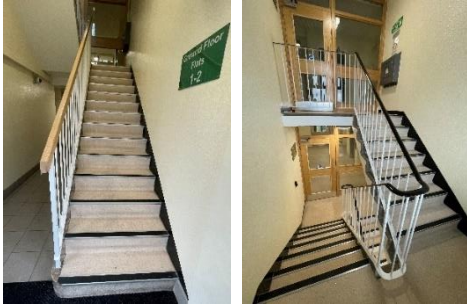
There are two protected staircases to the front and rear of the building that serve all floors, ground floor to the eighth floor.

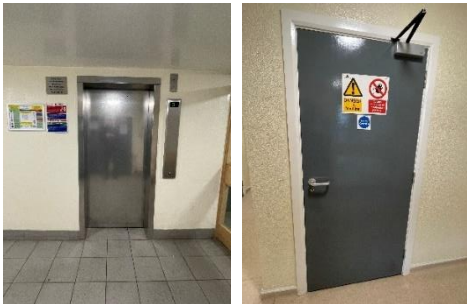
There is one lift car provided that serves ground floor to the seventh floor. The lift motor room is on the eighth floor.

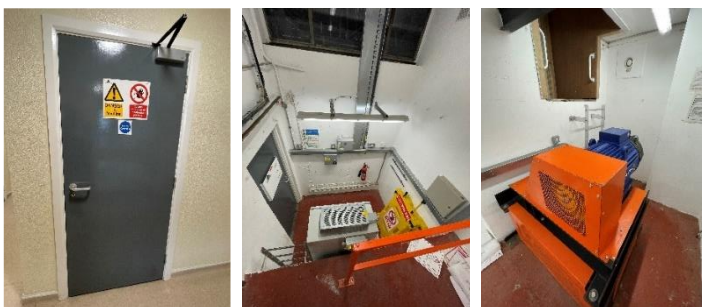
The lift motor room is located on the 8th floor and is secured behind an FD60s timber door (suited 54 key & mortice lock).

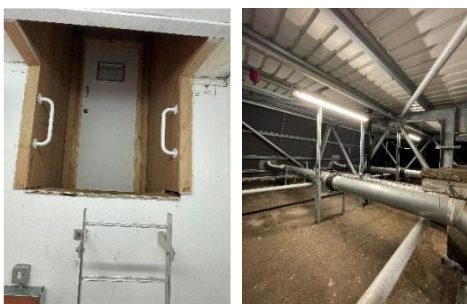
Within the lift motor room is a secured door which leads to the internal roof area (suited 54 key & mortice lock).

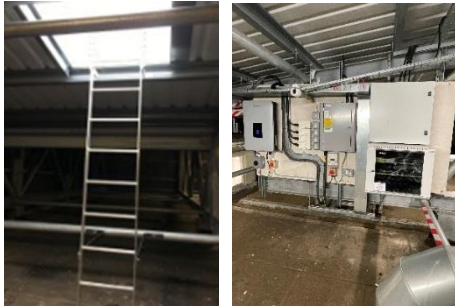
The internal roof area contains the electrical switch gear for the solar PV system and a vertical ladder which leads to the external roof via a sky light.

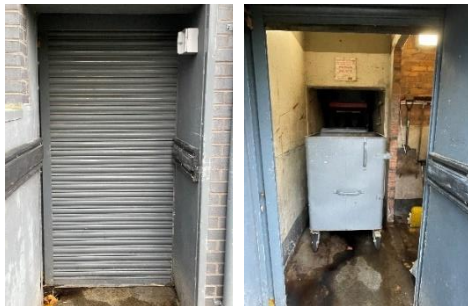
The bin store is situated to the right-hand side of the rear entrance.

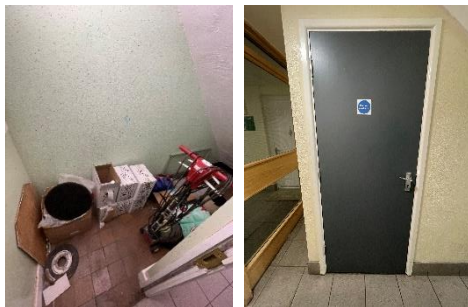
There is a cleaner's cupboard beneath the front ground floor staircase.

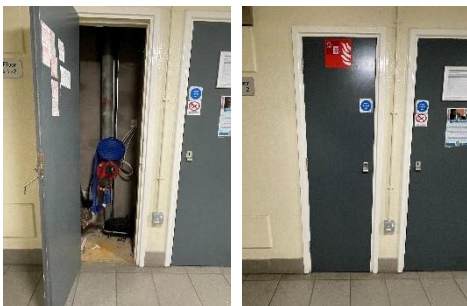
Service cupboards containing resident's electricity meters are in each lift lobby.

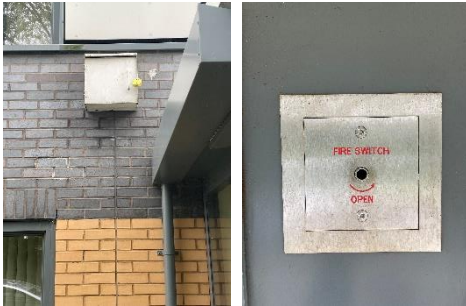
There is a firefighter's white box externally to the left-hand side of the main entrance to the front of the building. The box contains keys for the building and is secured with a bridge-door padlock.

Access is gained via the firefighter's door override switch using the drop latch key in the white box.

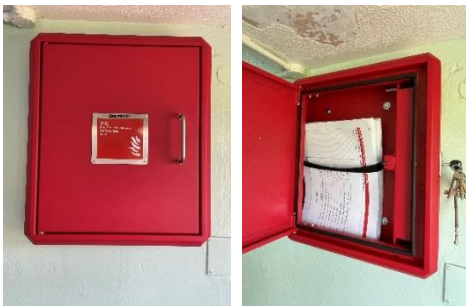
There is a Secure Premise Information Box (PIB) located in the ground floor front entrance lobby. It is a Gerda box that uses a standard WMFS suited key. The PIB contains floor plans, vertical plans, orientation plans, information for WMFS and documents for those with vulnerabilities who may require additional consideration if there is a fire incident (PEEP).

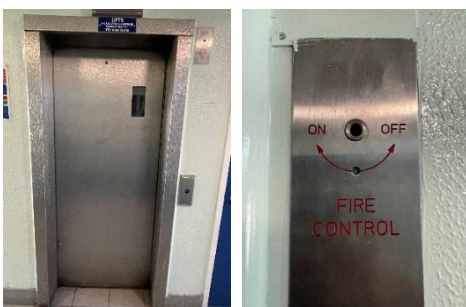
There is a firefighter's lift override switch to the right-hand side of the lift car. This is operated by the drop latch key.

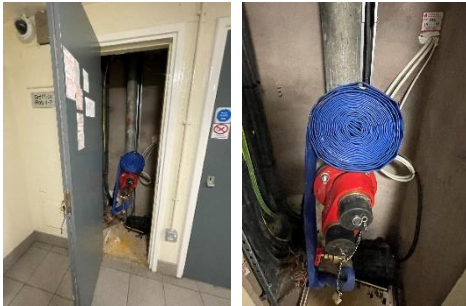
The dry riser inlet is next to the ground floor lift car. Accessed is gained using the suited 54 key, also contained in the white box.

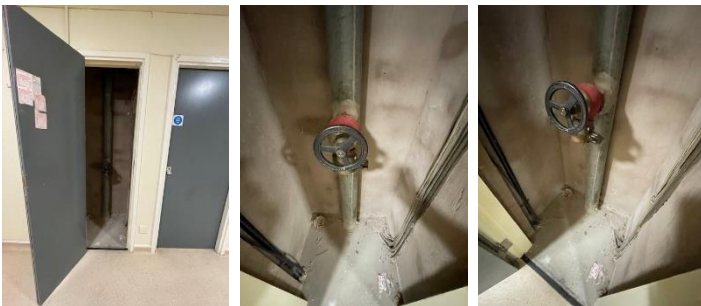
Dry riser outlets are available on each floor within the secured cupboards adjacent to the lift car by suited 54 key & mortice locks.

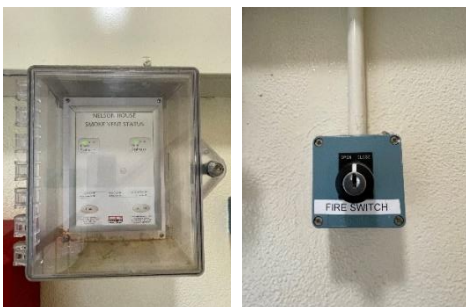
Automatic opening vents are installed to the front and rear staircases. The information panel & firefighter override switch are immediately left the main front entrance.

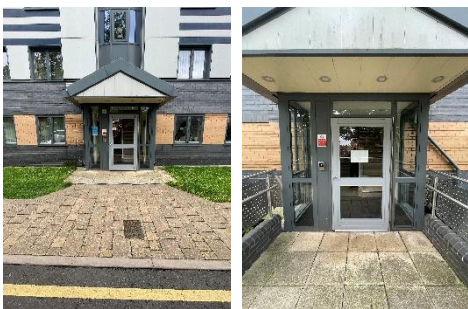
- 4) Entrance doors to the building are powder coated aluminium units.

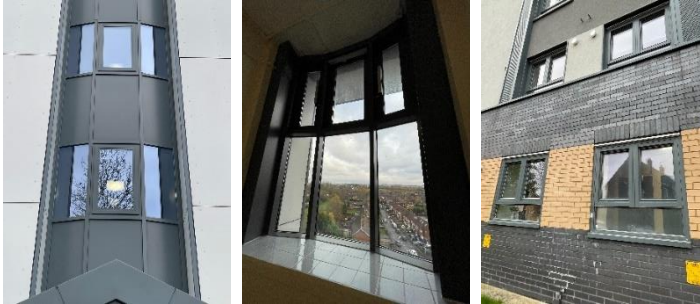
- 5) Windows to individual flats and communal storage areas are powder coated aluminium externally and timber internally.

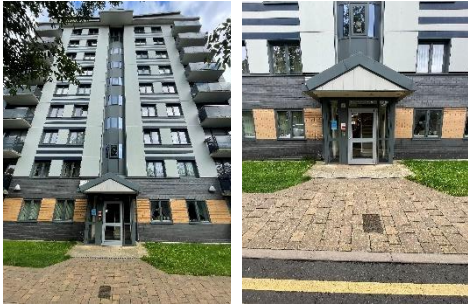
- 1) There is a fire hydrant adjacent the front main entrance.

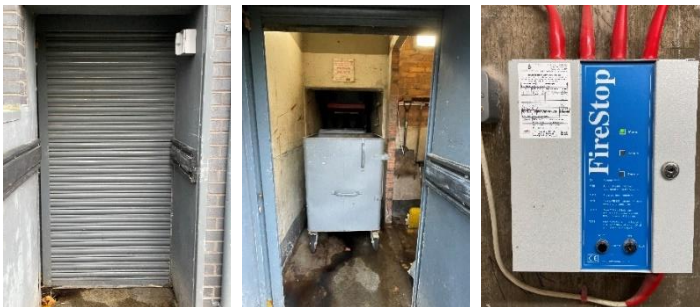
- 7) Bin room is protected by Deluge/sprinkler system and serviced 6-monthly. The control panel is in the ground floor area containing the welfare room.

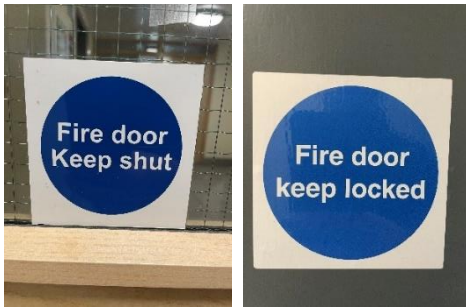
- 1) All fire doors display “Fire Door Keep Shut” where appropriate.

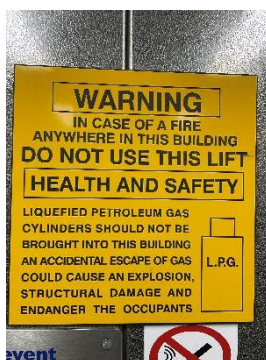
- 3) Yellow LPG warning signs are displayed within the lift cars.

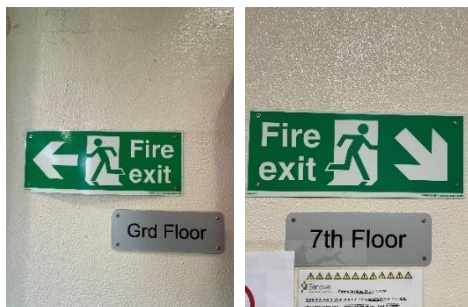
- 6) Directional fire escape signage has been installed throughout the building.

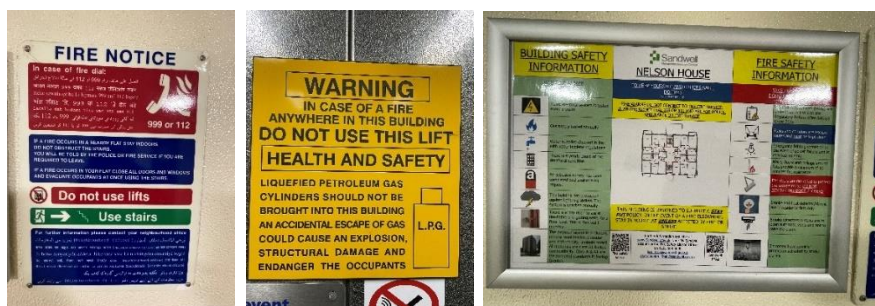
- 1) All Caretaking / Cleaning Employees have undertaken fire safety training. This includes use of bespoke 'Fire Safety in High / Low Rise Flatted Accommodation' Video.
- 2) All employees are encouraged to complete 'In the line of fire' training on an annual basis.
- 3) Caretaking Teams are not currently trained in the effective use of fire extinguishers. The only extinguishers located are within the lift motor room. Caretaking Teams are not expected to tackle fires in this area.
- 4) Staff undertaking fire risk assessments are qualified to Level 4 Diploma in Fire Safety.
- 5) Fire safety information has been provided as part of tenancy pack.
- 6) Building safety and evacuation notices are displayed in common areas and lift cars.

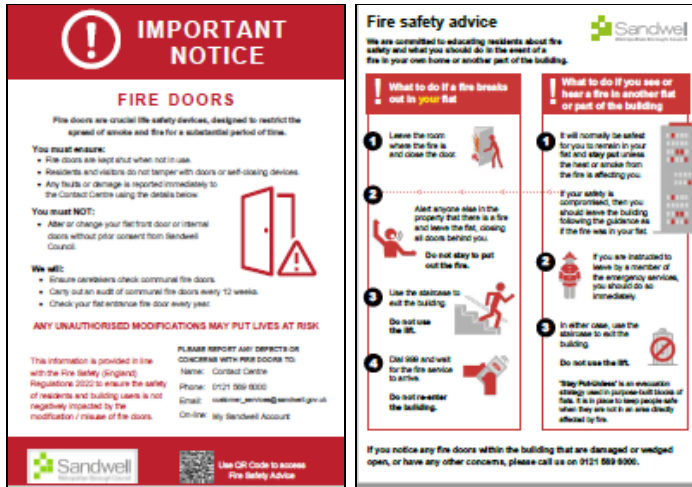
- 7) Fire safety information has been provided as part of tenancy pack. Information regarding the Stay Put Unless fire evacuation strategy is provided to tenants.

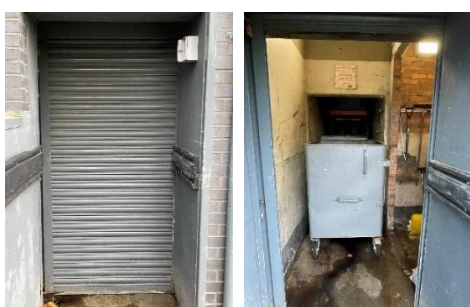
- 2) Refuse containers are located in the bin store which is to the right-hand side of the rear entrance. Access is via a motorised roller shutter; key is stored in the firefighter's white box. All refuse containers are emptied regularly.

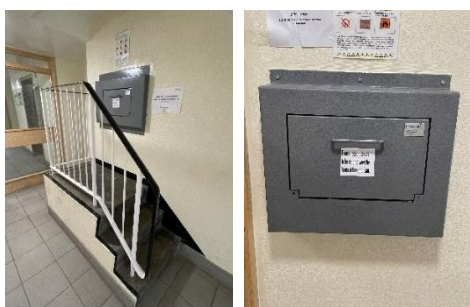
- 3) Refuse hoppers are accessed in each floor of the rear staircase.

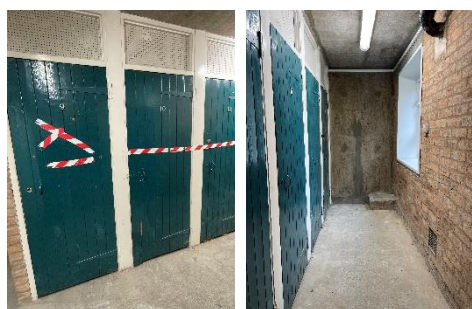
- 2) The tenancy conditions, Section 7 – Condition 5.6 stipulates “If you live in a flat or maisonette, you, people living with you and any visitors to your property must not keep or use paraffin oil, petrol, bottled gas appliances or any other explosive, FLAMMABLE, or dangerous material in the property. This restriction also applies to any storage facility situated in or attached to the block, which has been provided for your use.”
- 3) No Flammable liquids stored on site by Caretakers / cleaners.
- 4) All store cupboards are kept locked.
- 5) There are no flammable liquids or gas cylinders stored on site.
- 6) Residents have access to storage sheds located on the ground floor. The area is accessed via an FD30s nominal door and protected with hardwired smoke detection. All shed doors are secured with mortice locks.
