Fire Risk Assessment

**Flats 1 - 12 – 19 - 30
Howard Street.
Tipton,
DY4 8UF.**

Date Completed: 08/11/2024.

Officer: A. Jones Fire Risk Assessor.

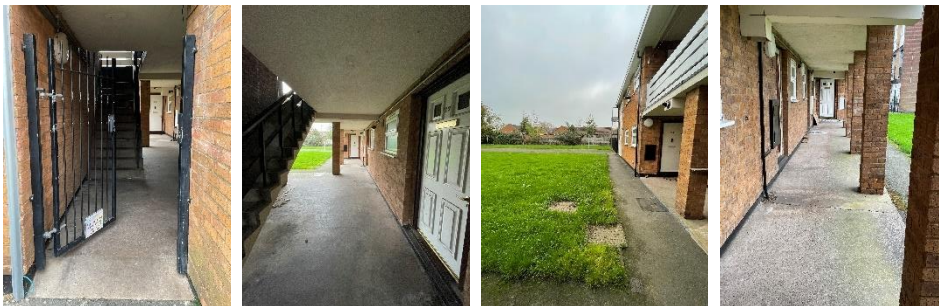
- 4) Access is gained to all flats from the ground floor using the main access gate at the front elevation of the building. The rear of the building is open plan with deck access on the first floor.

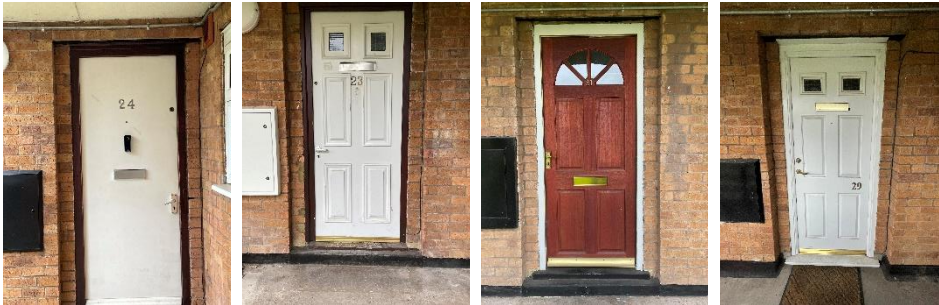
- 6) There is an out of hour's service that allows combustible items of furniture / rubbish to be removed.
- 7) Automatic smoke ventilation is not employed as areas are open deck. However, there is an openable double glazed window on the first floor which could be used for ventilation if necessary.
- 8) The means of escape are protected to prevent the spread of fire and smoke with a combination of nominal FD30s doors consisting of composite and timber front doors. Where applicable, timber flat entrance doors should be replaced when the fire door replacement programme commences.

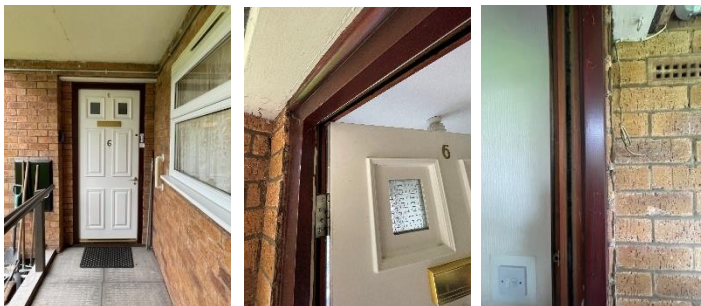
- 9) No internal access to flats was gained during the fire risk assessment to ensure the doors have not been tampered with by residents etc. The resident at flat number 1 provided information on the flat entrance doors. This door appeared to be an FD30s door, no issues with the door.
- 10) The resident at flat number 6 provided information on the flat entrance doors. This door appeared to be an FD30s door, no issues with the door.

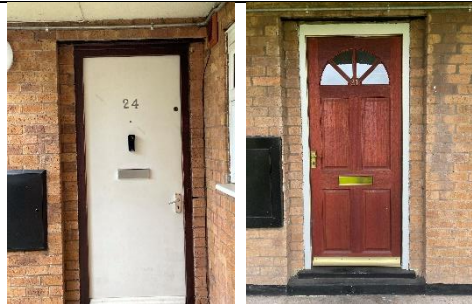
Observations	
As part of any future upgrades, replace timber flat entrance doors for FD30s.

As part of any future refurbishments internal store cupboard doors should be upgraded to FD30 fire doors. to provide adequate protection on the means of escape.
