Fire Risk Assessment

Trinity House 1-18

**Florence Road,
West Bromwich.**

Date Completed: 21/11/2024.

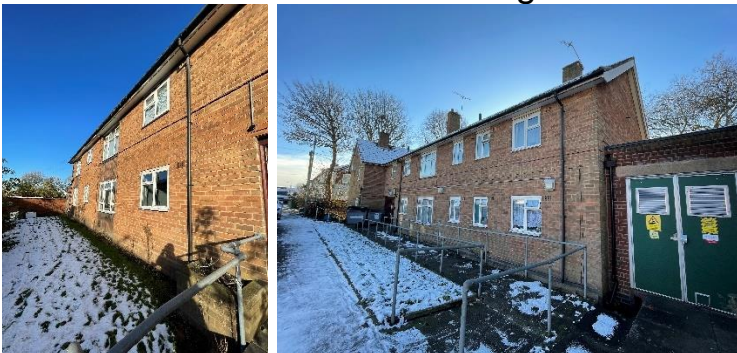
- 1) The external walls of the building are a brick masonry.

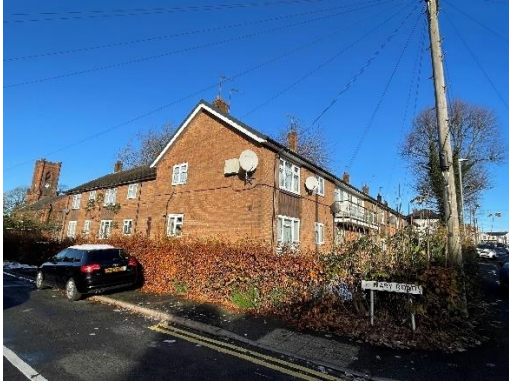
- 2) The building has a pitched and concrete tiled roof.
-

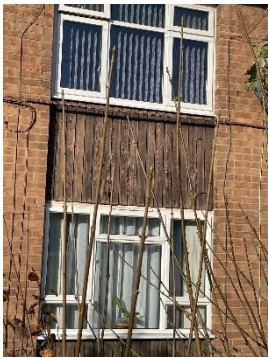
- 4) Flat windows are UPVC glazed units.

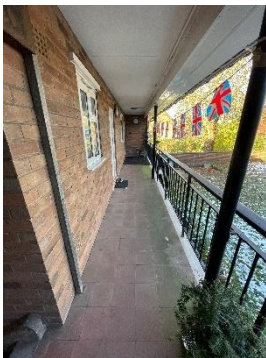
- 5) Concrete open deck access corridors with steel balustrades to the rear.

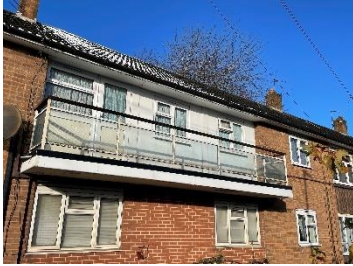
- 6) The only balcony at Trinity House is accessed by flat 6a. The balcony has a steel and glass balustrade with presumed concrete cantilevered floor and UVPC soffit board.

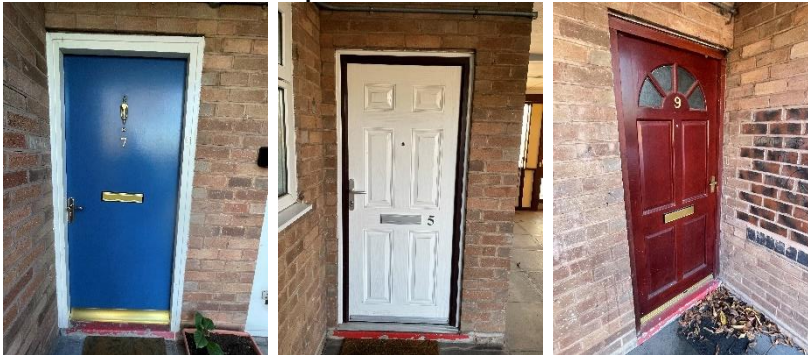
- 7) Flat entrance doors are upgraded notional fd30 timber, timber non fire rated and composite which is flat 5.

Where necessary replace all upgraded notional flat entrance fire doors / non fire doors with FD30s	n/a

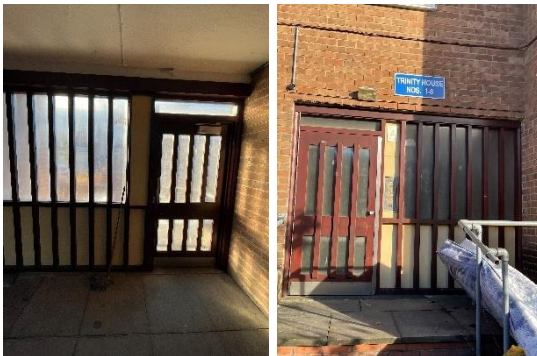
- 8) Entrance doors and combination frames to the block are timber.

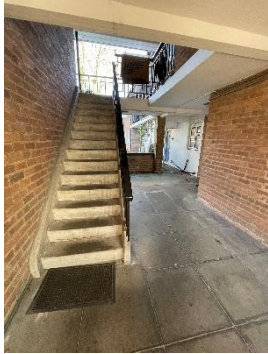
- 1) A concrete staircase 980mm in width leads to an open deck corridor which provides access & egress for flats 2,4,6,6a & 8

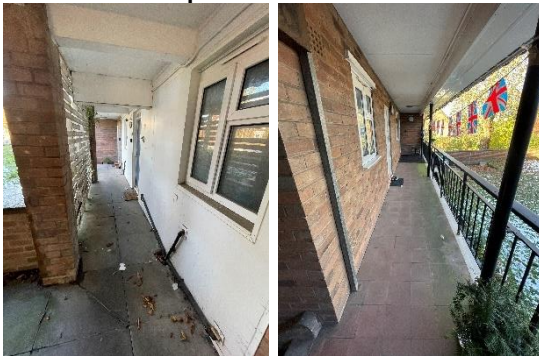
- 2) A second concrete staircase also 980mm wide leads to an open deck corridor which provides access & egress for flats 10, 12, 14, 16 & 18.

- 3) There are no internal communal corridors. Open deck corridors are of adequate width at 1320mm wide.

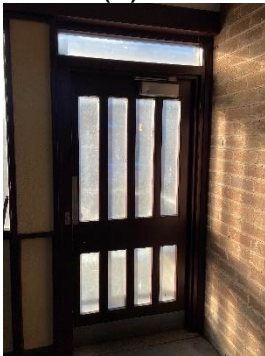
- 6) The only communal doors within the blocks are the final exit doors, these are fitted with automatic closing devices that are checked on a regular basis by Caretaking Teams as part of their checks. Defective closing devices are replaced either by the Caretaking Team(s) or the in-house repairs team(s).

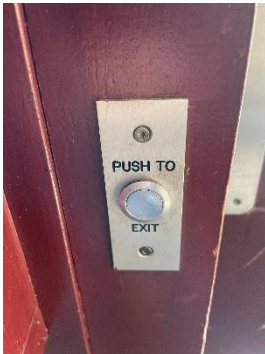
- 7) Both final exit doors have push buttons to exit.

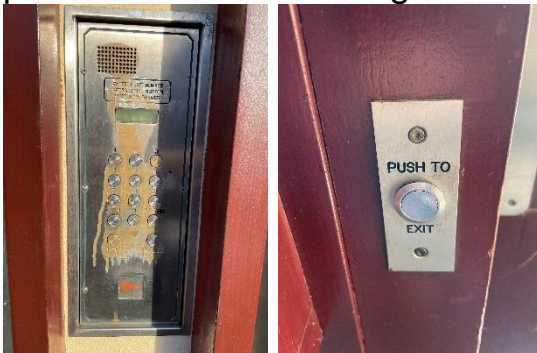
- 8) Residents have a choice of two final exit doors. Both doors have door entry systems installed. These systems are designed to fail safe i.e., door unlocked in the event of a power failure. This prevents residents being locked in or out of the building.

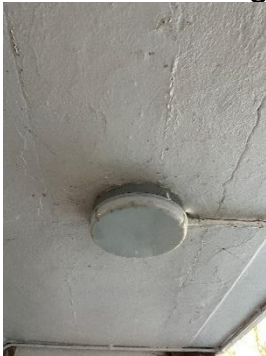
- 10) There is no requirement for emergency lighting to be installed. Conventional lighting is present within the communal areas.

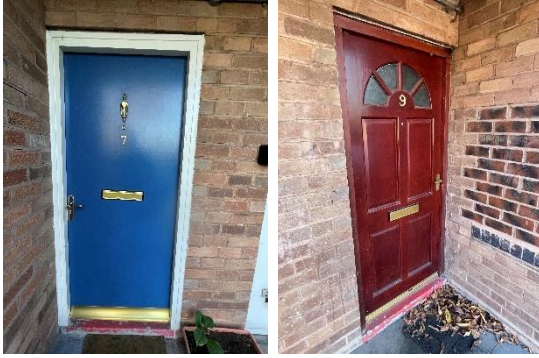
- 11) The building has sufficient passive controls that provide effective compartmentation to support a Stay Put-Unless Policy. Therefore, residents are advised to remain in their flat unless the fire directly affects them.
- 12) Based on information from the previous fire risk assessment, and information gathered during this survey, individual flat entrance doors are a combination of notional timber upgraded FD30, a single composite door (flat 5 ground floor / unknown fire resistance) and non-fire rated timber doors.

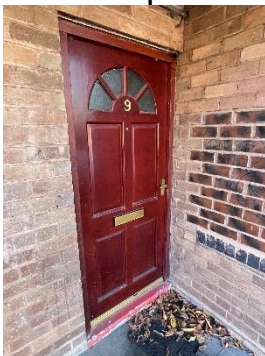
14) Flat 9 ground floor, has a standard non-fire rated timber door which is acceptable because the door opens to the elements and the area doesn't form part of the route to relevant safety for other relevant persons in the building.

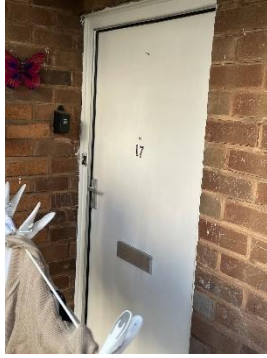
a) Flat 17 ground floor – This door is a notional timber 30 minute fire door upgraded with an intumescent strip. The door was correct.

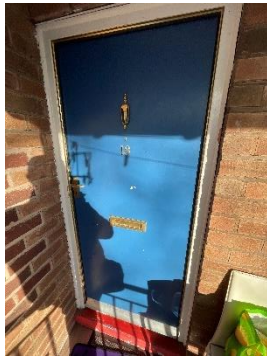
- b) Flat 18 – 1st floor furthest from the stair. This door is a notional timber 30 minute fire door upgraded with an intumescent strip.

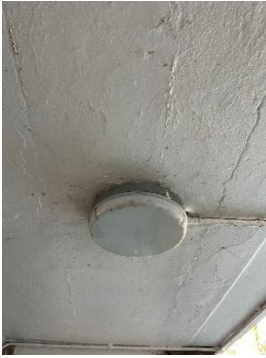
- 1) The blocks have conventional lighting to the communal areas.

- 2) Emergency lighting is not necessary and therefore has not been installed.

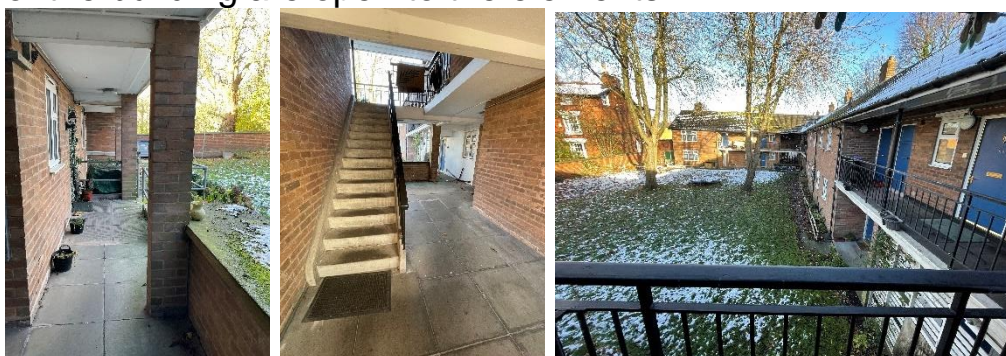
- 1) The building is designed to provide as a minimum 1-hour vertical fire resistance between dwellings and 1-hour horizontal fire resistance around flats.
- 2) The premise does not have sufficient compartmentation to limit the travel and effect of smoke and flame in event of a fire in communal areas due to open plan design of the building. All communal areas of the building are open to the elements.

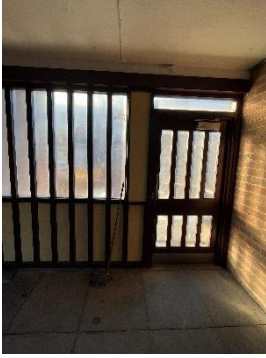
- 3) There is a cyclical programme (annually) to ensure fire stopping has not been compromised by third parties and where applicable enhance the fire stopping.
- 4) Any remedial works arising from the fire stopping / compartmentation check(s) will be actioned immediately by the Fire Safety Rapid Response Team.
- 5) The only communal doors within the building are the final exit doors.

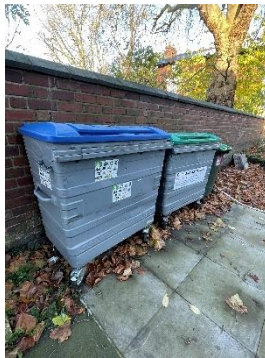
a) Two euro bins are stored in the rear garden against the wall at a safe distance from the building.
