Fire Risk Assessment

Kynaston House

**Rydding Lane, Millfield's,
B71 2HD**

Date Completed: 16/01/2025.

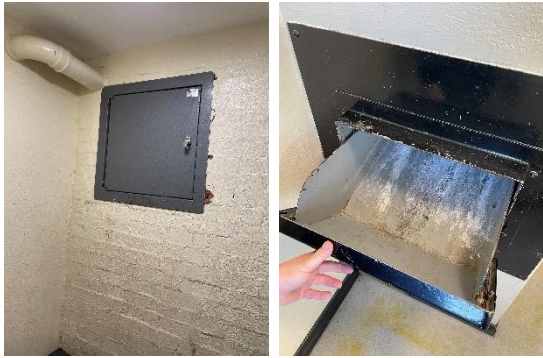
Refuse chute hoppers are available on each floor. The ground floor hopper is contained within a room adjacent flat 44. Hoppers on floors 1 – 10 are not housed in cupboards but are adjacent an AOV in the corridor.

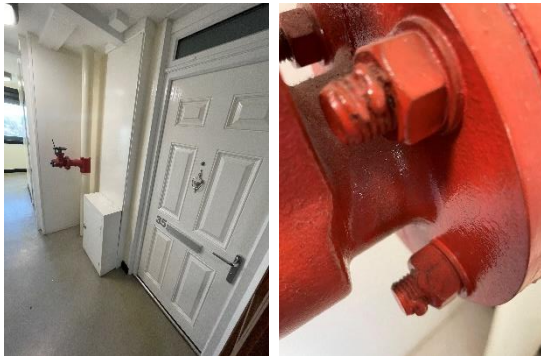
The dry riser outlets are located on all floors 1-10 within the rear corridors. Riser outlets are not contained in cupboards therefore, the thread bolts have been welded to prevent unauthorised removal.

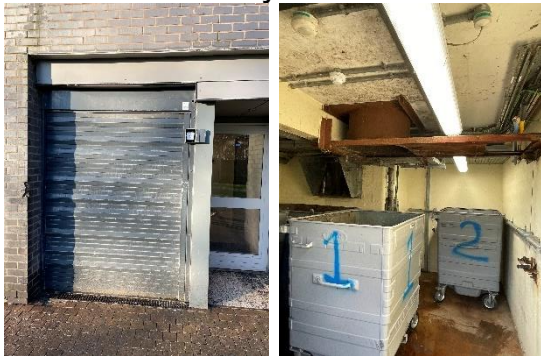
A fire suppression system and automatic chute closer plate has been installed to the bin store which is at the rear of the building. The bin store roller shutter key is stored in the Firefighter's white box.

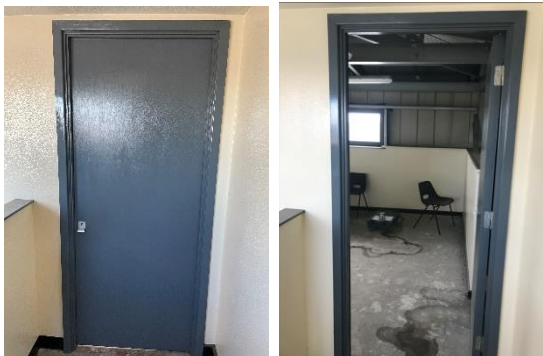
The staircase adjacent the lift motor room and roof void door continues up one more level. A vacant room is at the top of the stairs and is secured with a suited 54 key mortice lock stored in the Firefighter's white box. At the time of this assessment the room appeared to be unused.

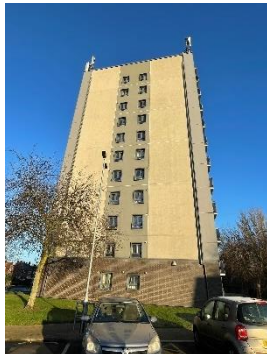
- Rockwool RedArt Silicone render system to the side elevations. This consists of a EWI fixed with board adhesive and mechanical fixing. Then a basecoat complete with mesh and Rockwool silicone top coat (fire classification unknown FRAEW to be completed by Firntec).

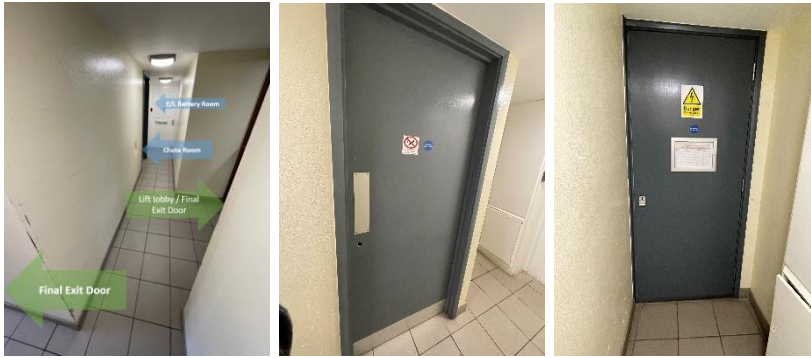
- 3) The maximum travel distance from the furthest flat to the protected stair is 6 metres.
 - 4) The communal corridor providing a means of escape for flat 44 (ground floor) is 820mm in width and 3.5 meters long to the nearest place of reasonable safety (lift lobby). This corridor contains a chute room with an FD60s self-closing door and a service cupboard housing the central battery system for the emergency lighting which is secured with an FD60s locked door (suited 54 key mortice lock). The risk is sufficiently mitigated to maintain an acceptable means of escape for flat 44.
-

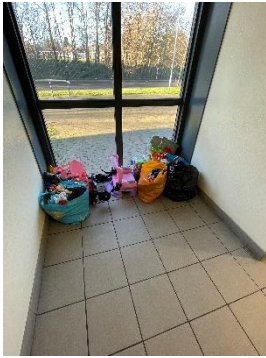
16) Bags of clothes and toys were noted in the ground floor front entrance lobby. The occupants of flat 1 agreed to remove the items and began to do this immediately.

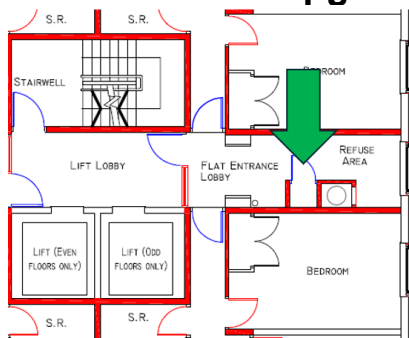
- 9) The door to service cupboard on floors 1-10 in the rear lobby access corridor (next to chute hopper) is an upgraded notional FD30 fire door with an intumescent strip and 25mm stop. The cupboard contains AOV control equipment and cabling which penetrates the floor slab. It was noted that cupboards on the 10th and 4th floor are utilised as a cleaner's cupboard / store. The keys are held centrally at SMBC Roway Lane, and within the firefighter's white box. **It is recommended that all of these doors on floors 1-10 are further upgraded with cold smoke seals.**

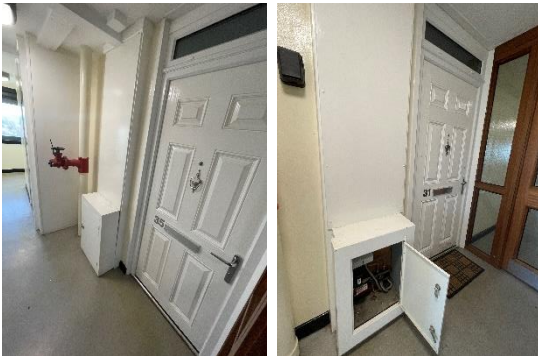
12) Individual electricity meters are housed in modular units fitted with budget locks, located outside each flat within the lobby access corridors. There is an automatic opening vent, FD30s cross corridor door and each installation is regularly inspected (DEICR) which contributes to mitigating the risk. Further Notes added to the observations in section 19.

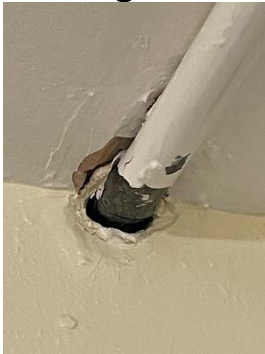
- 20) Fire stopping required around 5th floor penetration above landing door.

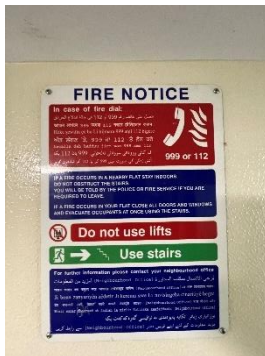
- 2) Fire Action Notices are displayed throughout the building.

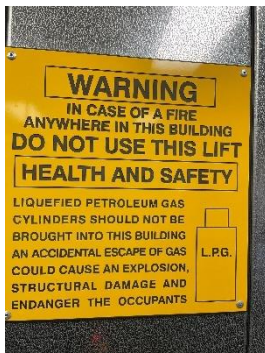
- 3) Yellow LPG warning signs are displayed within the lift cars.

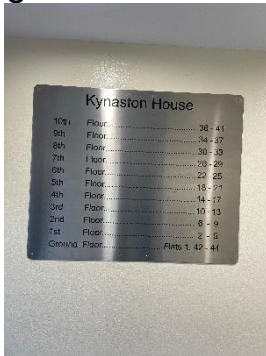
- 4) Signage depicting the floor location of each flat is fitted to the ground floor lobby wall.

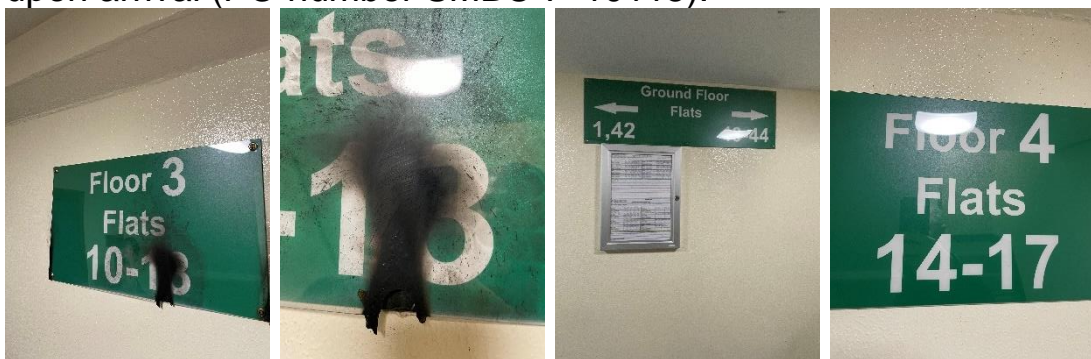
- 5) Photoluminescent wayfinding signage depicting floor level and flat numbers are fitted to the walls on all floors adjacent the lift car's and to the wall of each landing on the communal staircase. Signage that meets the requirement of ADB and Fire Safety (England) Regulations 2022. A 3rd floor sign has been damaged by arson however a replacement has been ordered and will be fitted upon arrival (PO number SMBC-P-10115).

- 1) Regular checks are undertaken by Caretakers / Cleaning Team(s) 365 days per year which helps reduce the risk of arson.
- 2) Restricted access to the premises by means of a door entry system.
- 3) No CCTV systems installed within the block.
- 4) Evidence of arson was noted to the 3rd floor stairwell wayfinding signage ([also recorded in section 12/5](#)).

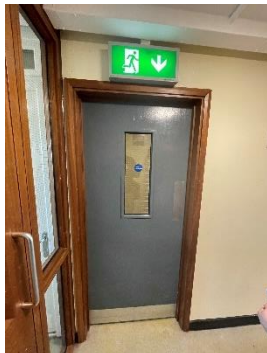
- 6) Directional escape signage is present in lift lobbies on floors 1-10.

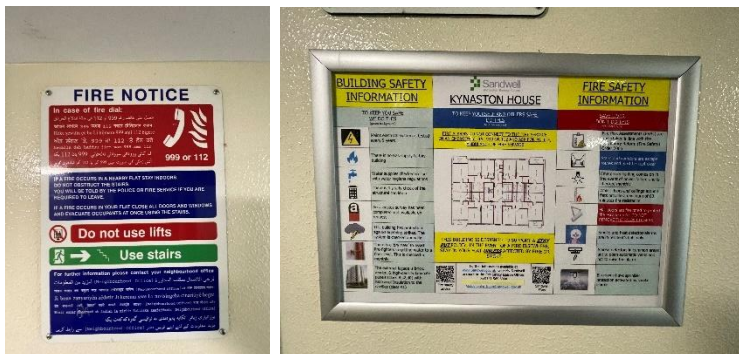
- 1) All Caretaking / Cleaning Employees have undertaken fire safety training. This includes use of bespoke 'Fire Safety in High / Low Rise Flatted Accommodation' Video.
- 2) All employees are encouraged to complete 'In the line of fire' training on an annual basis.
- 3) Caretaking Teams are not currently trained in the effective use of fire extinguishers. The only extinguishers located within the lift motor room. Caretaking Teams are not expected to tackle fires in this area.
- 4) Staff undertaking fire risk assessments are qualified to Level 4 Diploma in Fire Risk Assessment.
- 5) Fire safety information has been provided as part of tenancy pack.
- 6) Building safety and evacuation notices are displayed in common areas and lift cars.

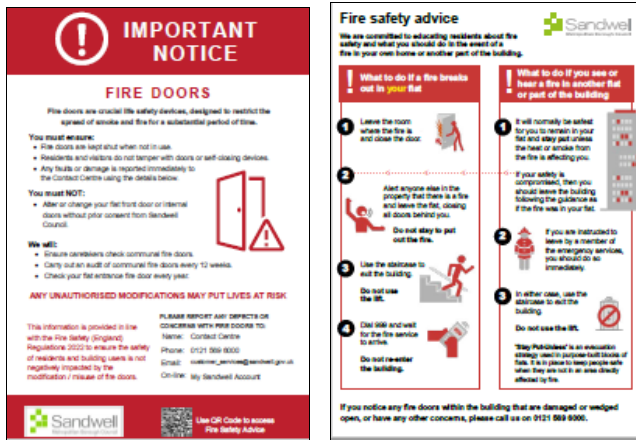
7) Information regarding use of fire doors and the Stay Put Unless fire evacuation strategy is provided to residents.

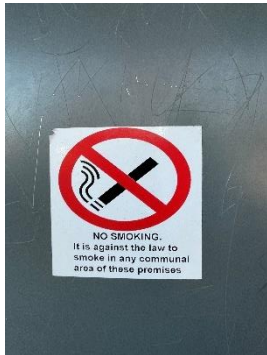
- 1) Smoking is prohibited within any communal parts of the building in line with Smoke Free England legislation.

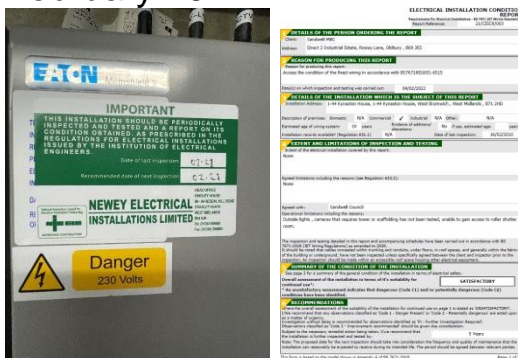
- 2) Hot working is not normally carried out. If essential maintenance requires the use of hot work processes, then corporate policies and procedures are to be followed.
- 3) Portable electrical equipment used as part of the Caretaking / Cleaning regime is subject to annual PAT Testing. This information is held by the Estate Services Manager Bryan Low.
- 4) The fixed electrical installation shall be tested every 5 years. It was noted that the last inspection was recorded as “satisfactory” 9th February 2022.

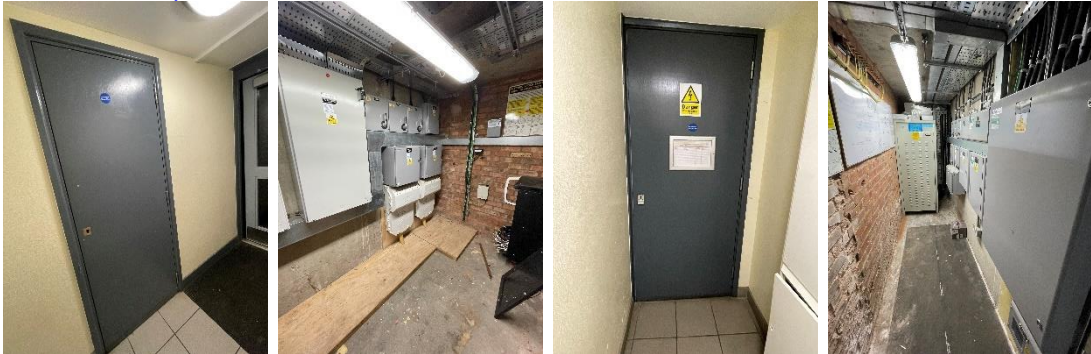
- 5) The electrical installation i.e. risers are contained within dedicated service cupboards that are secured with locked fire door [sets \(see section 10\)](#).

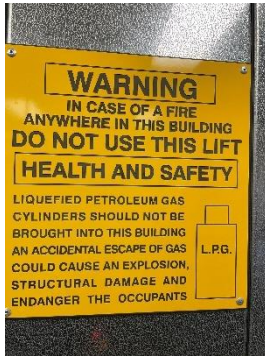
- 1) Residents instructed not to bring L.P.G cylinders into block.

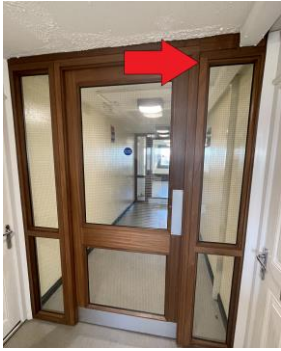
10/19	10 th floor lift lobby door near flat 38 – fire stop small gap in frame with intumescent filler.

P2	1-3 Months Rapid Response Fire	
10/20	5 th floor – firestop penetration above landing door.

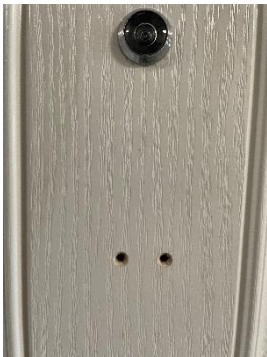
P2	1-3 Months Rapid Response Fire	
10/21	4 th floor - Flat 14 fire stop to small holes in entrance door.

P2	1-3 Months Rapid Response Fire
