# Fire Risk Assessment

## Greenford House

**Maria Street, West Bromwich,  
B70 6DX**

**Date Completed:** 20/12/2024.

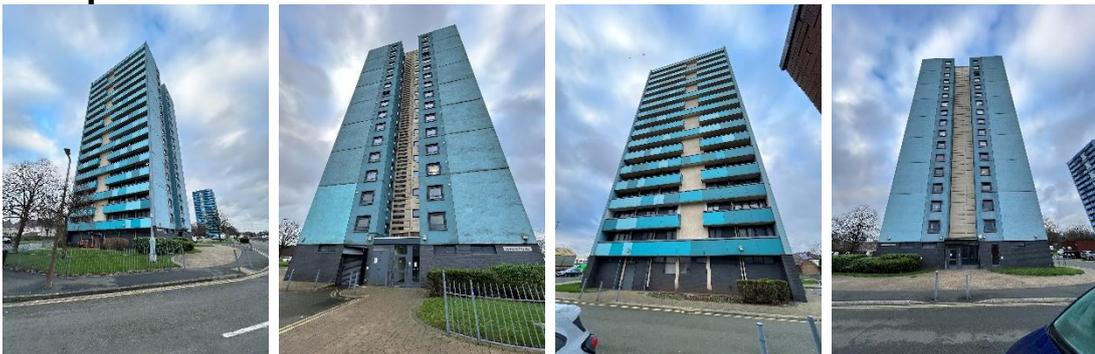
- 1) The block was constructed of a Insitu concrete frame with masonry infill (Wates) construction, last refurbished in 2010 with the addition of a external wall system. The external facade consists of high density laminate board (B,s1, d0), Rockwool insulated render (A2), brick (A1) . The combination of the materials used present an **acceptable** level of risk.

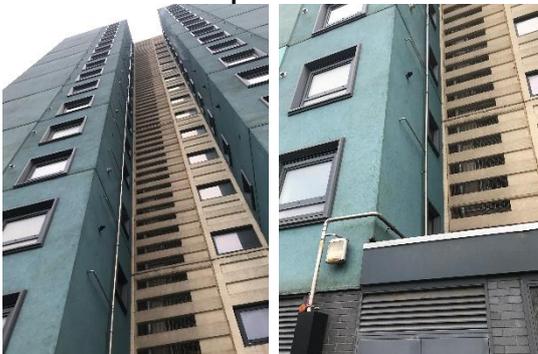
- 9) Gas was noted to be external running along the rear elevation. Gas isolation points located on the orientation plan.

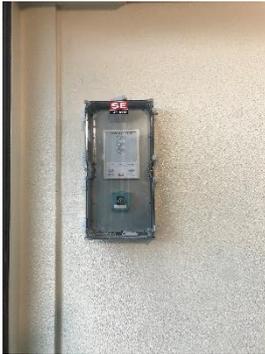
- 23) Smoke control systems located on the ground floor near the main entrance to the block.

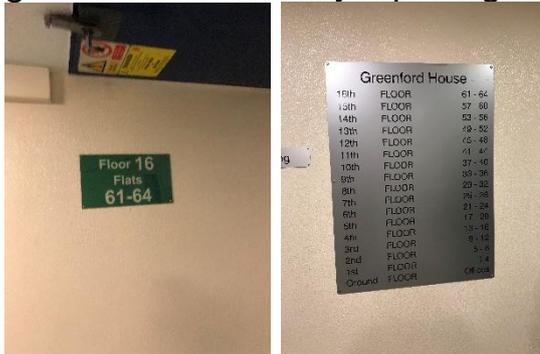
- 27) Wayfinding signange has been introduced on all floors including lift lobby and the stair landing in line with the Fire Safety (England) Regualtions 2022, as well as existing signage in place on the ground floor lift lobby dipicting all floors.

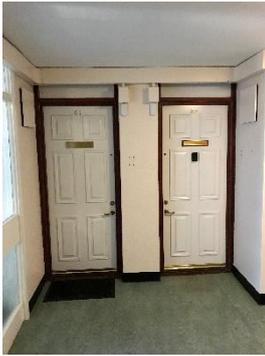
- 8) Any remedial works arising from the fire stopping / compartmentation check(s) will be actioned immediately by the Fire Safety Rapid Response Team.
- 9) Individual flat doors are predominantly nominal 44mm fire door sets with intumescent strips, cold smoke seals and self-closing devices.

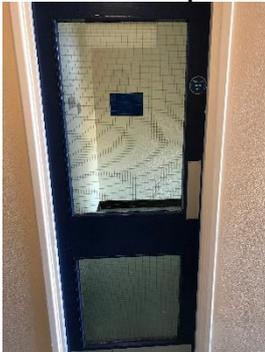
- 10) The communal landing, staircases & chute rooms are protected by use of notional self-closing 44mm 30-minute timber fire doors with vision panels & 25mm stops.

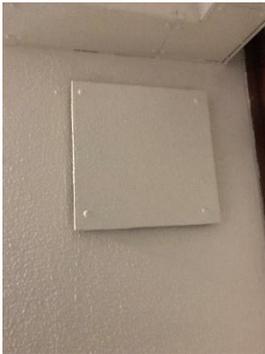
- 12) Access panels to stop taps are fixed to masonry and bedded on Intumescent material.

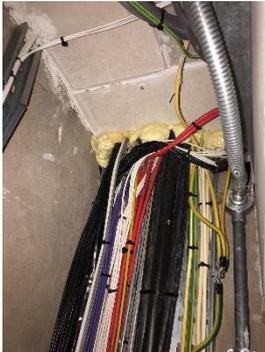
- 16) The use of expanding foam was present within the communal cupboards around cabling as part of the fire stopping knowing that intumescent pads and a concrete slab is present and this foam is only used as an enhancement it is deemed tolerable. This should be enhanced as part of future works to the building and replaced with intumescent mastic to improve fire stopping.

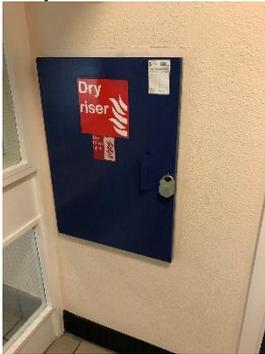
- 1) The dry riser inlet cupboard is located in the ground floor lift lobby and is appropriately signed. The riser is accessed behind a metal cupboard and secured via a padlock.

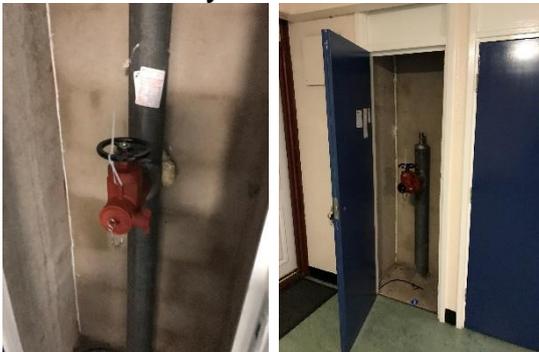
- 2) The riser outlets are available on each floor lobby (1<sup>st</sup> – 16<sup>h</sup>) these are protected via notional 44mm 30-minute fire doors secured by suited 54 key & mortice locks.

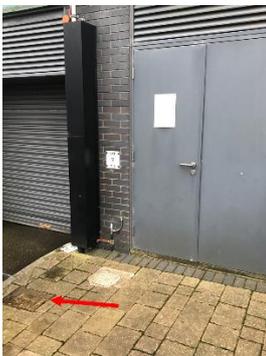
- 6) Fire hydrant can be located at the rear entrance/exit of the building 1m from the door near the bin store shutters.

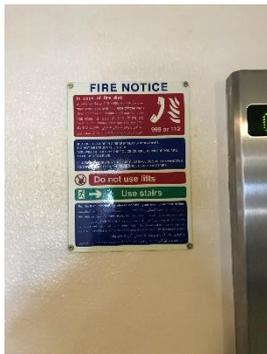
- 2) Fire Action Notices are displayed throughout the building.

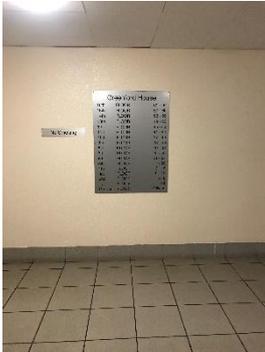
- 4) Signage depicting the floor location of each flat is fitted to the ground floor lobby wall it was noted that the sign displays the office space on the first floor as flats 1-4 the location of the flats is correct however these flats have been converted into office spaces.

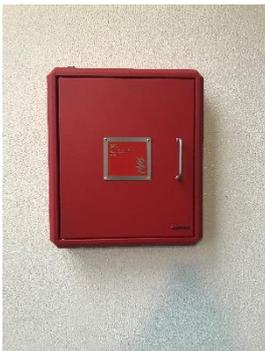
- 8) Premise information box is signed appropriately and located at the main entrance to the block.

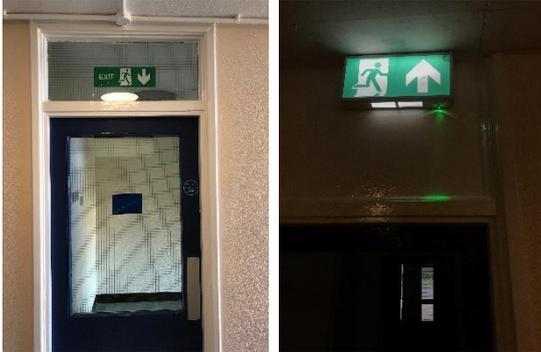
- 9) The fire escape routes have directional signage placed within the block, note the illuminated emergency escape light testing records are yet to be established and should be confirmed.

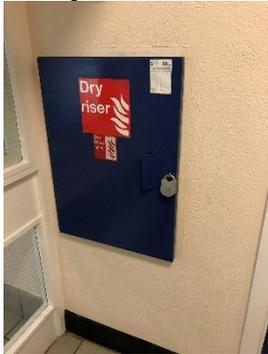
- 10) Dry risers are appropriately signed.

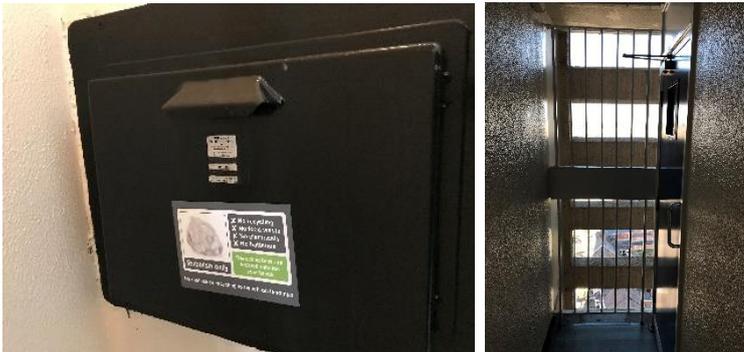
- 2) Refuse hoppers are accessed on each floor secured behind its own dedicated notional 44mm 30-minute door with combined intumescent and cold smoke seals.

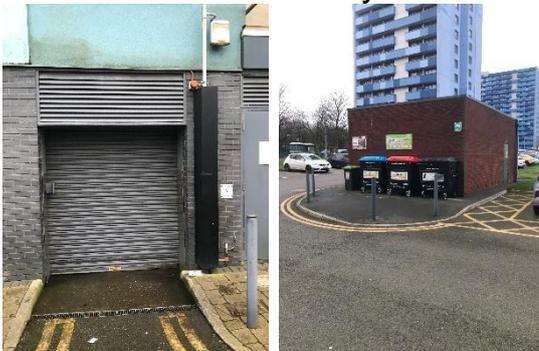
- 3) Refuse containers regularly emptied bin store located at the rear elevation of the block. There is also a recycling project currently being undertaken at the block, recycling bins are stored at a suitable distance away from the block within the car park.

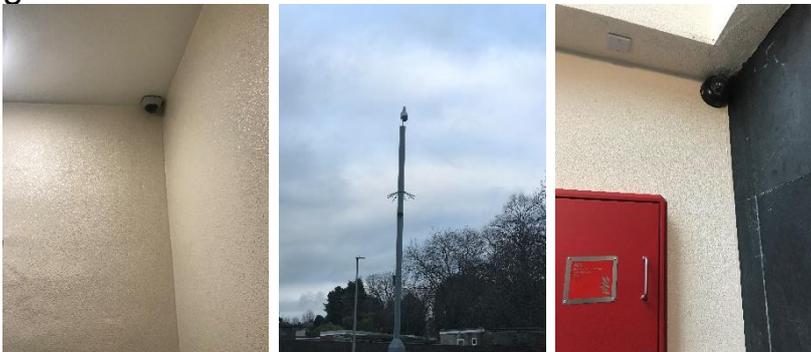
- 3) There is CCTV system in place that covers the external perimeter, ground & First floors and lift cars.

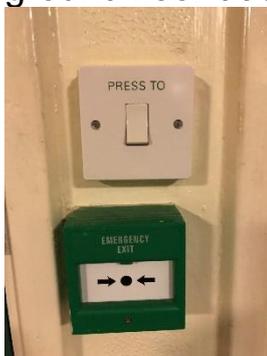
- 9) Kitchens are located the furthest point away from the exit doors (see plans).
- 10) Push to exit buttons allow safe easy exit from the office space into the protected staircase or Lobby areas, thumb turns in place on ground floor doors leading lobby area.

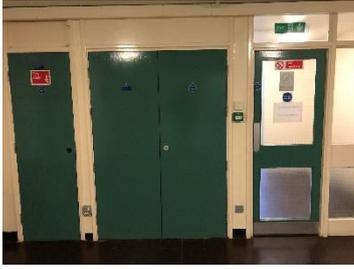
- 15) A dry riser is present within the lobby entrance in the first-floor office area with adequate signage.
-

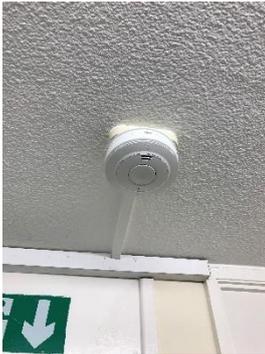
- 16) Normal fire hazards present including office supplies, furniture, and electronic devices within the main office. This area is generally well maintained with good housekeeping.
- 17) Detection is in place along the means of escape to support the current evacuation strategy within the main office area. Fire action notices and escape signage is strategically placed throughout. Break glass points are no longer in use and a manual call/bell is used to alert to fire.

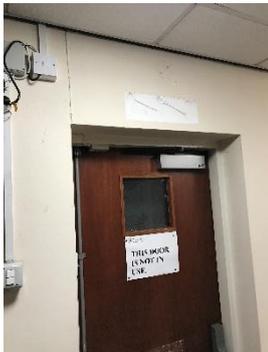
- 18) Emergency exit door Located on the ground floor is no longer in use and therefore redundant SMBC employees who access the site are aware and adequate signage is in place.

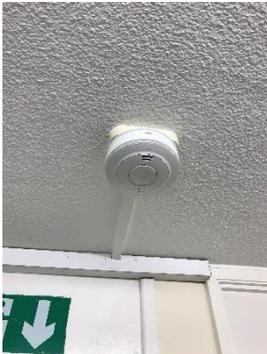
- 21) Early warning systems are limited to hard wire battery smoke alarms within the main office.

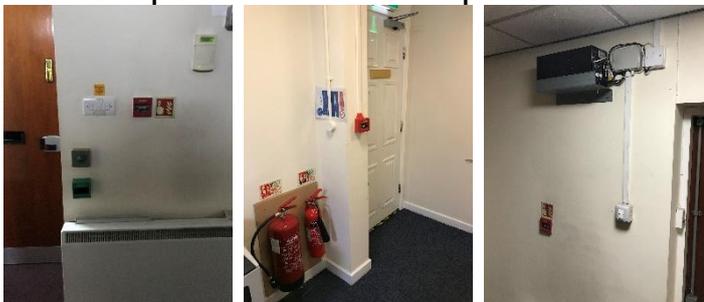
- 22) There were 3 break glass manual call points strategically located within the premises with two manual call points located in the downstairs office areas and 1 in converted flats 1/2 now meeting area. The manual call points are no longer in use. Employees accessing the site are aware of this and the use of Manual verbal evacuation procedures are in place including a bell this is deemed acceptable due to the occupancy robust procedures that are in place. Signage should be used to clarify these manual call points are not operational and the panel is decommissioned.

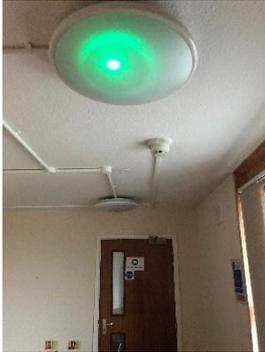
- 25) The premise allows adequate natural daylight to all parts of the office space (excluding store cupboards) via windows.
- 26) The premise has a sufficient emergency / escapes lighting system in accordance with BS 5266 and test points strategically located.

- 27) **It could not be determined whether the installed equipment is checked and tested.**
- 28) Emergency lighting on the ground floor has an isolation point located near the exit door.

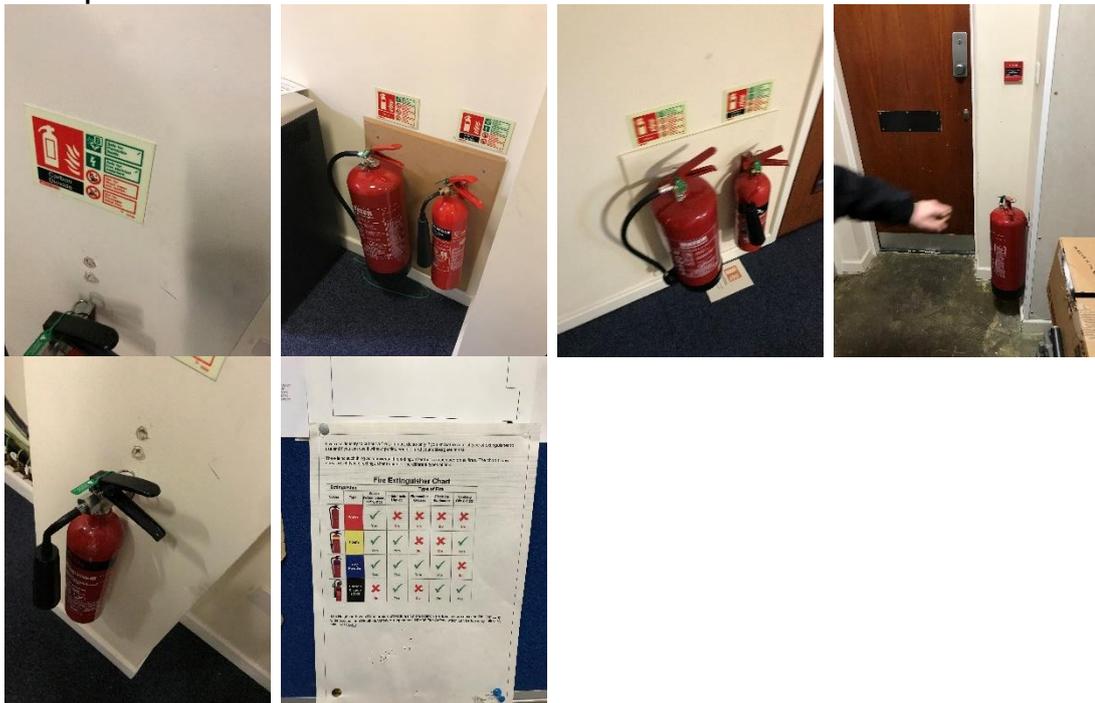
- 32) The office spaces contain adequate provisions for firefighting equipment.
- 33) Firefighting equipment is strategically located along means of escape routes. This includes fire blankets within kitchens, fire extinguishers in the hallway, main office area, meeting room areas and ground floor office spaces. Guidance on fire extinguishers is also provided.

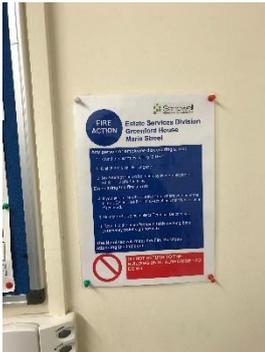
37) Fire action notices are displayed throughout the office spaces. It is not expected for employees who are not trained to use firefighting equipment. Incorrect signage was displayed during the FRA however has since been replaced.

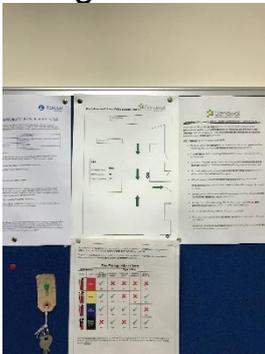
38) Signage detailing the escape route from offices placed strategically around the premise. All employees who use the site being aware of the procedures.

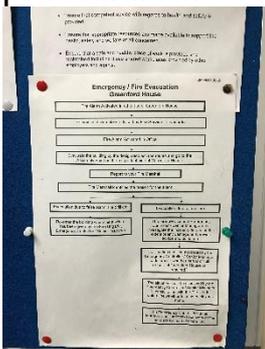
39) Emergency fire evacuation plans placed strategically around the premise. All employees who use the site being aware of the procedures.

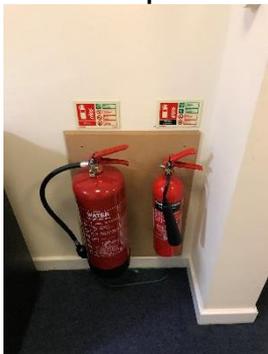
- 40) Appropriate signage has been installed for firefighting equipment's and call points.

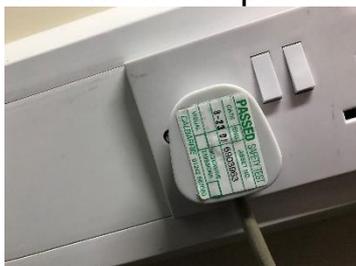
- 48) Smoking is prohibited within any communal parts of the building in line with Smoke Free England legislation.
- 49) Hot working is not normally conducted. If essential maintenance requires the use of hot work processes, then corporate policies and procedures are to be followed.
- 50) Portable electrical equipment used as part of the Caretaking / Cleaning regime is subject to annual PAT Testing. This information is held by the Estate Services Manager Bryan Low.
- 51) Portable electrical equipment that is used within the office should be tested in accordance with corporate procedures. It was noted that the latest pat testing was conducted August 2024

- 52) **No evidence of Fixed electrical testing this should be completed every 5 years** - email sent to JN and was stated not to be on the list for testing and the housing office should complete this.
- 53) Daisy chained extension leads were present while conducting the FRA in the main office area (3-4). These could potentially overload the sockets and create a fire risk and should be removed, BL has since been informed and will action this.
- 54) Gas appliances and pipework (where installed are subject to annual testing and certification. The cyclical contract is managed by the in-house gas team.
- 55) It was noted that combustibles and paperwork stored within the office are well maintained and kept to a minimum.
- 56) The employees have access to Kitchen equipment e.g. microwaves, these areas are to remain clear of combustibles.
-

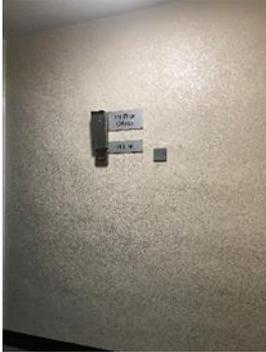
- 63) There is fob entry system that only employees that work within the office can use to access the space visitors must use an intercom and be approved access to enter.

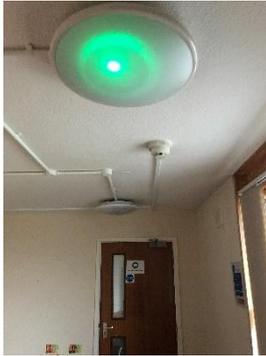
P3	1-3 months Electrical	
20/27	Provide evidence of Emergency lighting tests.
